## status report

#### Audi A5 Coupe 2.7 TDI

| Vehicle identification number | <b>WAUZZZ8T98A027197</b> | mileage read: | <b>189234 km</b> |
| First Registration / construction year: | <b>25.01.2008 / 2007</b> | Visit Date / place of birth: | <b>05.06.2025 Neuss</b> |

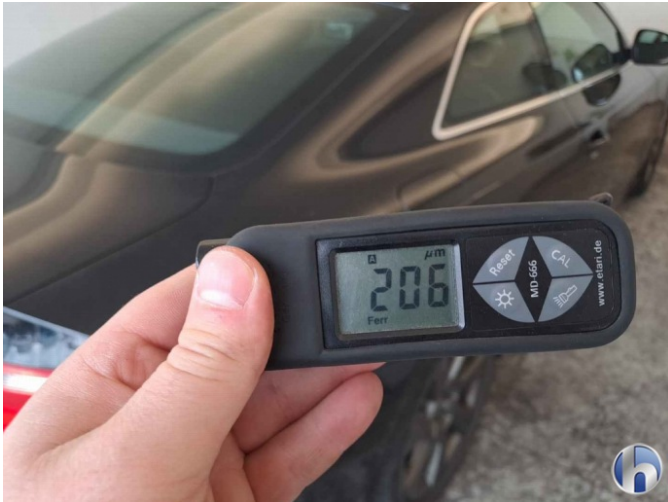
4. Sidewall - Rear - right

| component | Damage | Rep kind |
|---|---|---|
| 32. Sidewall - Rear - right | Damaged | Refurbish and paint |

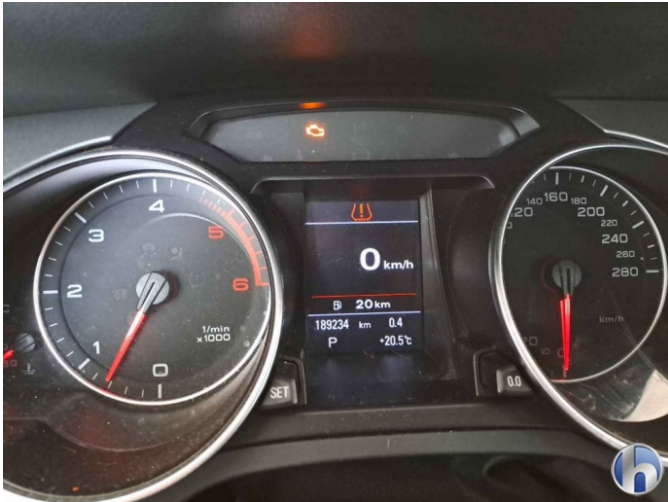
10. Malfunction Indicator Lamp

| Performed testing technology | |
|---|---|
| <b>engine running:</b> | A field test of the engine had to acoustic or visual defects for visiting time .<br>**Engine warning light. It rattles were found. |

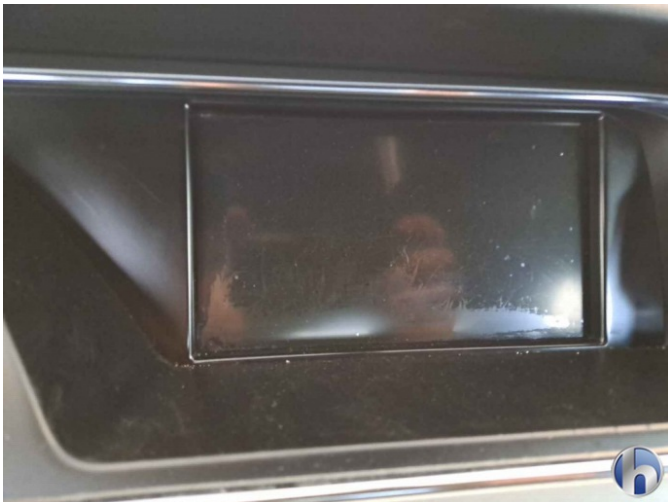
| component | Damage | Rep kind |
|---|---|---|
| 11. | Damaged | Replace |

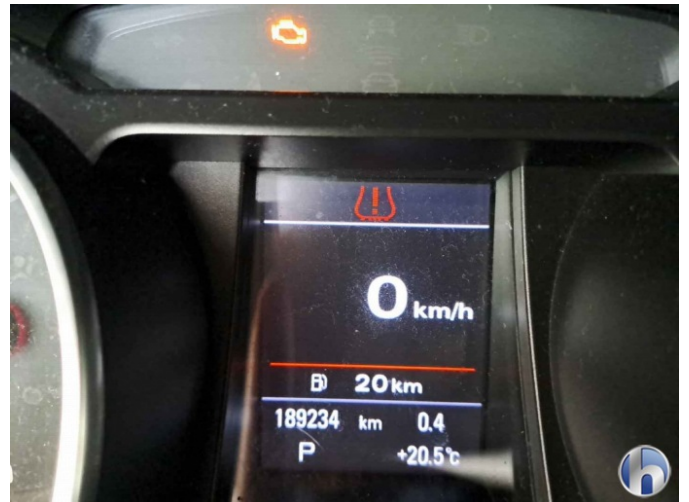
12. warning light

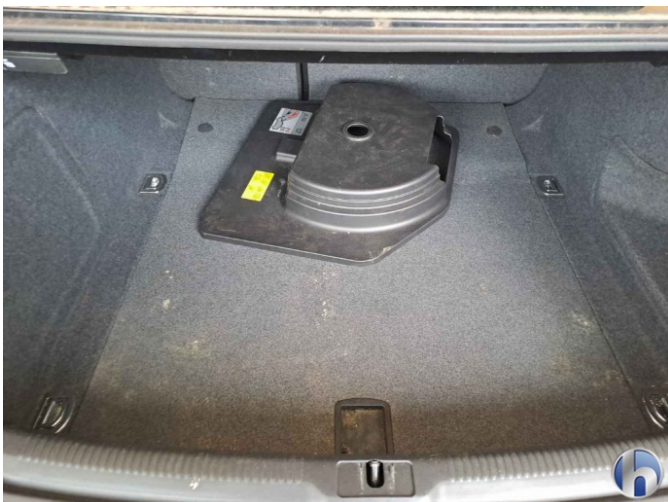
| component | Damage | Rep kind |
|---|---|---|
| 13. Trunk Flooring | Damaged | Replace |

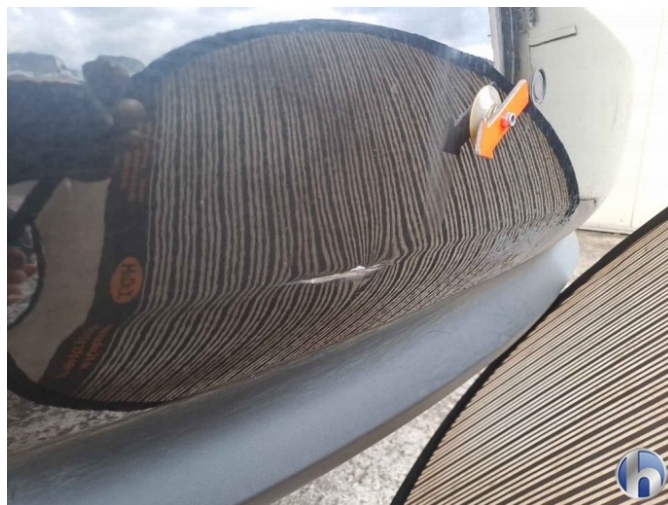
| component | Damage | Rep kind |
|---|---|---|
| 14. Rear bumper | Damaged | Replace |

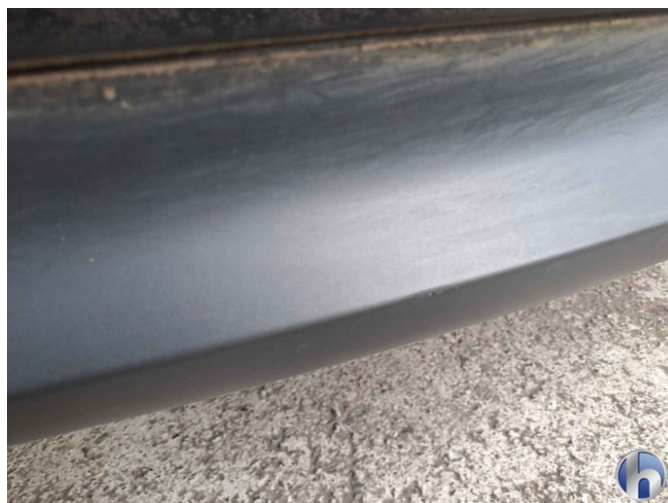
| component | Damage | Rep kind |
|---|---|---|
| 15. Diffusor | Scrape | Replace |

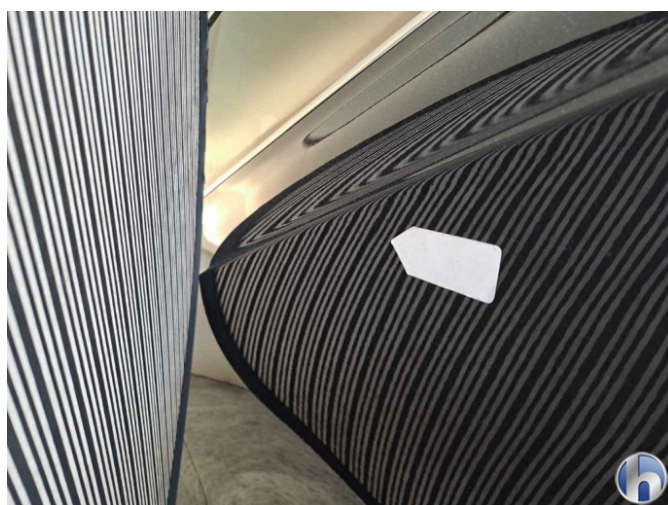
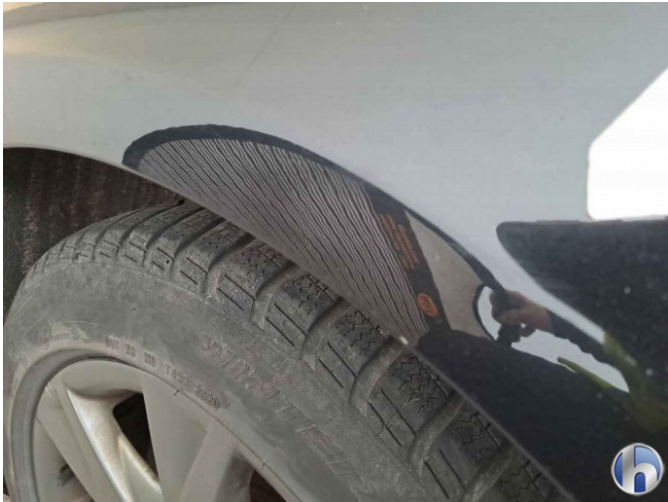
| component | Damage | Rep kind |
|---|---|---|
| 16. Sidewall - Rear - Left | Damaged | Refurbish and paint |

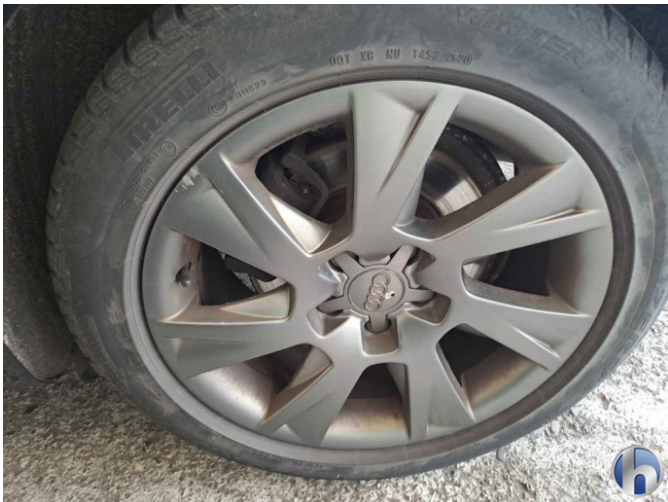
| component | Damage | Rep kind |
|---|---|---|
| 18. | Damaged | Paint |

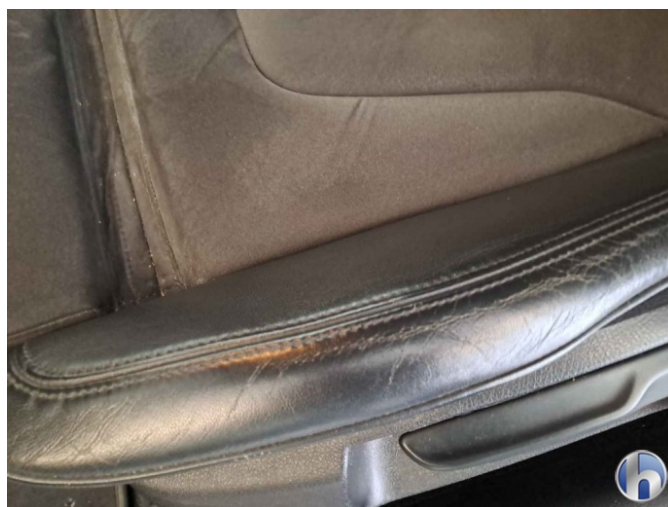
| component | Damage | Rep kind |
|---|---|---|
| 21. Sitz - Vorne - Links: Kissen (Leder-Alcantara) | Damaged | Replace |

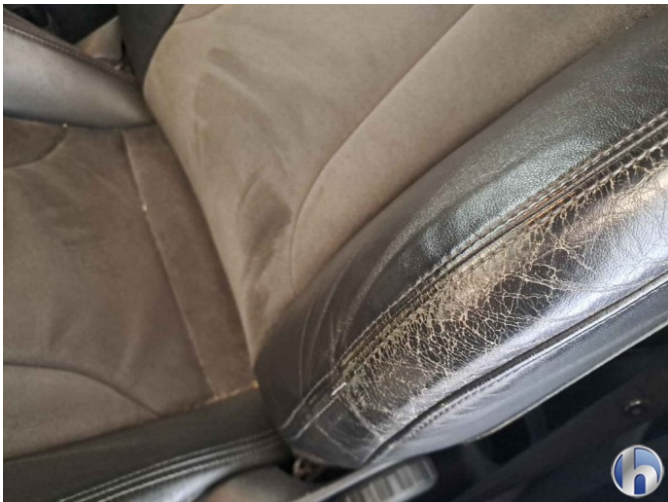
| component | Damage | Rep kind |
|---|---|---|
| 22. Sitz - Vorne - Links: Lehne (Leder-Alcantara) | Scrape | Replace |

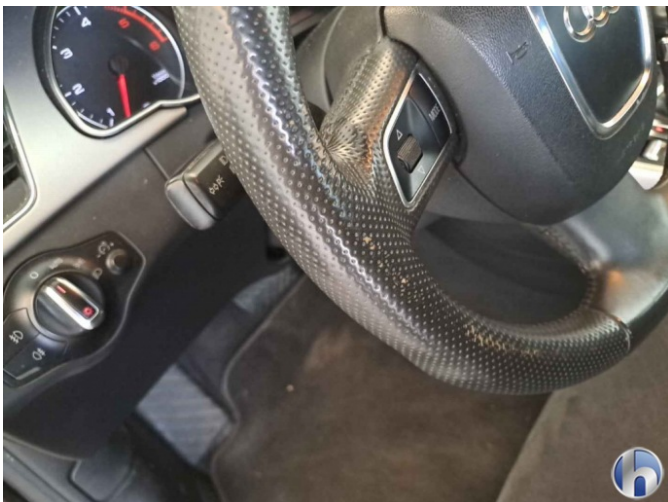
| component | Damage | Rep kind |
|---|---|---|
| 23. Steering wheel (leather) | Scratch(es) | Replace |

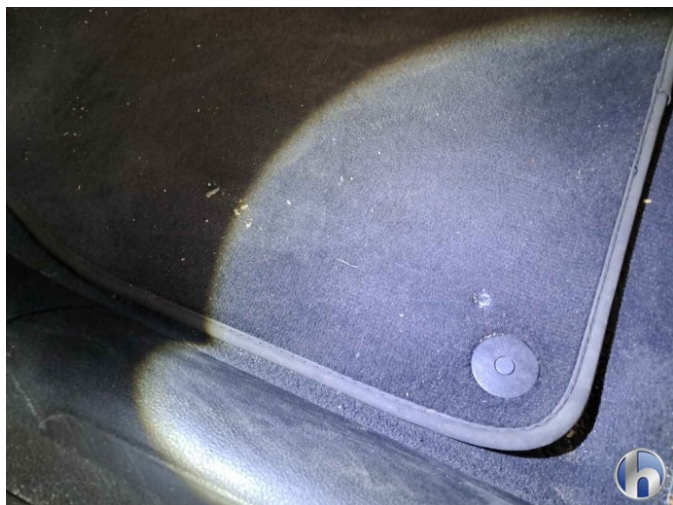
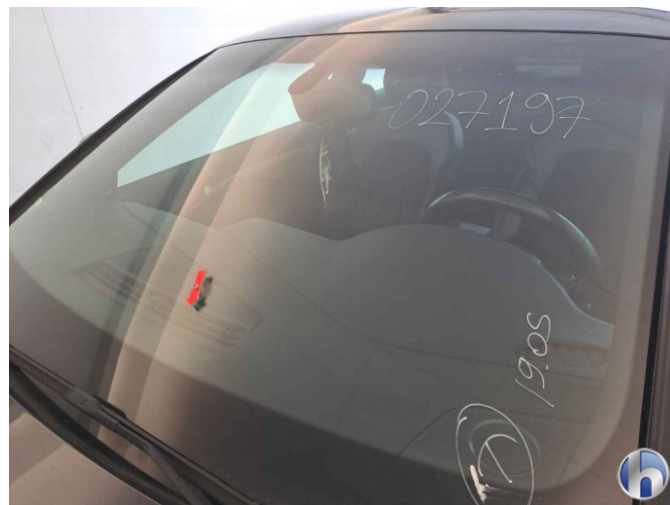
| component | Damage | Rep kind |
|---|---|---|
| 24. | Burn hole | Replace |

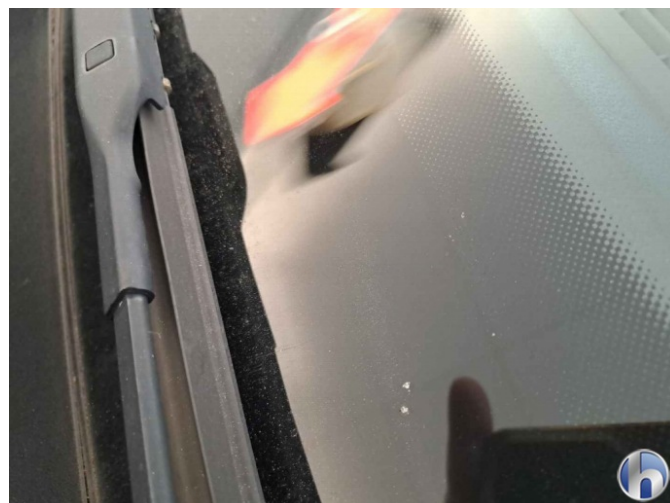
| component | Damage | Rep kind |
|---|---|---|
| 25. Windshield | Chipping from stones in field of view | Replace |

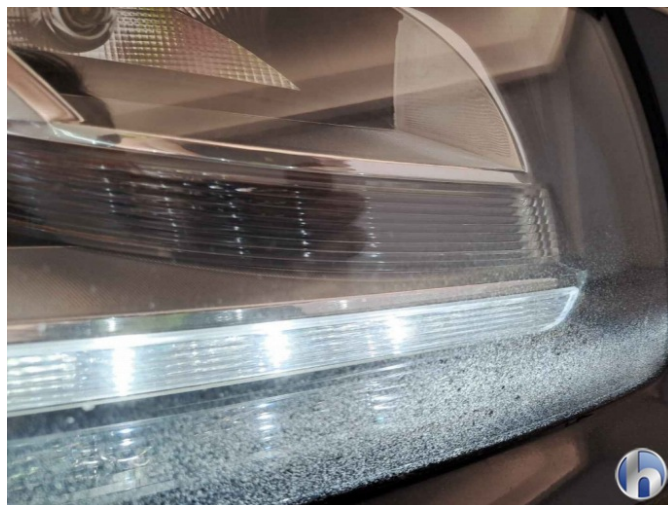
| component | Damage | Rep kind |
|---|---|---|
| 27. Scheinwerfer - Rechts | Damaged | Replace |

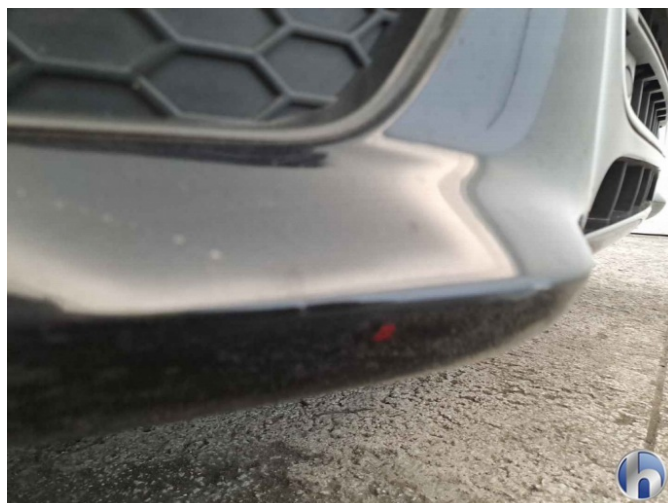
| component | Damage | Rep kind |
|---|---|---|
| 28. Front bumper | Damaged | Replace |

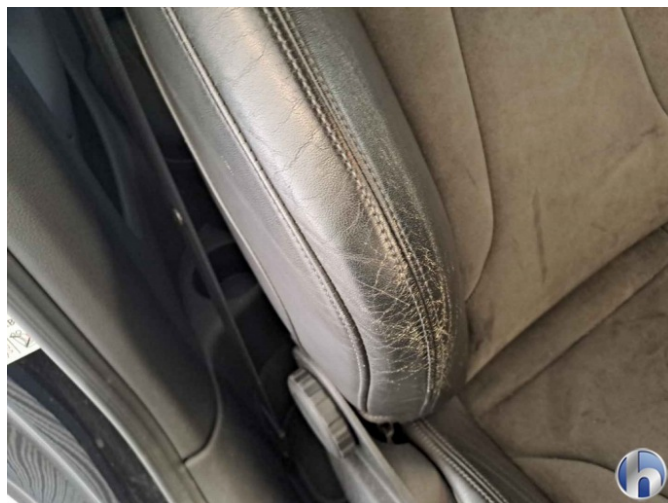
| component | Damage | Rep kind |
|---|---|---|
| 34. Sitz - Vorne - Rechts: Lehne (Leder-Alcantara) | Scrape | Replace |

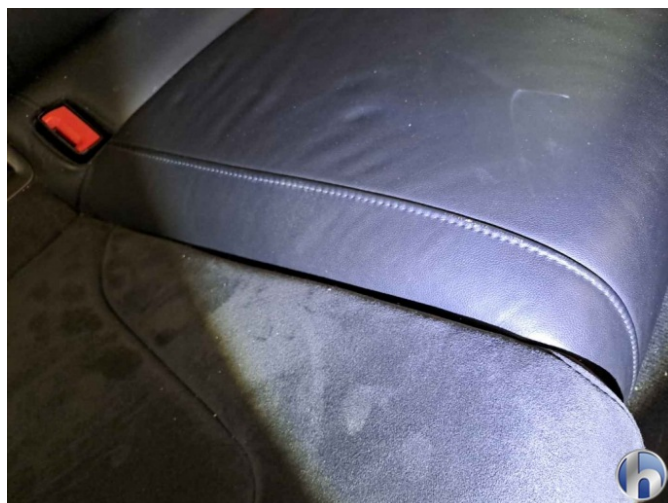
35. Sitzbank - Hinten: Kissen (Leder-Alcantara)

| 35. | Sitzbank - Hinten: Kissen (Leder-Alcantara) | Scrape | Replace |

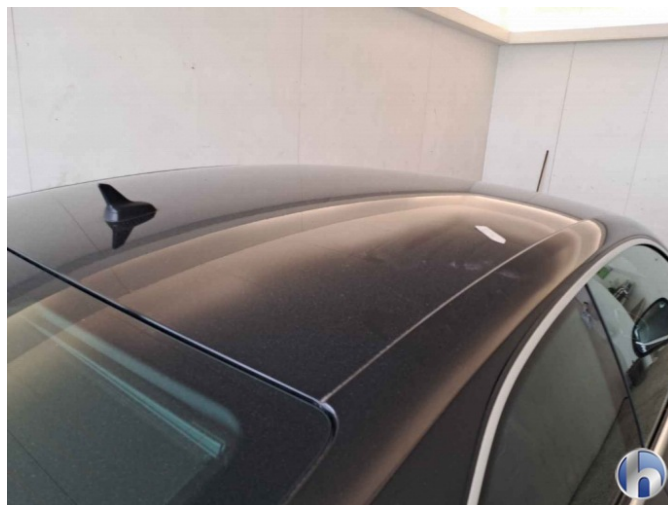
39. Trim Front - right

| 39. | Trim Front - right | Scratch(es) | Replace |

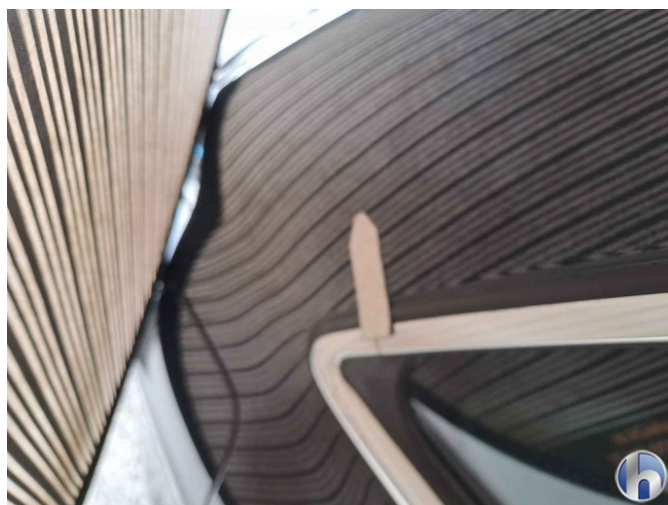
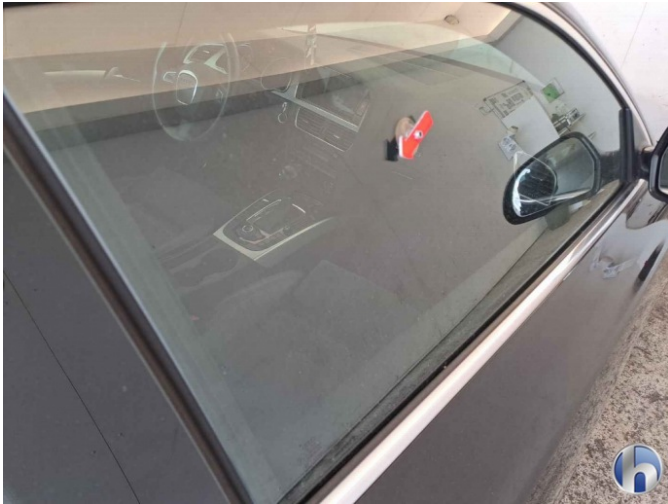
41. Roof frame - right

| 41. | Roof frame - right | Damaged | Refurbish and paint |

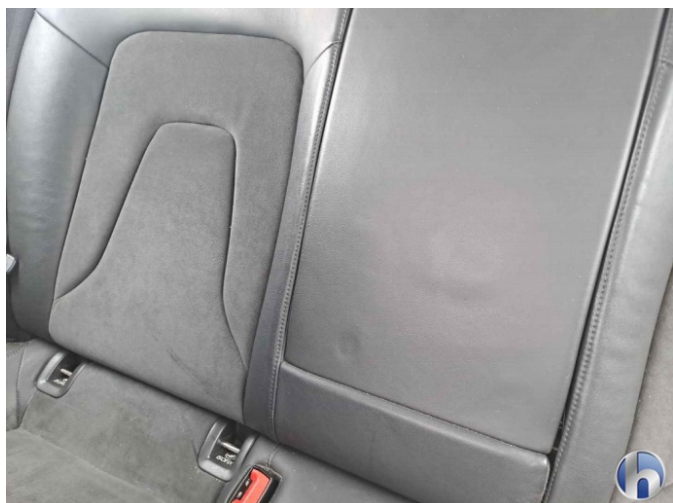
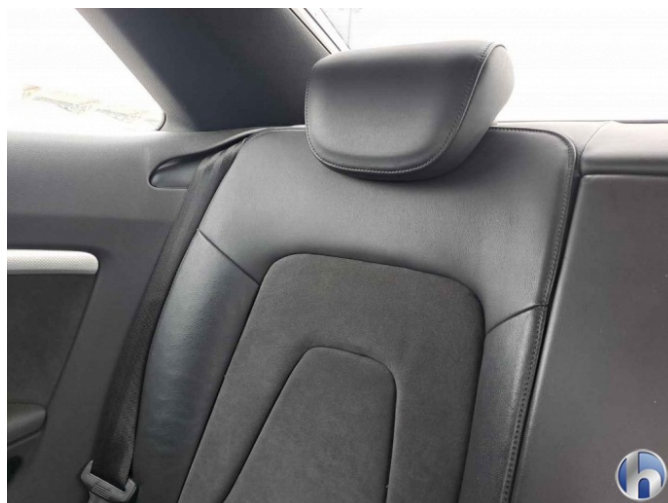
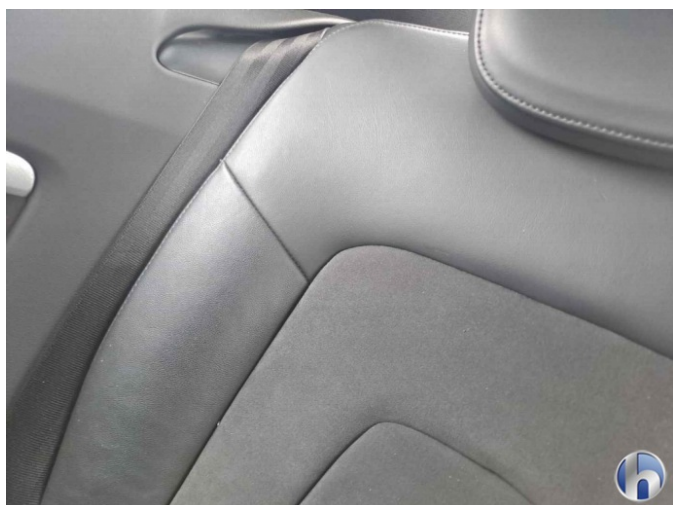
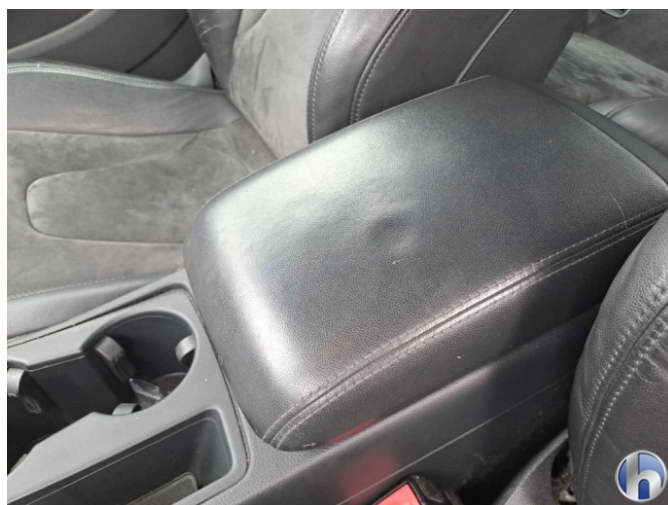
| 49. | | Wear and tear | acceptable |
