## status report

#### BMW Baureihe M4 Coupe Competition

| Vehicle identification number | <b>WBS31AZ070CF72163</b> | mileage read: | <b>29364 km</b> |

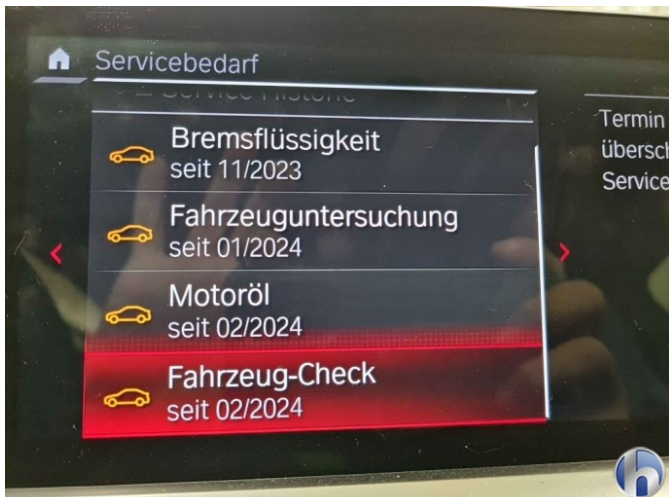
| component | Damage | Rep kind |
|---|---|---|
| 4. Wartung (Bremsflüssigkeit, Fahrzeug-Check, Motoröl, Fahrzeuguntersuchung) | Error message | Replace |

4. Wartung (Bremsflüssigkeit, Fahrzeug-Check, Motoröl, Fahrzeuguntersuchung)

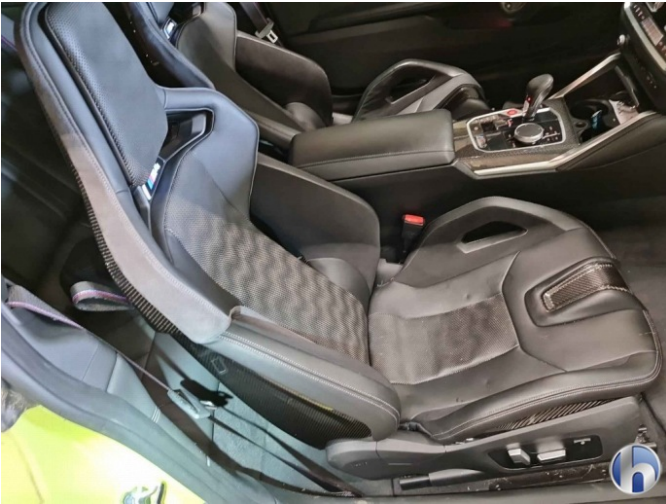
| component | Damage | Rep kind |
|---|---|---|
| 11. | Scrape | Smart repair |

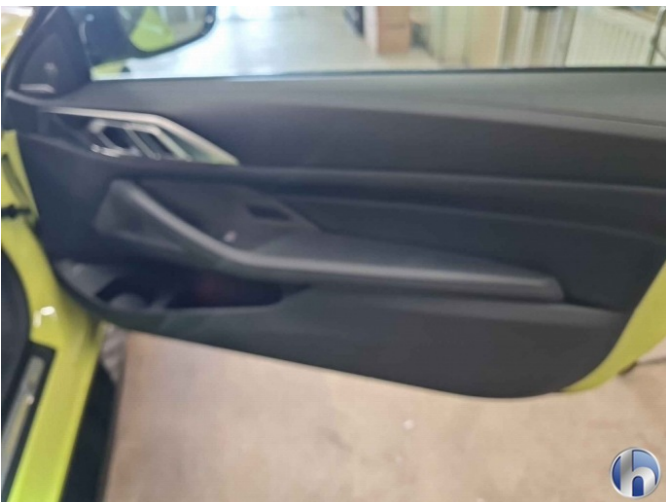
| component | Damage | Rep kind |
|---|---|---|
| 13. Door trim Front - right | Scrape | Smart repair |

13. Door trim Front - right

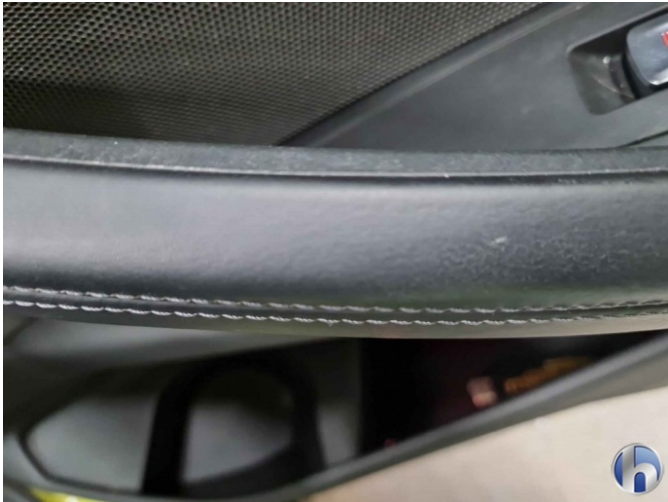
13. Door trim Front - right

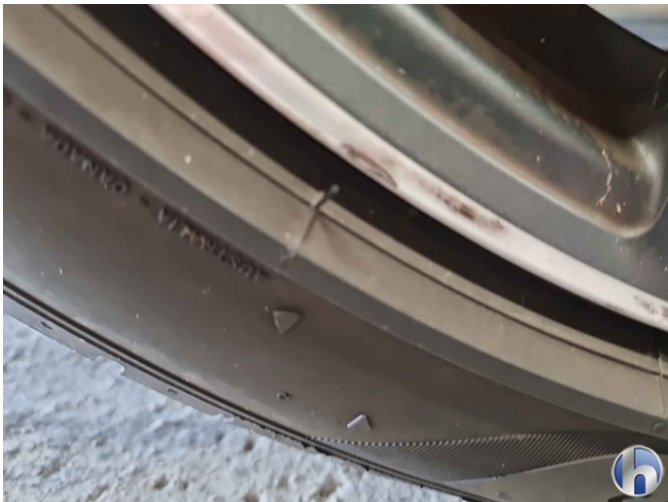
| component | Damage | Rep kind |
|---|---|---|
| 14. | Damaged | Replace |

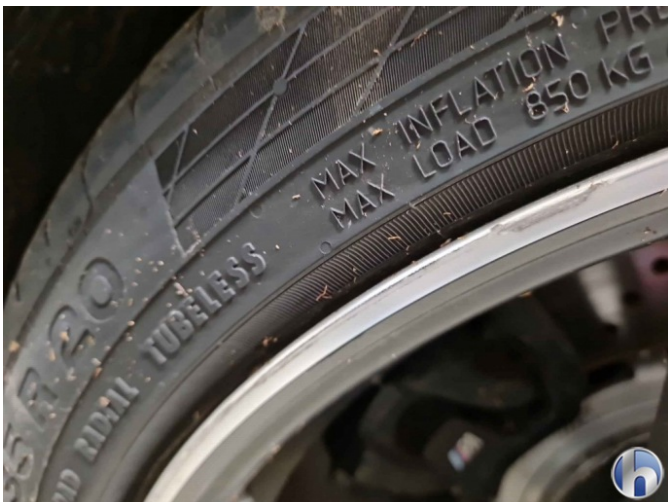
| component | Damage | Rep kind |
|---|---|---|
| 15. | Damaged | Replace |

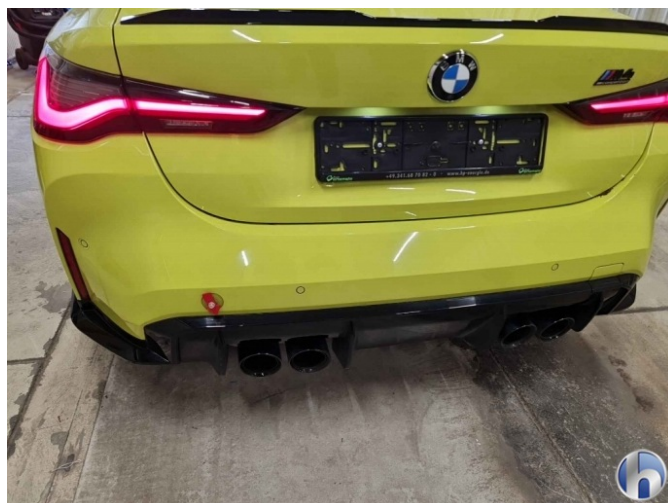
| component | Damage | Rep kind |
|---|---|---|
| 16. | Scrape | Smart repair |

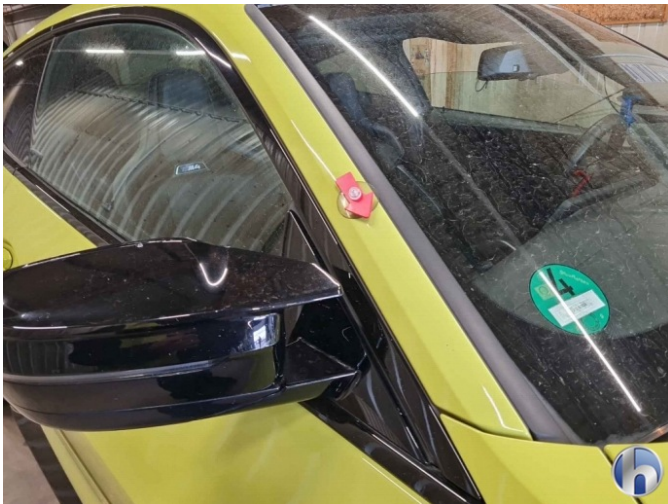
| component | Damage | Rep kind |
|---|---|---|
| 20. A-pillar Front - right | Chipping from stones | Smart repair |

20. A-pillar Front - right

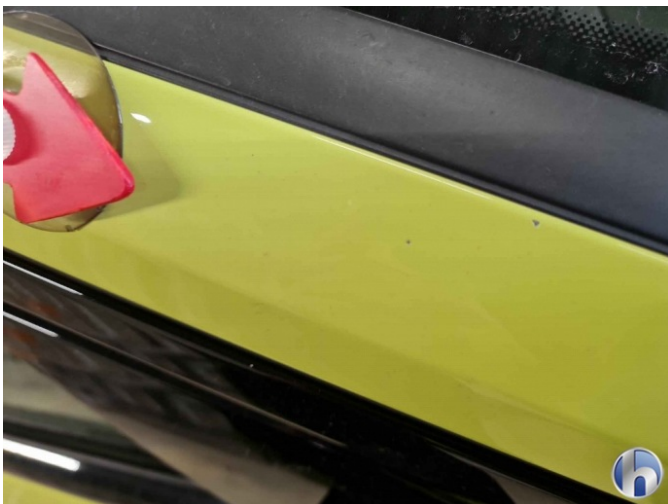
20. A-pillar Front - right

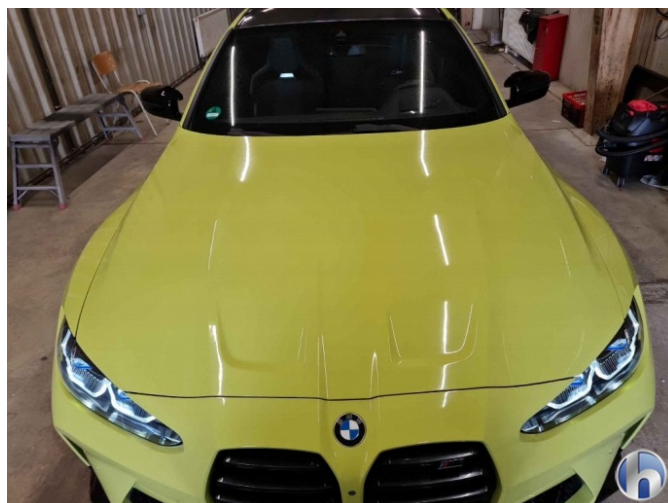
| component | Damage | Rep kind |
|---|---|---|
| 22. hood | Chipping from stones | Smart repair |

22. hood

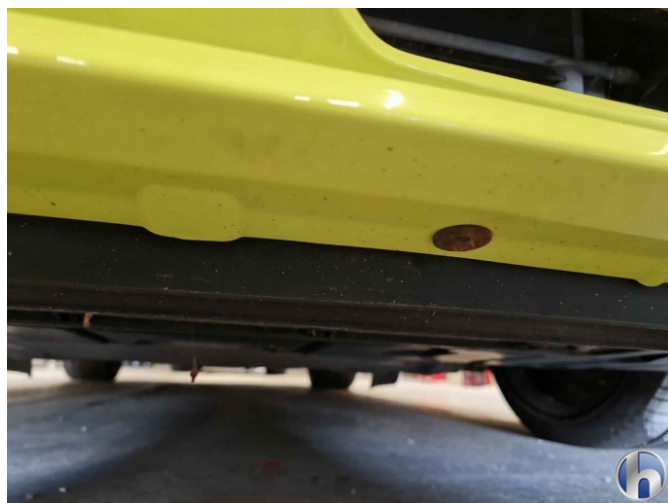
| component | Damage | Rep kind |
|---|---|---|
| 23. Stoßfänger Vorne: Schrauben | Rust | Replace |

23. Stoßfänger Vorne: Schrauben

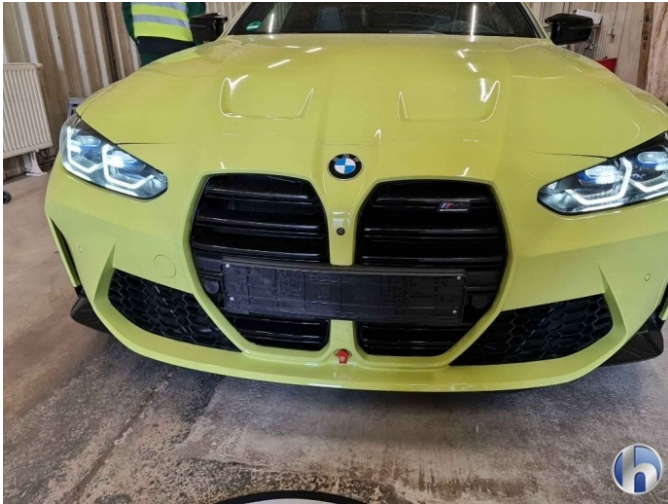
| component | Damage | Rep kind |
|---|---|---|
| 24. Front bumper | Scrape | Smart repair |

24. Front bumper

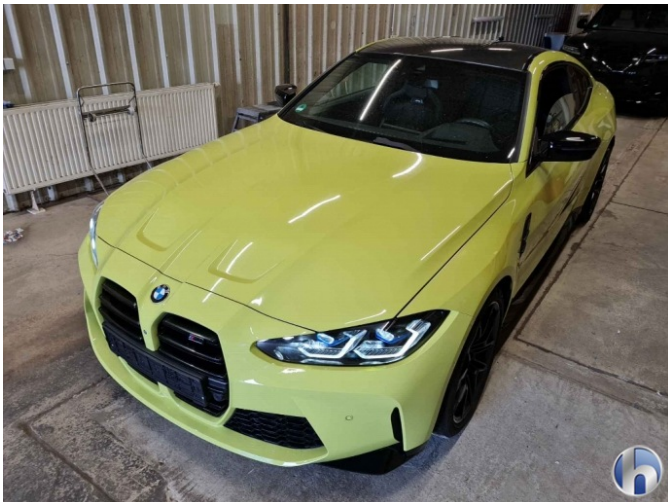
25. Fahrzeug (Kratzer, Harz-/Säureeinwirkung, Verschmutzungen)

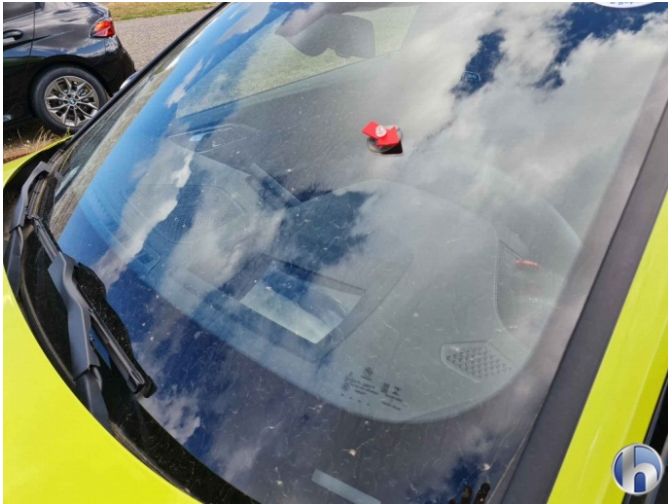
| component | Damage | Rep kind |
|---|---|---|
| 27. Windshield | Chipping from stones in field of view | Replace |

27. Windshield
