## status report

#### Mercedes-Benz C -Klasse Lim. C 220 CDI

| Vehicle identification number | <b>WDB2030081A861170</b> | mileage read: | <b>161428 km</b> |

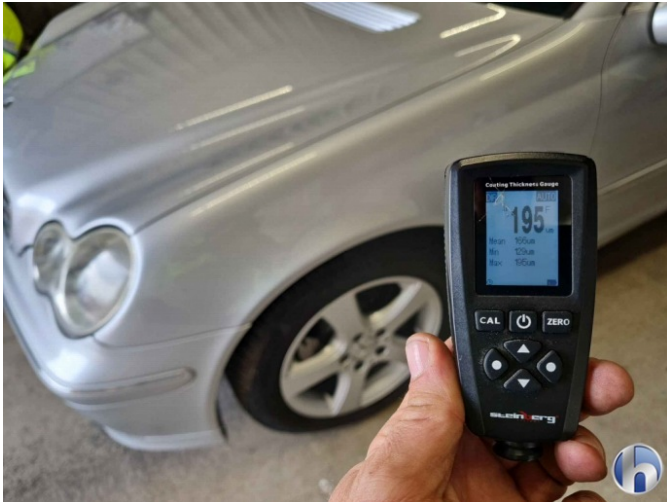
| component | Damage | Rep kind |
|---|---|---|
| 35. Front fender - left | Rust | Paint |

1. Front fender - left

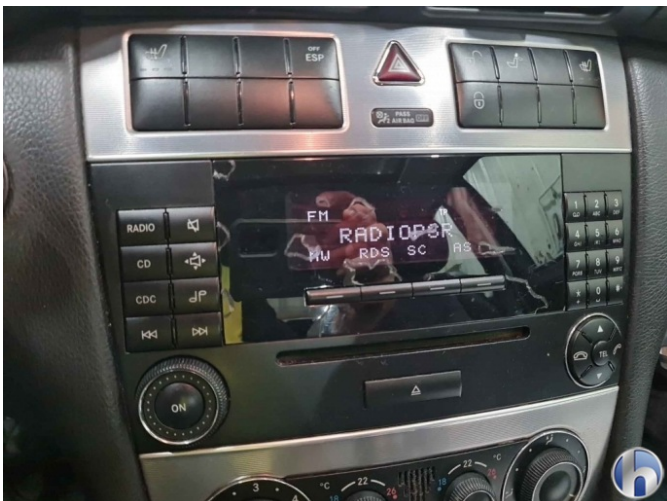
| component | Damage | Rep kind |
|---|---|---|
| 3. Radio: Display | Not okay | Replace |

3. Radio: Display

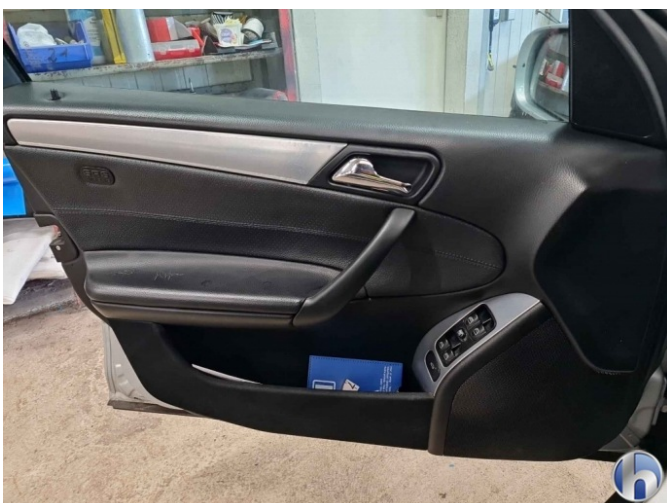
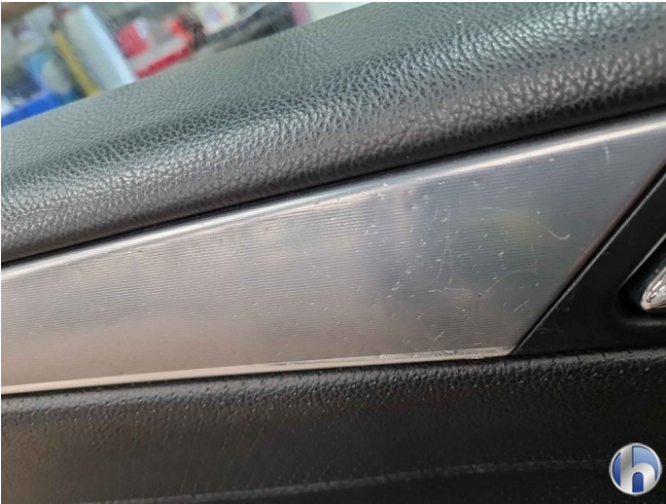
| component | Damage | Rep kind |
|---|---|---|
| 4. Front door trim - left | Damaged | Replace |

4. Front door trim - left

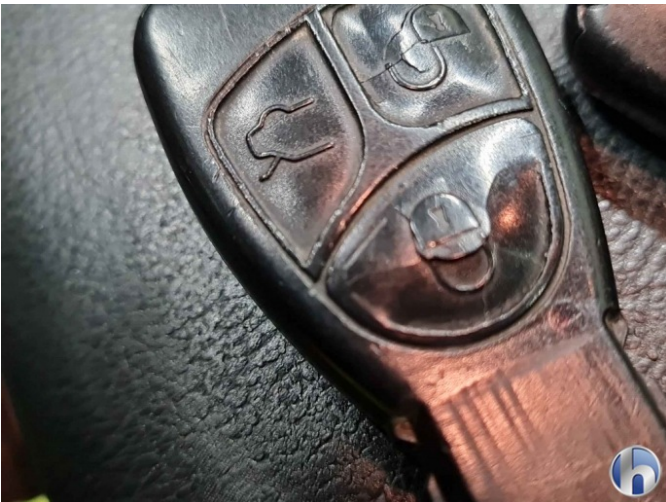
| component | Damage | Rep kind |
|---|---|---|
| 5. Key with remote control | Damaged | Replace |

5. Key with remote control

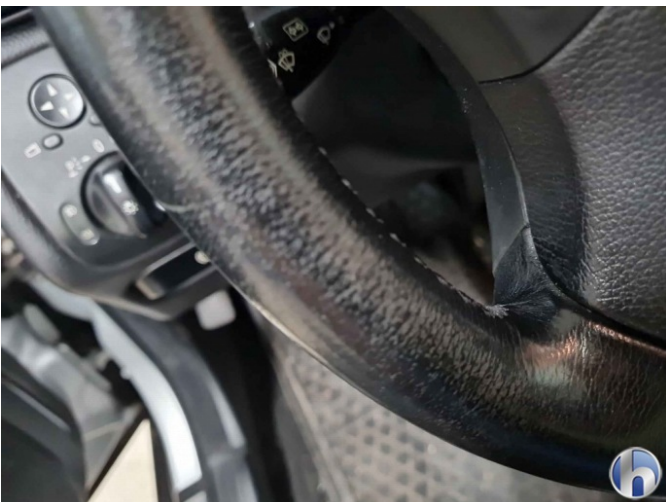
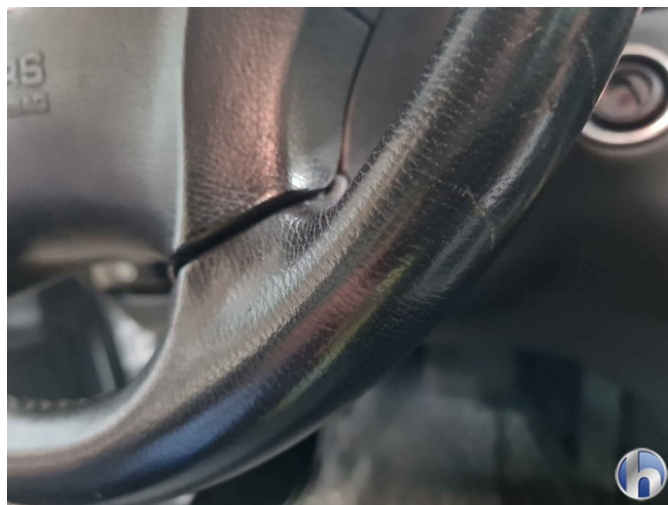
| component | Damage | Rep kind |
|---|---|---|
| 6. steering wheel | Material wear | Replace |

6. steering wheel

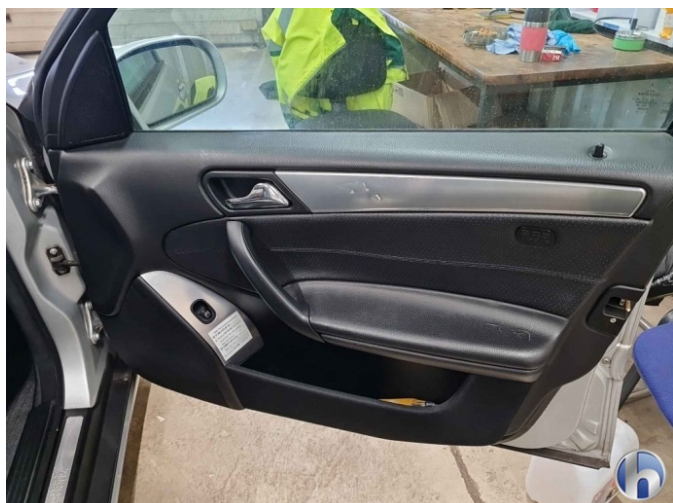
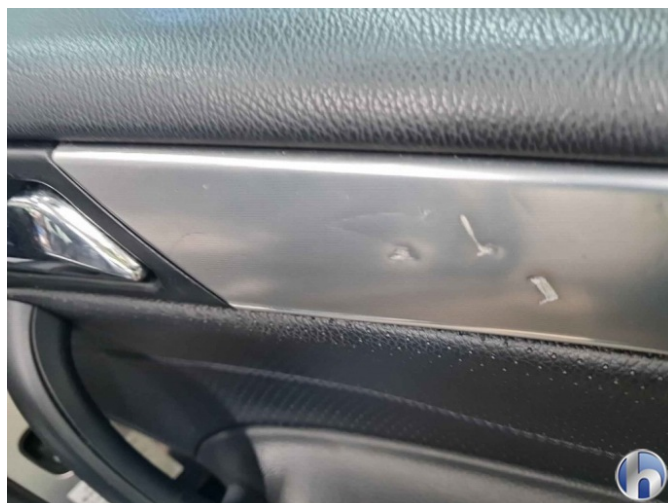
| component | Damage | Rep kind |
|---|---|---|
| 7. Door trim Front - right | Damaged | Replace |

7. Door trim Front - right

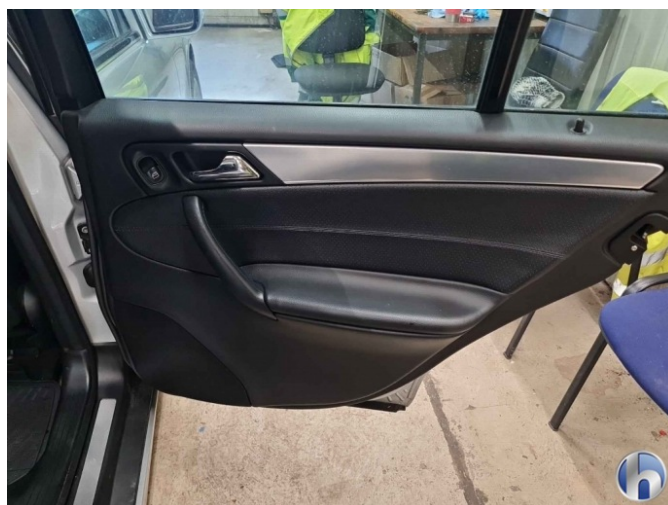
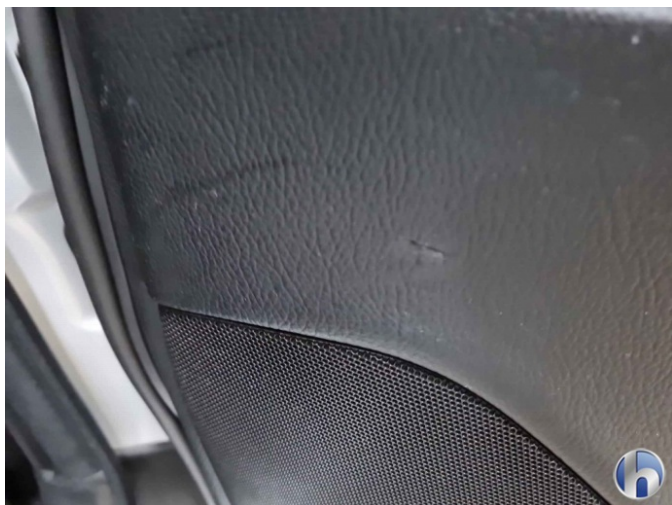
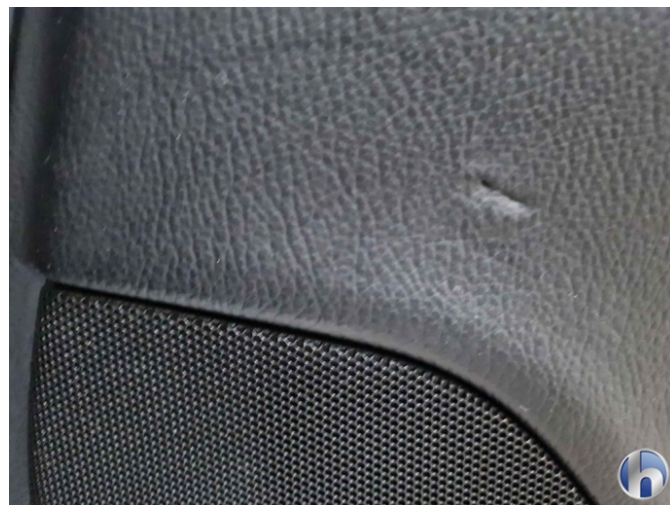
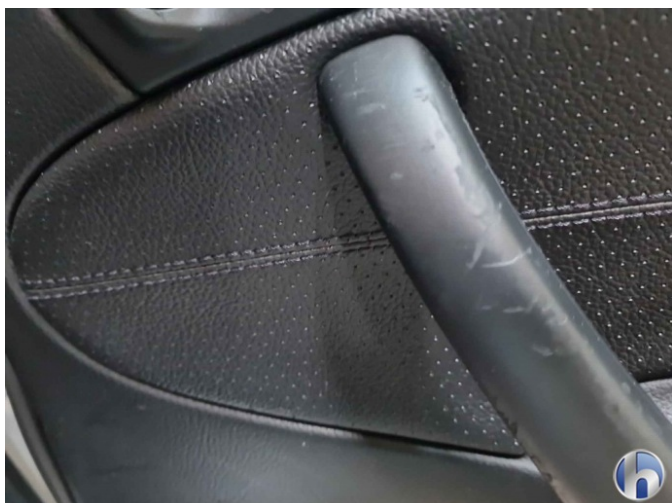
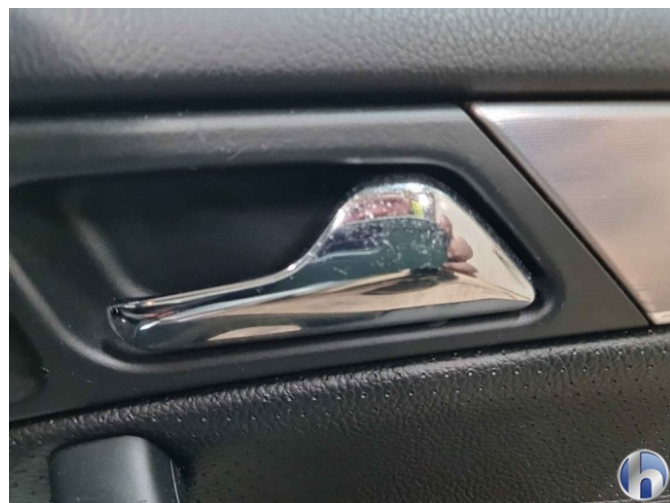
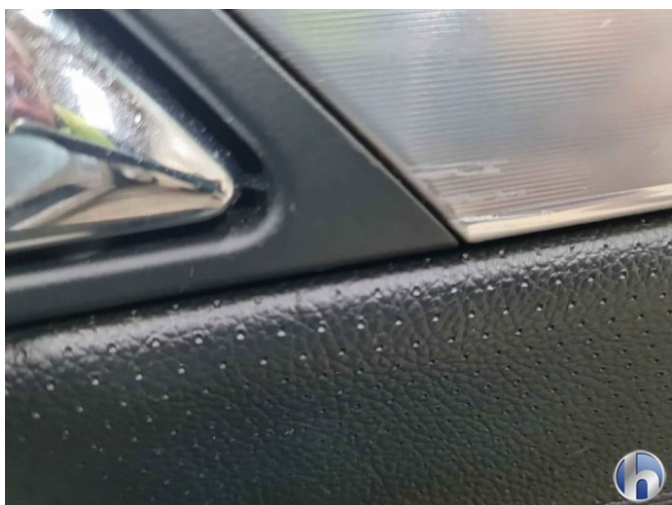
| component | Damage | Rep kind |
|---|---|---|
| 8. Door trim Rear - right | Damaged | Replace |

8. Door trim Rear - right

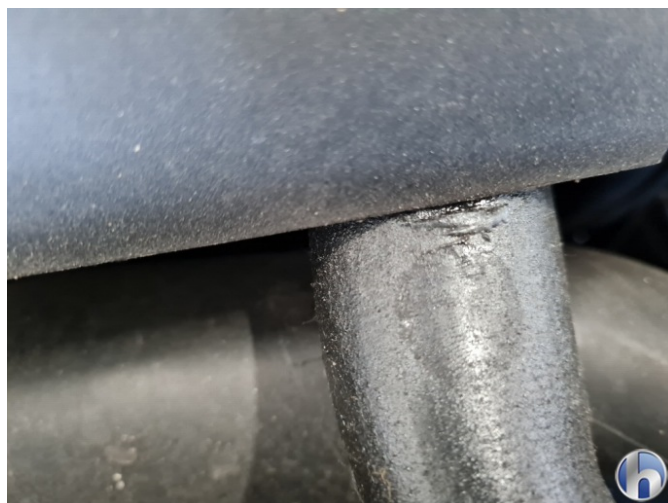
| component | Damage | Rep kind |
|---|---|---|
| 10. Schlauch | Damaged | Replace |

10. Schlauch

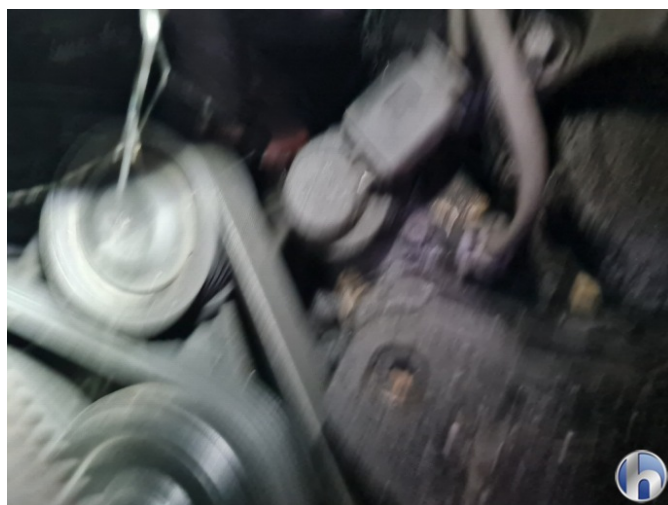
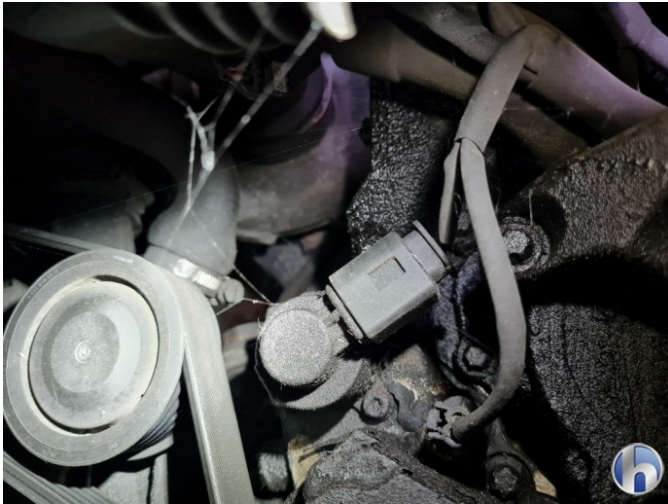
| Performed testing technology | |
|---|---|
| <b>oil loss:</b> | The vehicle was inspected during the visit to an oil leak .<br>**motor. |
| <b>engine running:</b> | A field test of the engine had to acoustic or visual defects for visiting time .<br>*springt schlecht an |

11. Motor

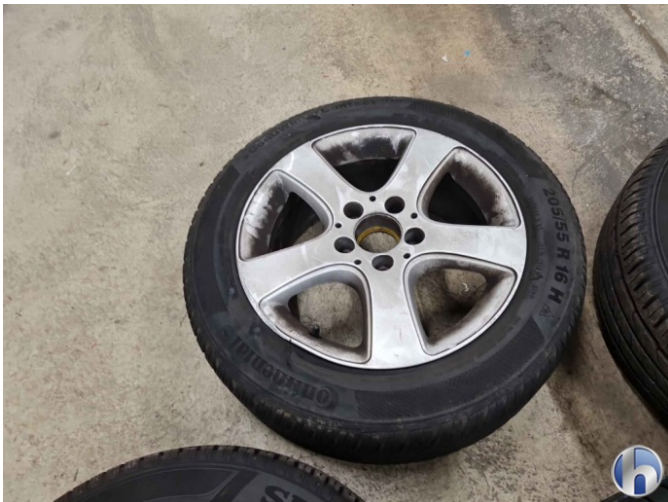
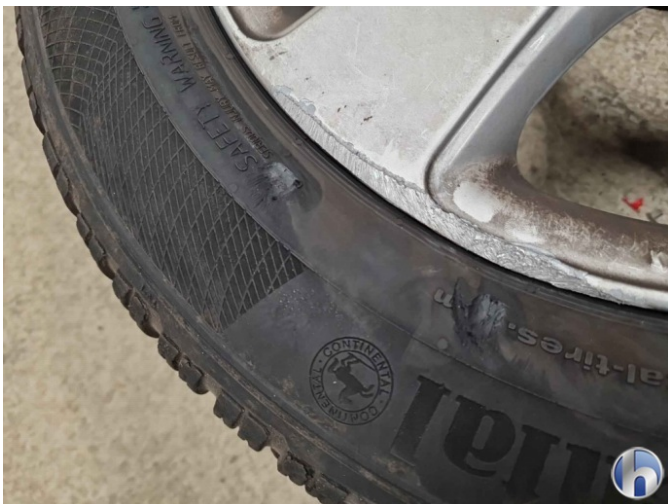
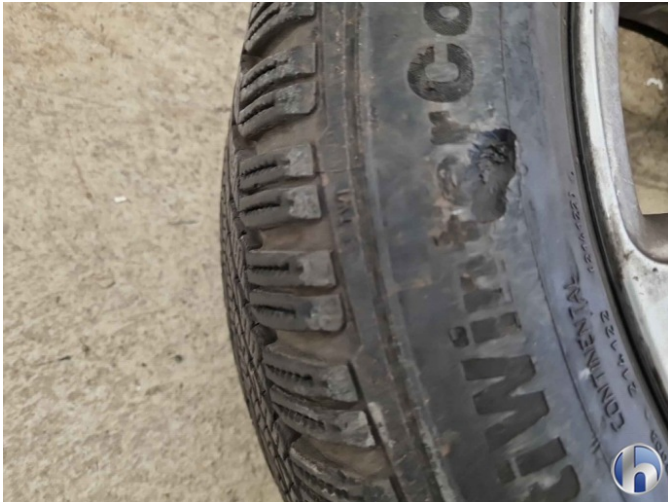
| component | Damage | Rep kind |
|---|---|---|
| 12. Winterrad (Aluminium - nicht montiert) | Damaged | Replace |

12. Winterrad (Aluminium - nicht montiert)

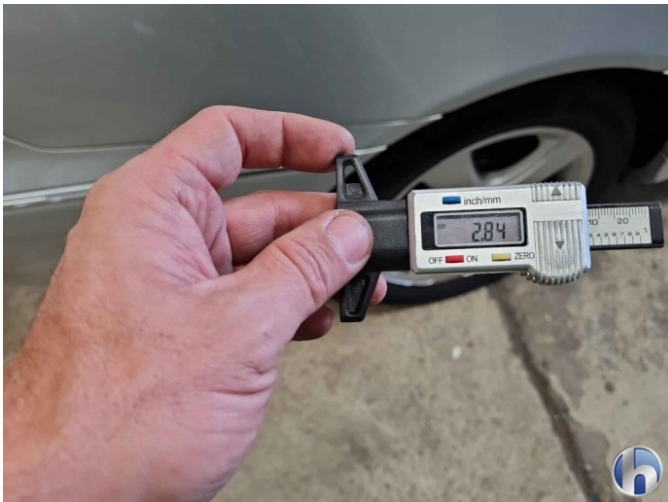
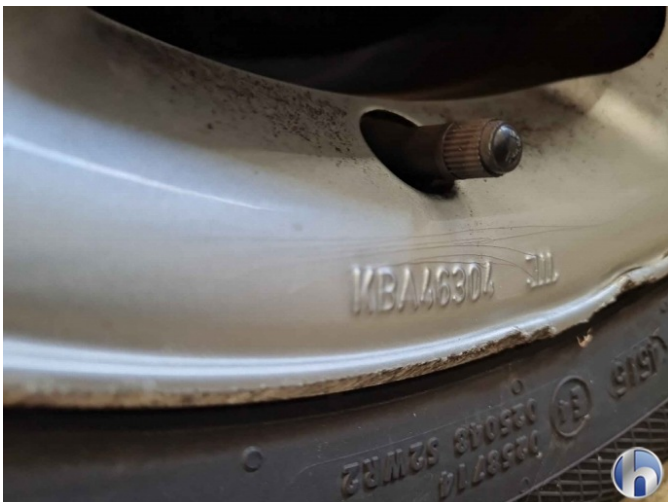
| component | Damage | Rep kind |
|---|---|---|
| 13. Komplettrad (Aluminium) hinten rechts | Damaged | Replace |

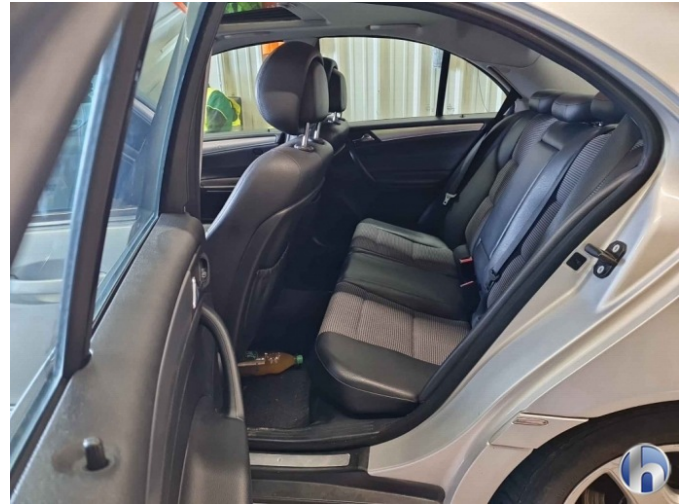
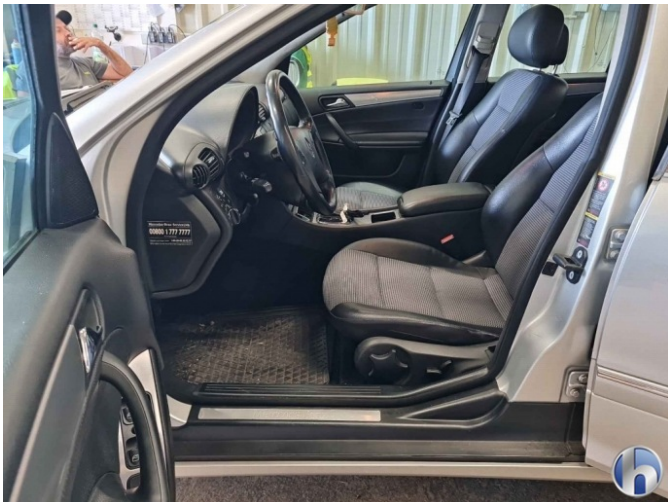
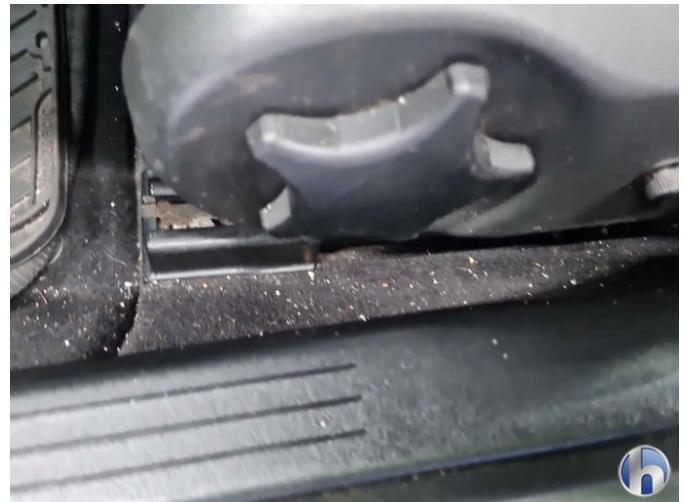
| component | Damage | Rep kind |
|---|---|---|
| 15. Kofferraum und Innenraum | Wear and tear | acceptable |

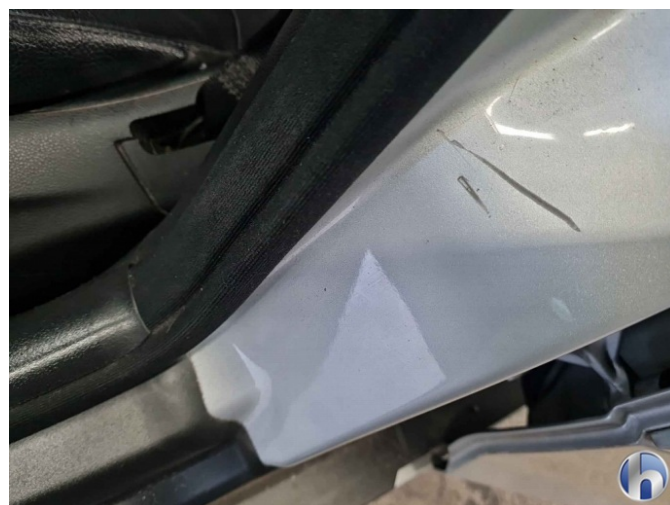
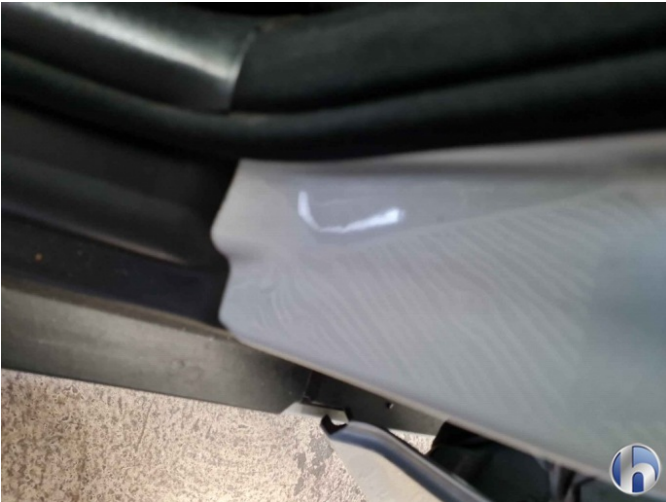
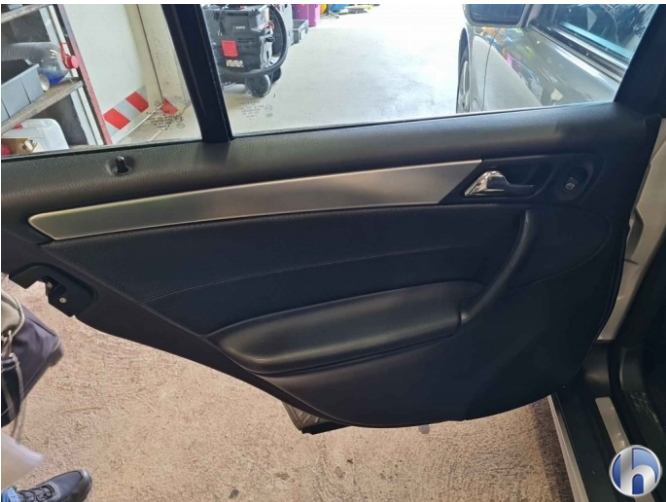
| component | Damage | Rep kind |
|---|---|---|
| 17. Türeinstieg Vorne - Links | Damaged | Refurbish and paint |

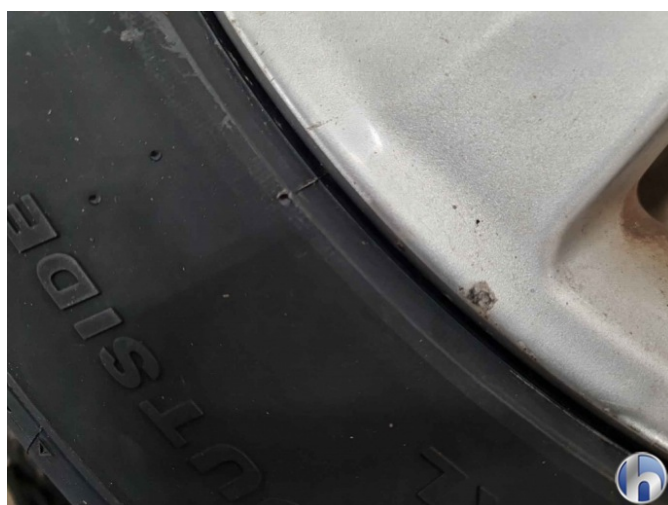
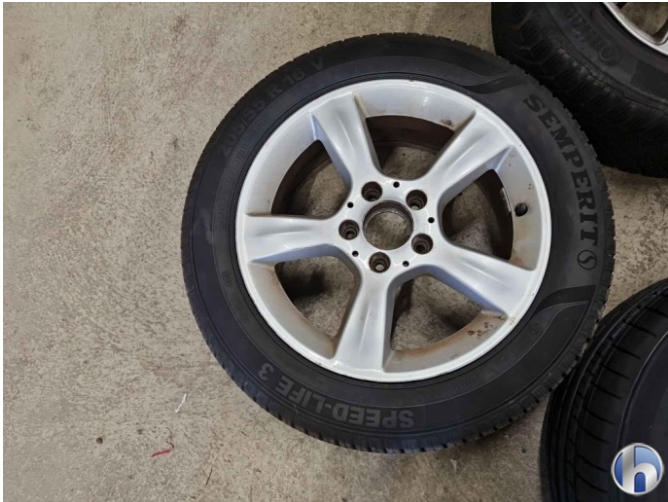
| component | Damage | Rep kind |
|---|---|---|
| 20. Felge (Aluminium) nicht montiert | Wear and tear | acceptable |

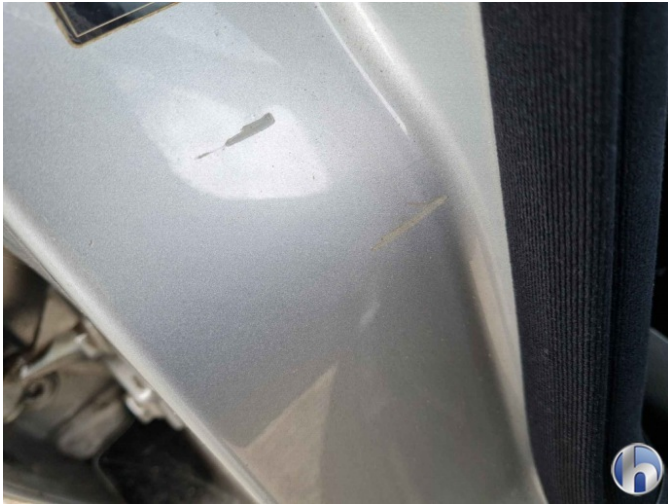
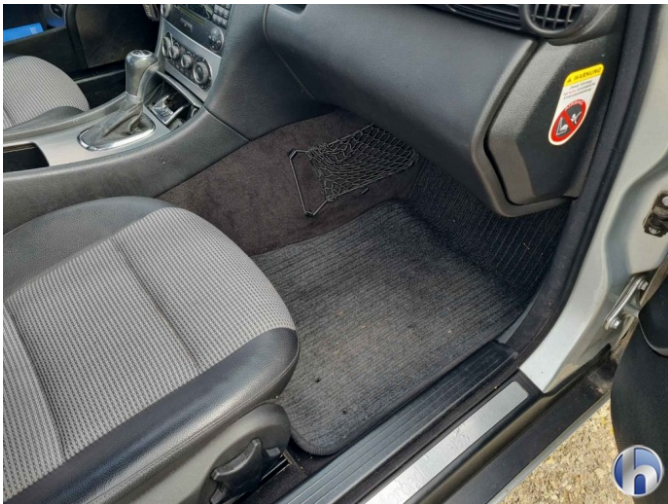
| component | Damage | Rep kind |
|---|---|---|
| 23. Türeinstieg Vorne - Rechts | Damaged | Refurbish and paint |

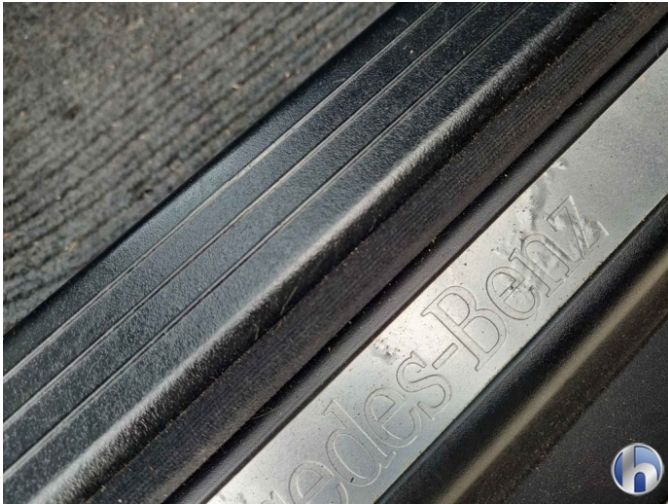
| component | Damage | Rep kind |
|---|---|---|
| 25. front door sill panel - right | Damaged | Replace |

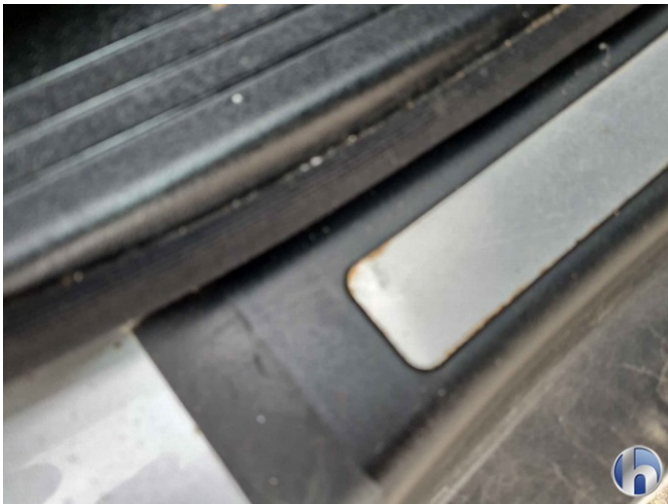
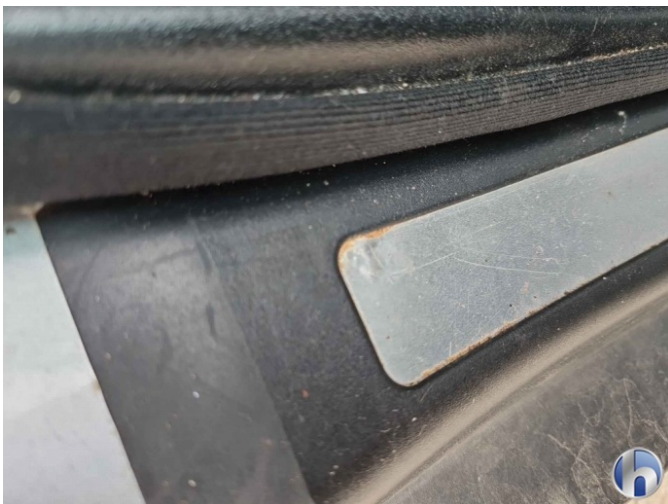
| component | Damage | Rep kind |
|---|---|---|
| 26. rear door sill panel - right | Damaged | Replace |

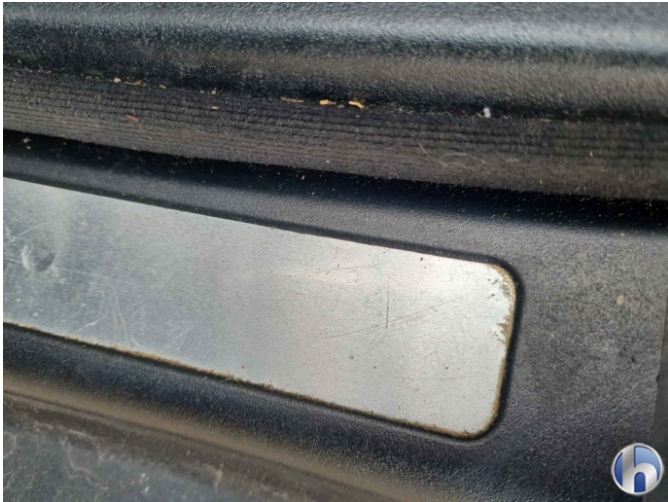
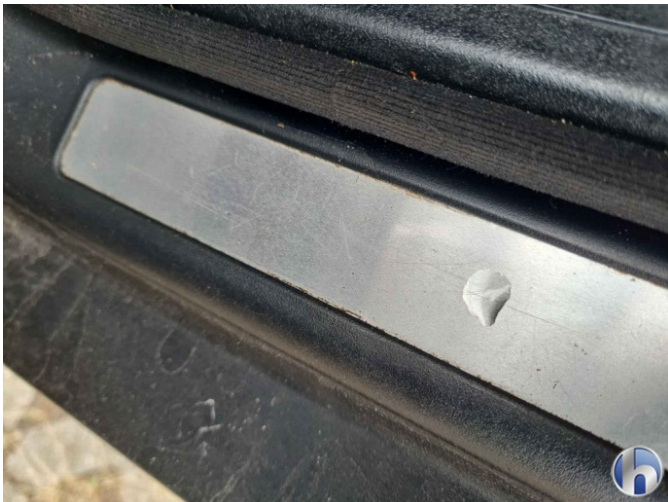
| component | Damage | Rep kind |
|---|---|---|
| 27. rear door sill panel - Left | Damaged | Replace |

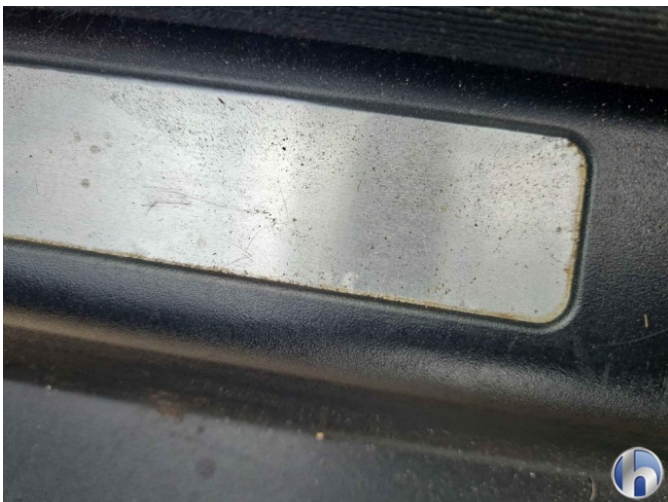
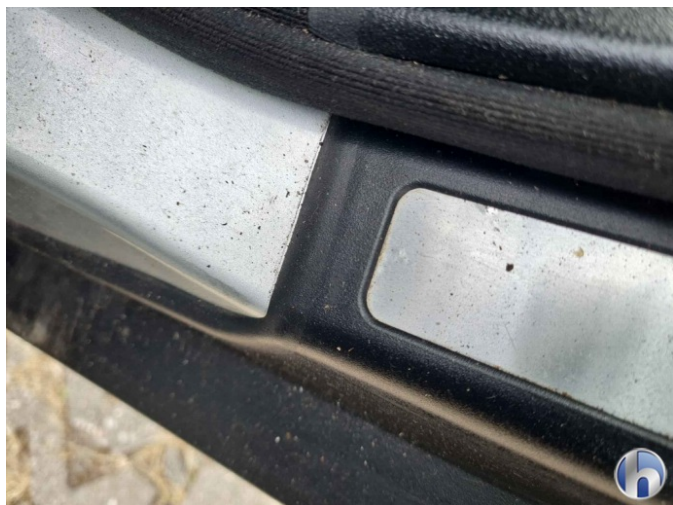
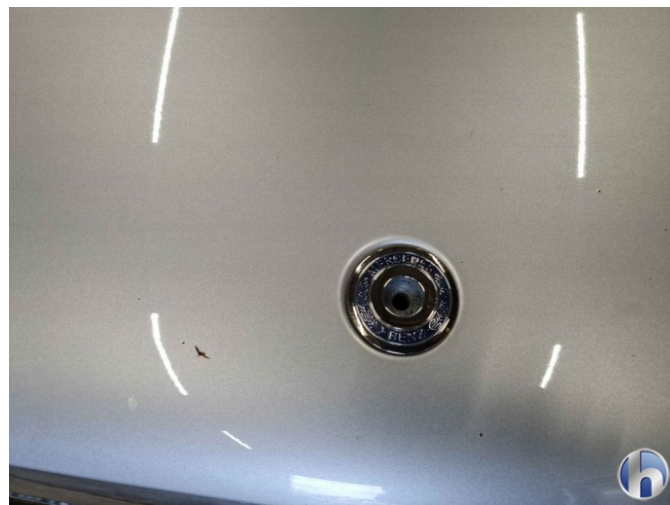
| component | Damage | Rep kind |
|---|---|---|
| 28. front door sill panel - Left | Damaged | Replace |

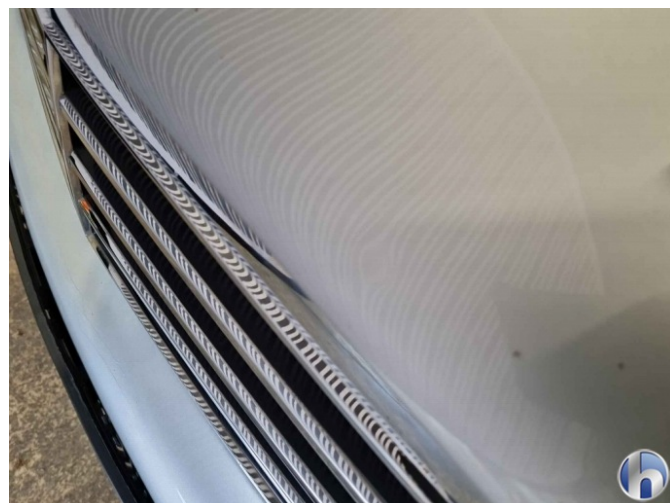
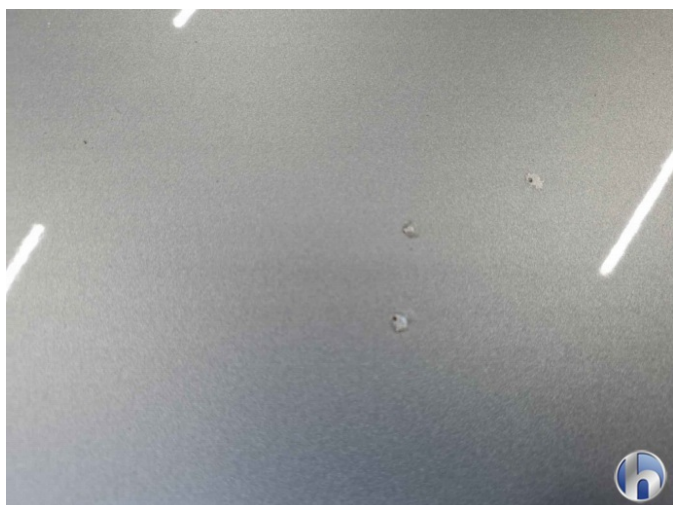
| component | Damage | Rep kind |
|---|---|---|
| 31. hood | Damaged | Refurbish and paint |

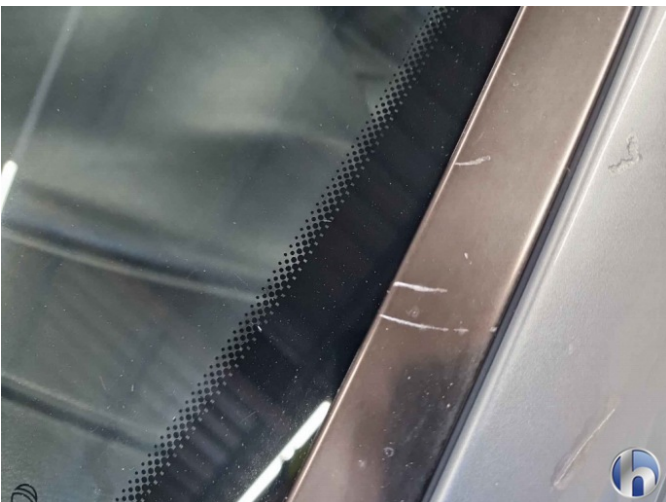
| component | Damage | Rep kind |
|---|---|---|
| 32. Frontscheibenleiste/Dachleiste links | Scrape | Replace |

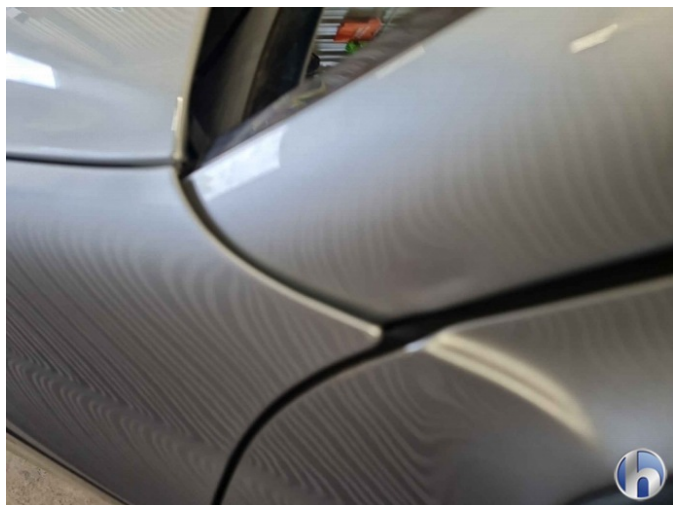
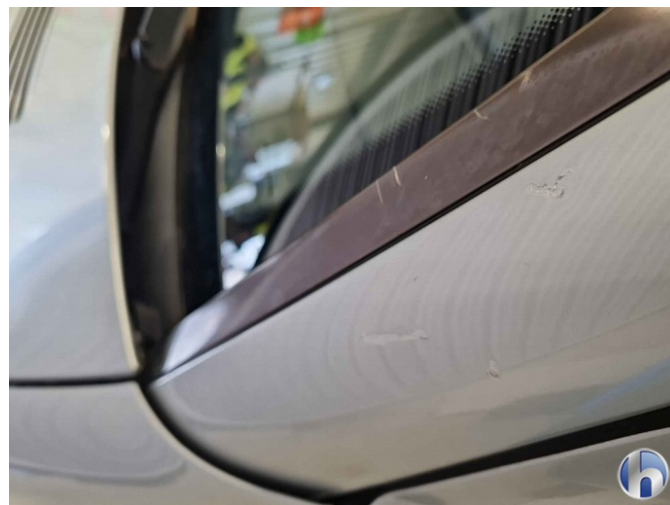
| component | Damage | Rep kind |
|---|---|---|
| 33. A-pillar Front - Left | Damaged | Refurbish and paint |

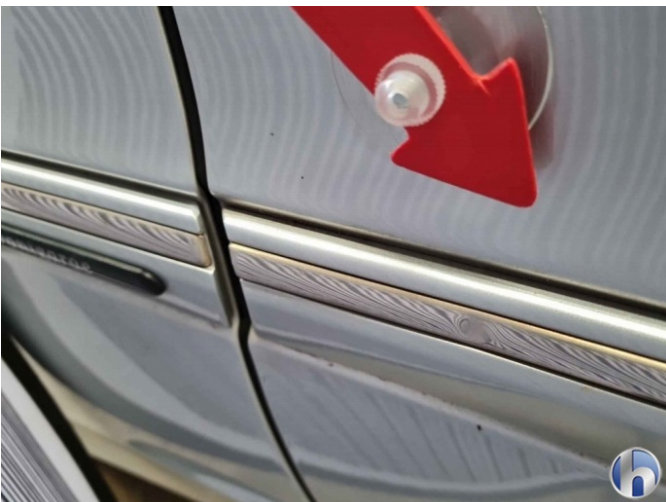
| component | Damage | Rep kind |
|---|---|---|
| 37. Tür Vorne - Links: Zierleiste | Damaged | Replace |

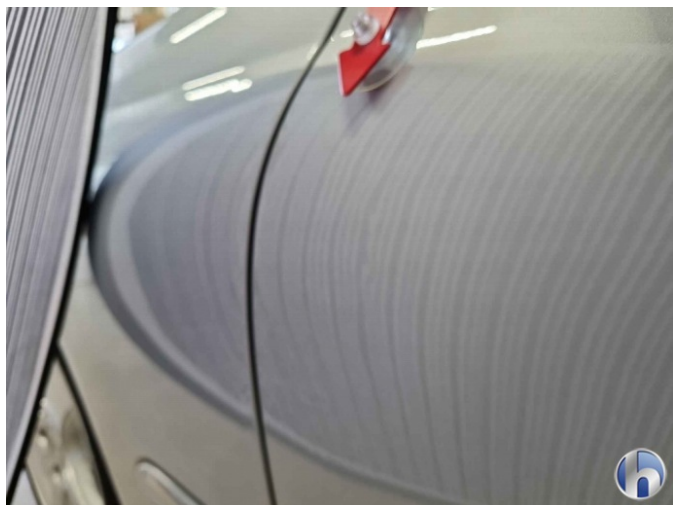
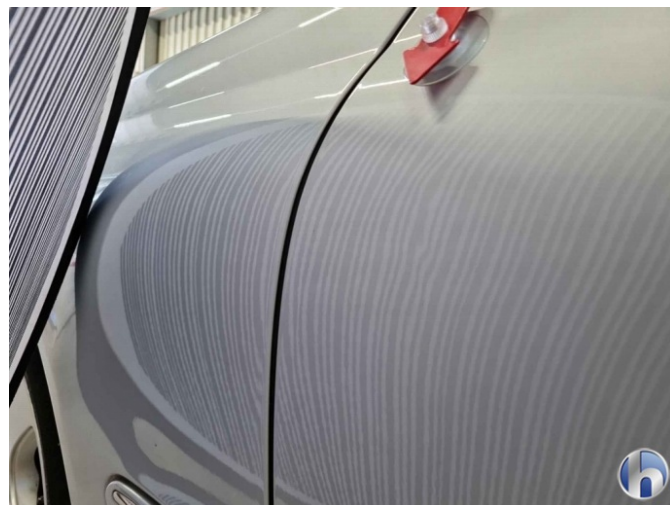
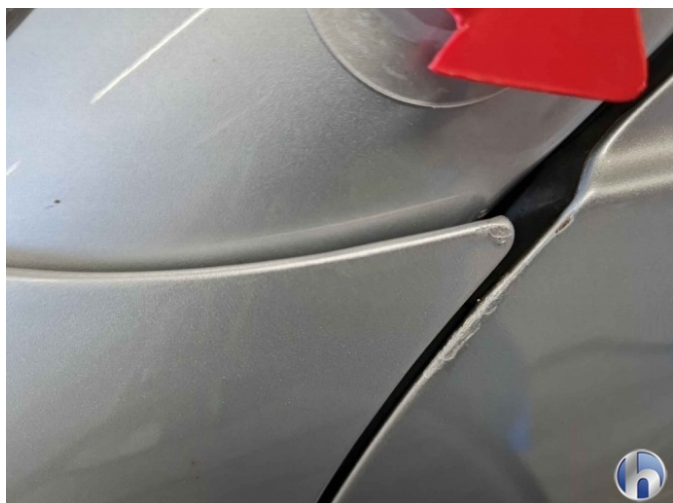
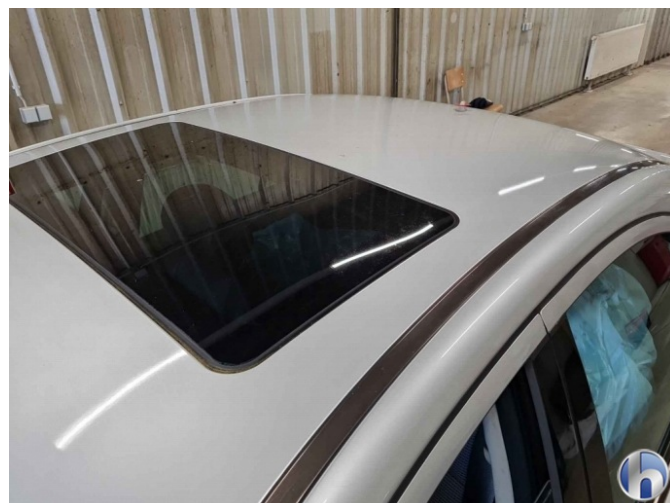
| component | Damage | Rep kind |
|---|---|---|
| 38. Front door - left | Damaged | Refurbish and paint |

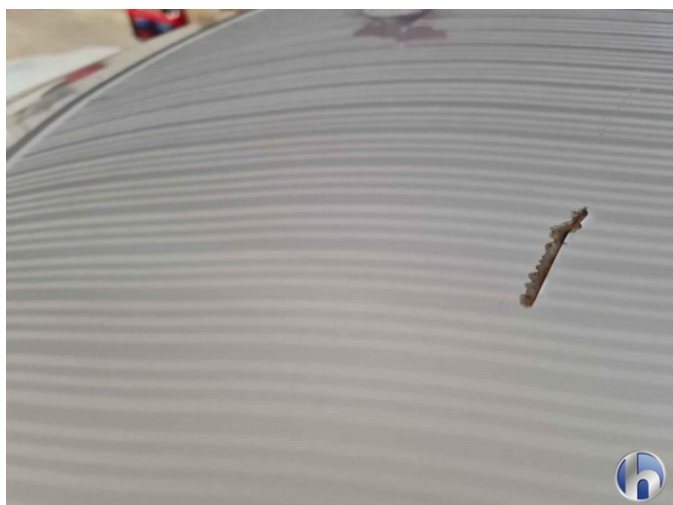
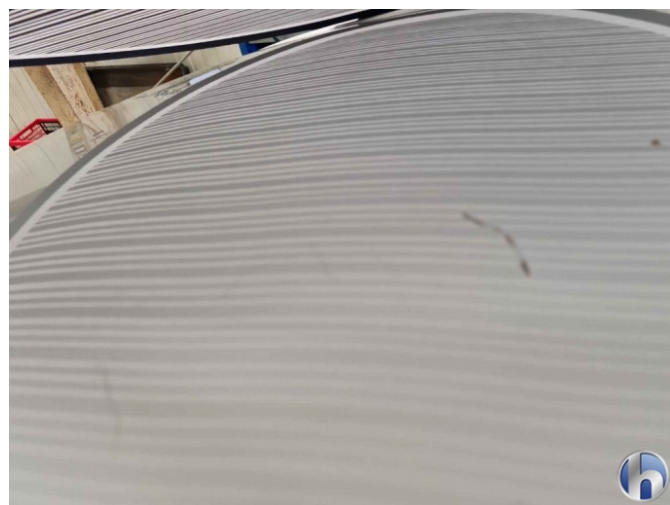
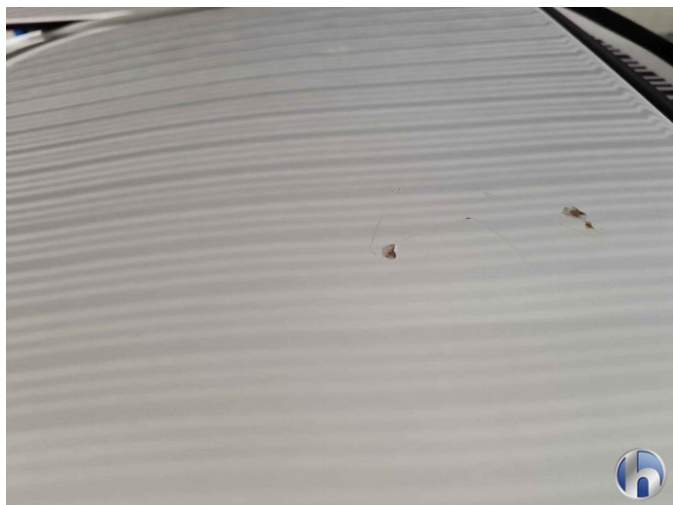
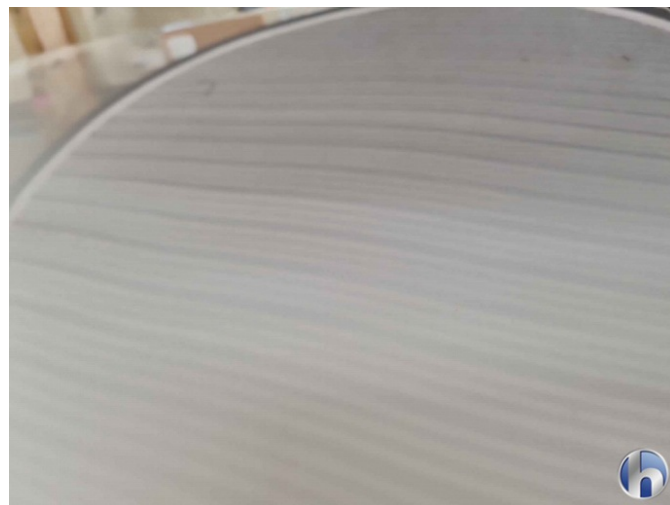
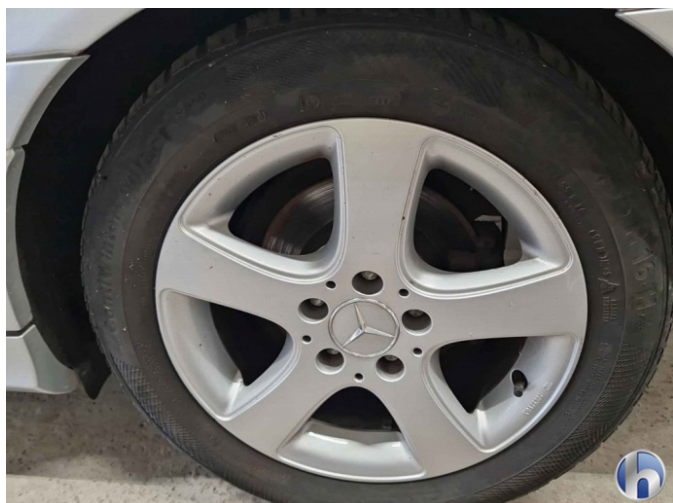
| component | Damage | Rep kind |
|---|---|---|
| 39. roof | Rust | Paint |

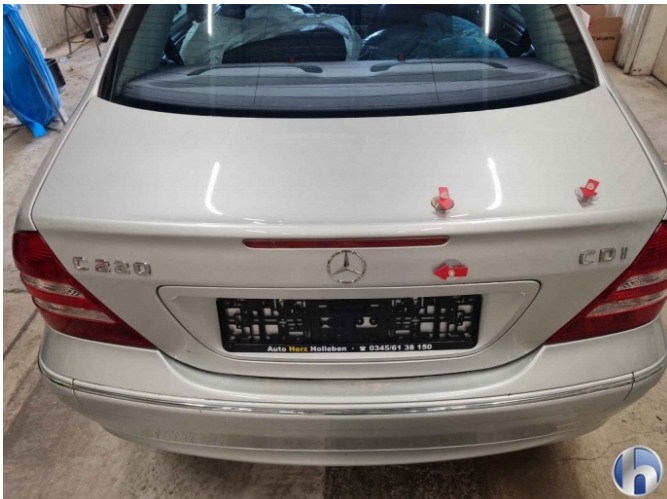
| 41. | Zusatzbremsleuchte | Damaged | Replace |

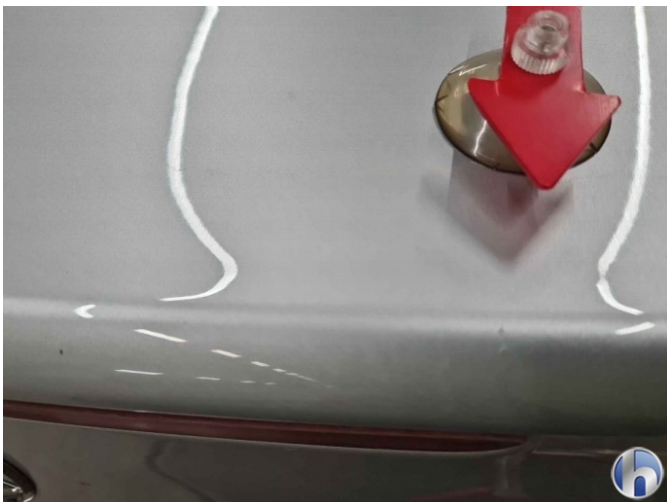
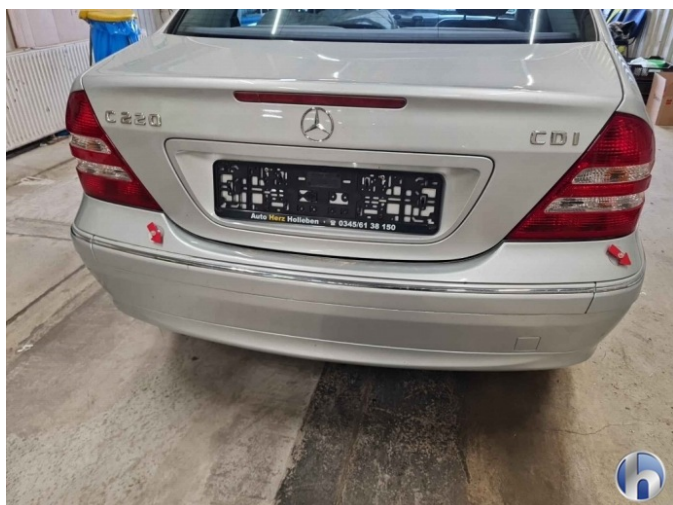
| 42. | tailgate | Damaged | Refurbish and paint |

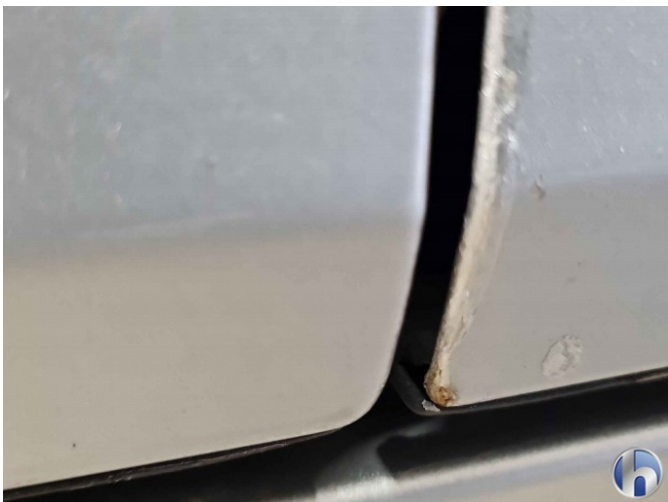
46. Door Rear - right

| 46. | Door Rear - right | chipped paint | Smart repair |

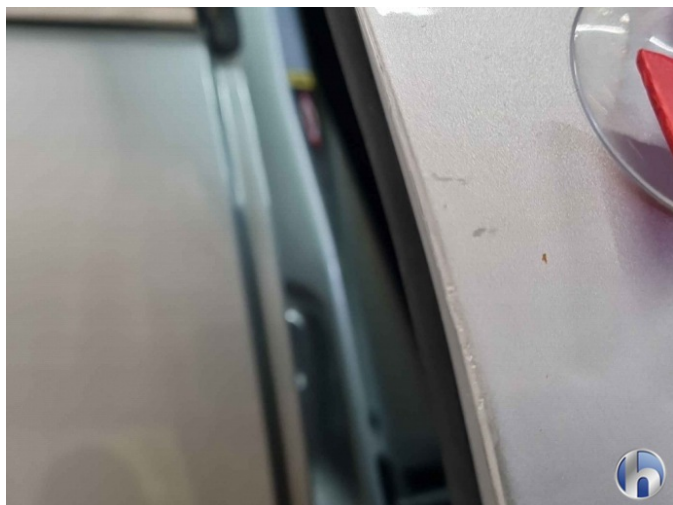
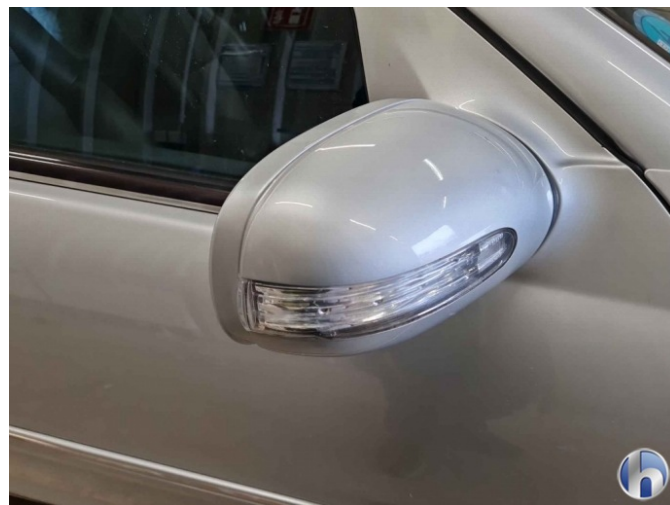
47. Front door - right

| 47. | Front door - right | Rust | Paint |

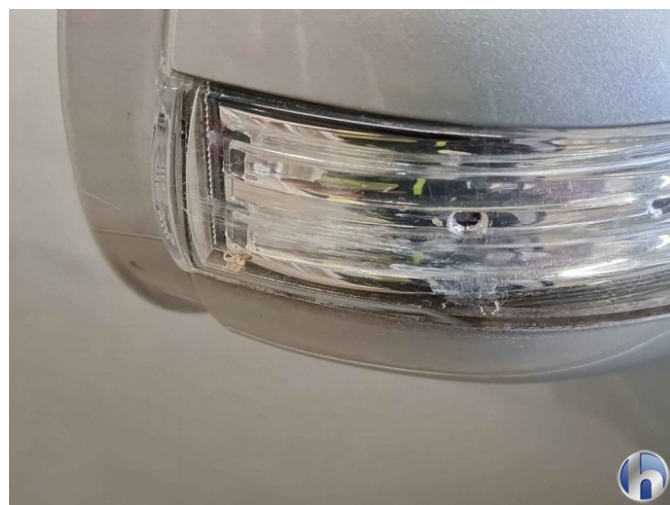
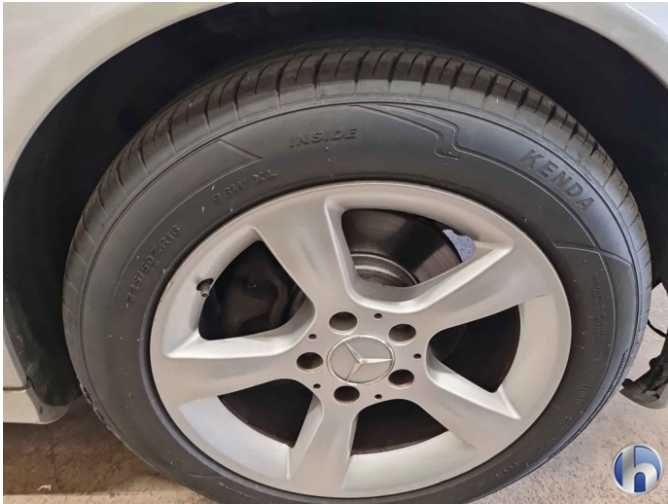
| 49. | | Scrape | Replace |

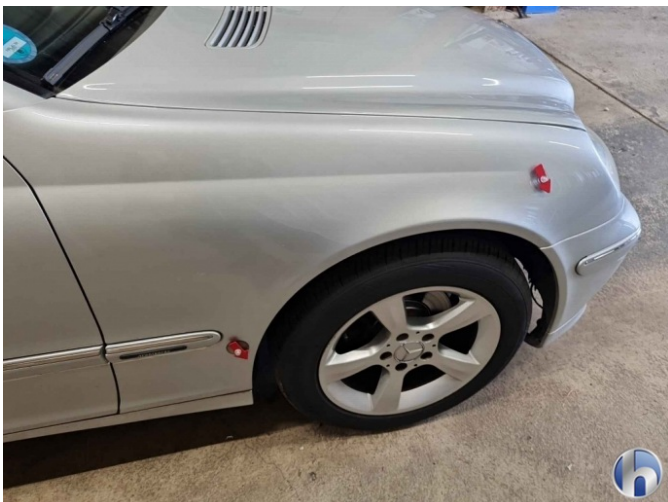
51. Front right wheel housing liner

| 51. | Front right wheel housing liner | Damaged | Replace |
