## status report

#### Mercedes-Benz A -Klasse A 220 CDI / d BlueEfficiency

| Vehicle identification number | <b>WDD1760031J461457</b> | mileage read: | <b>101062 km</b> |

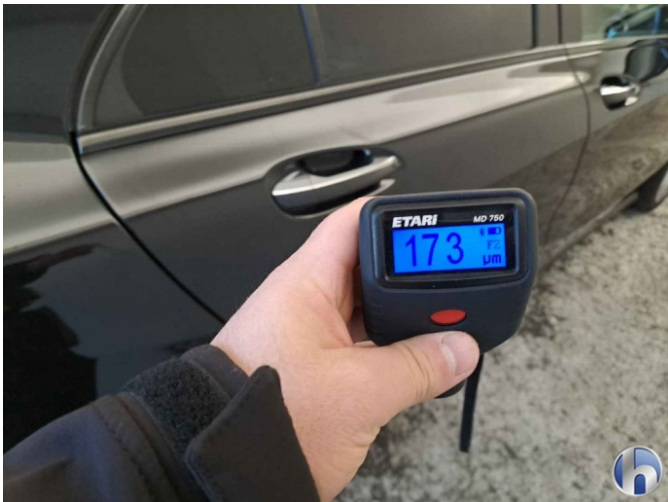
3. Door Rear - right

| 43. | Door Rear - right | Execution defect | Refurbish and paint |

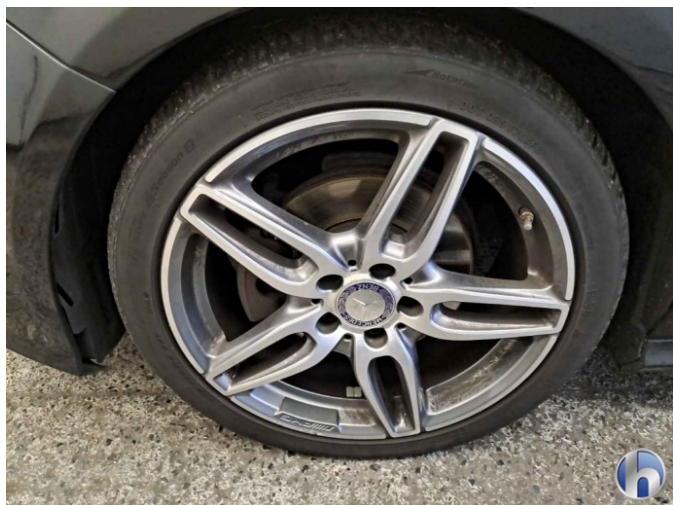
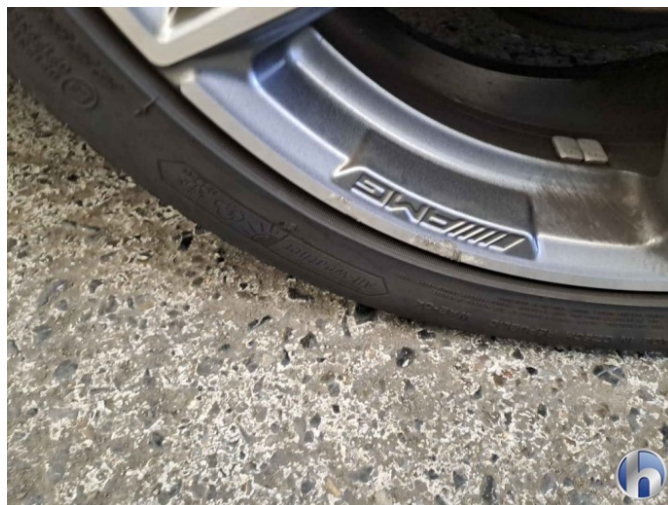
| component | Damage | Rep kind |
|---|---|---|
| 8. | Scratch(es) | Replace |

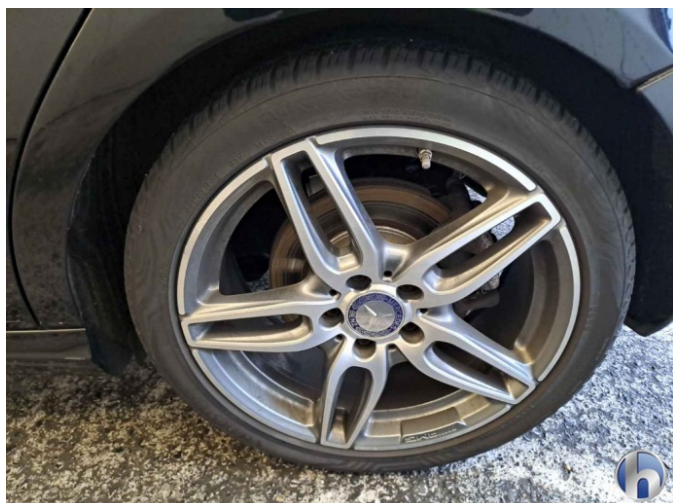
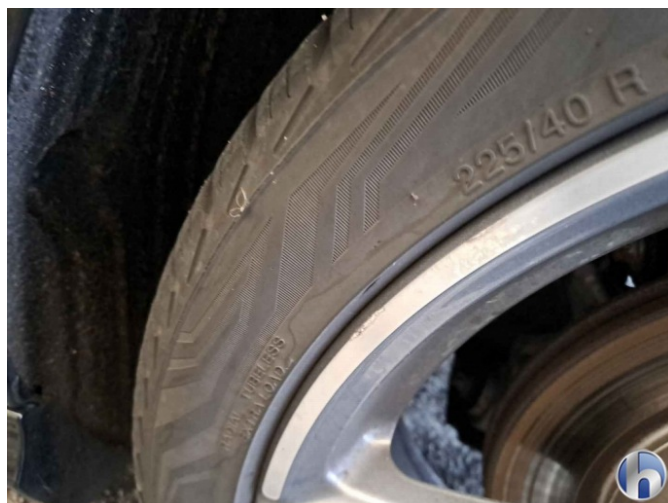
| component | Damage | Rep kind |
|---|---|---|
| 9. | Damaged | Replace |

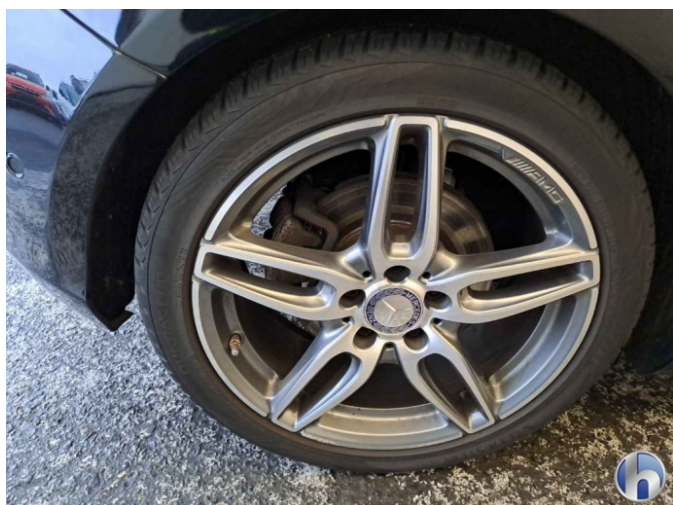
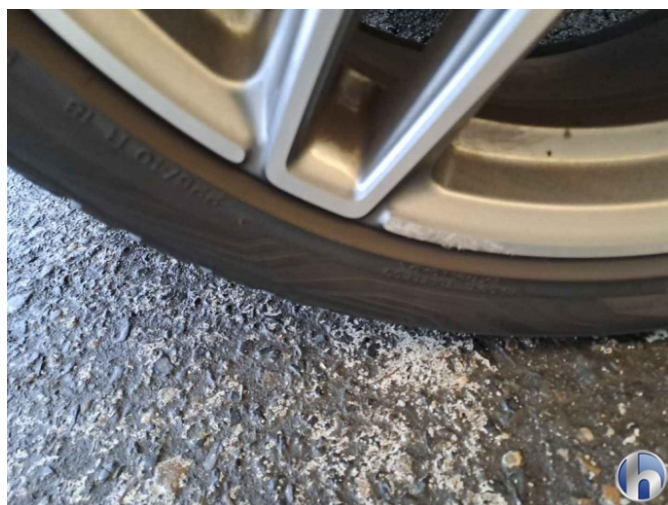
| component | Damage | Rep kind |
|---|---|---|
| 10. | Scratch(es) | Replace |

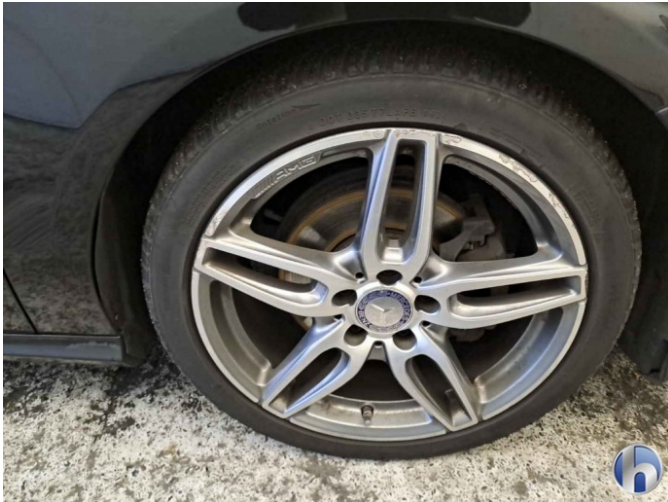
| component | Damage | Rep kind |
|---|---|---|
| 11. tire front - right | Damaged | Replace |

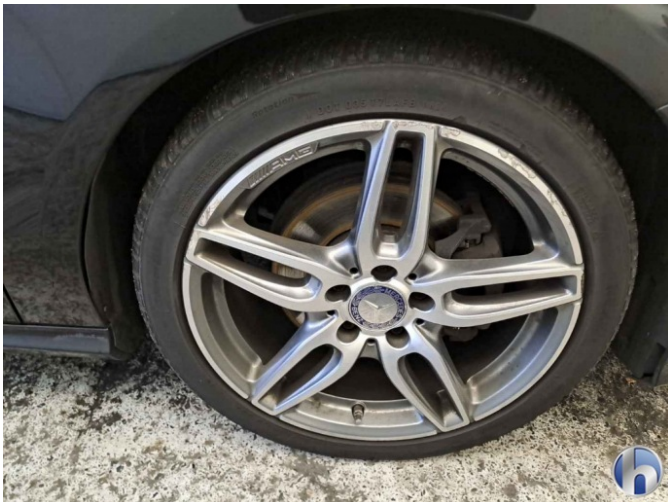
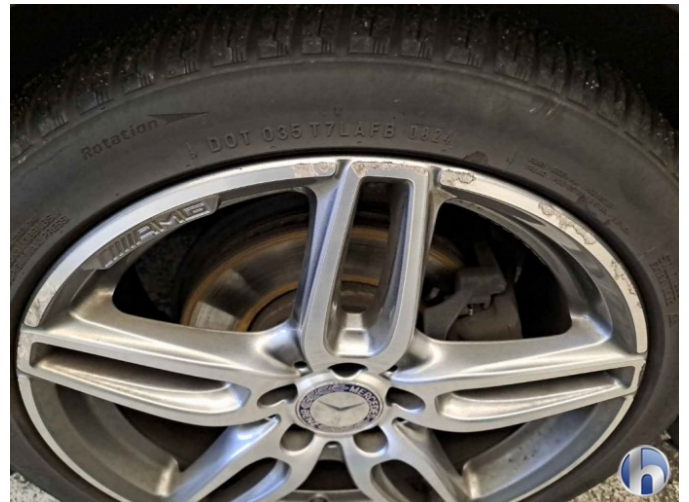
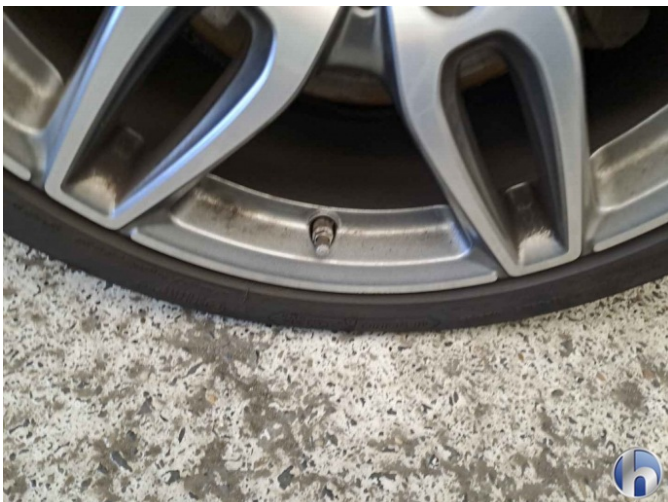
| component | Damage | Rep kind |
|---|---|---|
| 12. | Damaged | Replace |

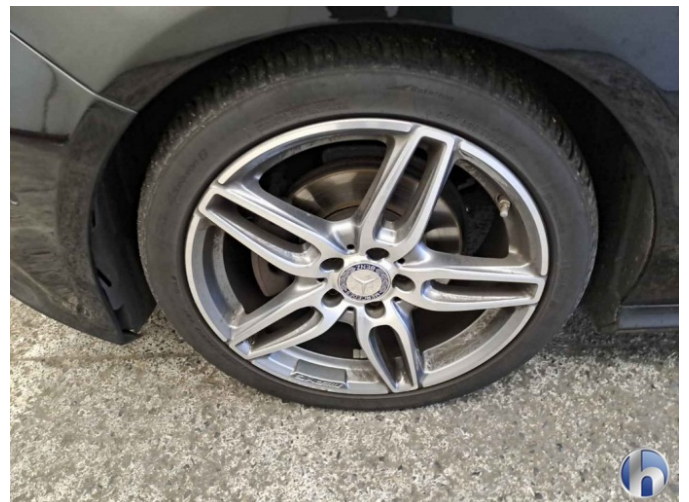
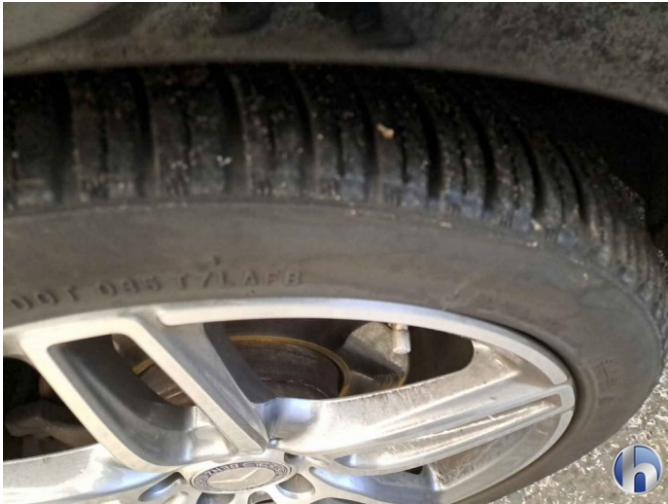
| component | Damage | Rep kind |
|---|---|---|
| 13. tire front - left | Worn | Replace |

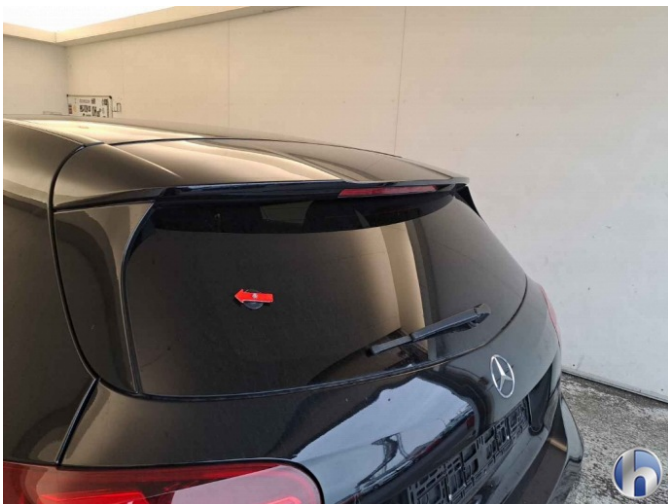
| component | Damage | Rep kind |
|---|---|---|
| 17. rear window | Scratch(es) | Replace |

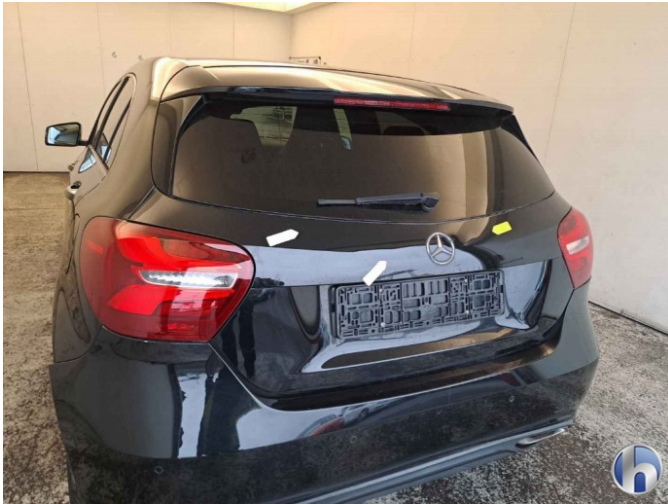
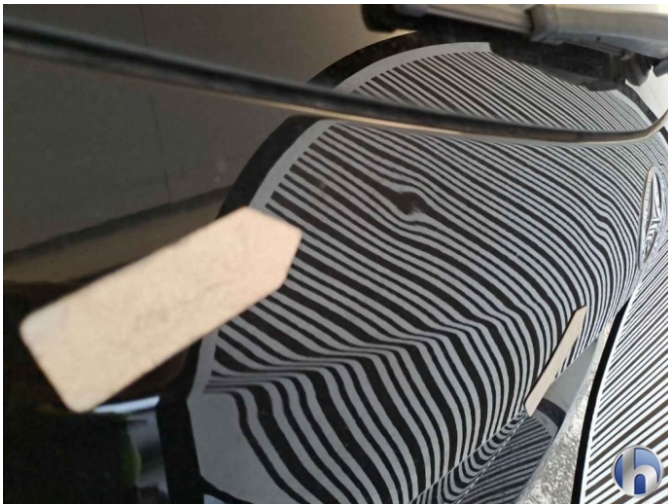
| component | Damage | Rep kind |
|---|---|---|
| 18. tailgate | Damaged | Refurbish and paint |

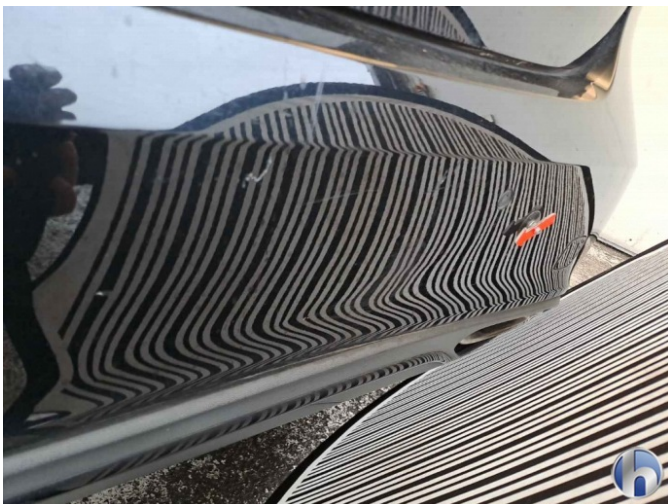
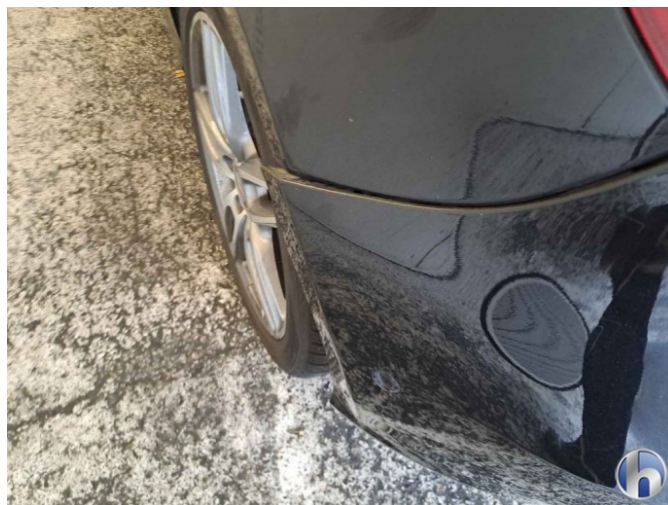
| component | Damage | Rep kind |
|---|---|---|
| 19. Rear bumper | Damaged | Replace |

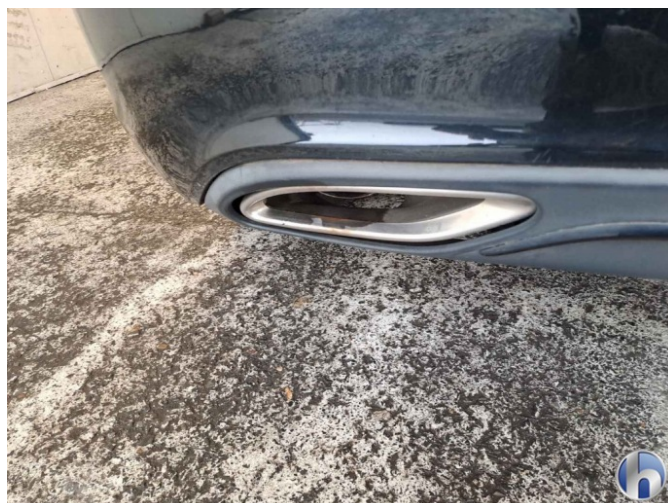
| component | Damage | Rep kind |
|---|---|---|
| 20. Auspuffblende | Damaged | Replace |

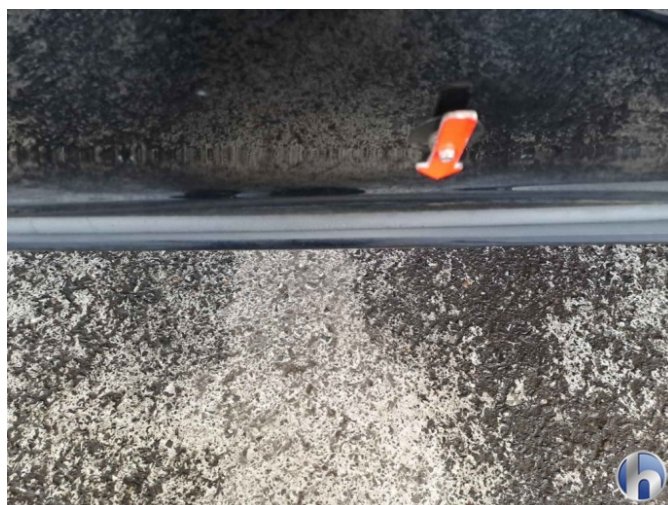
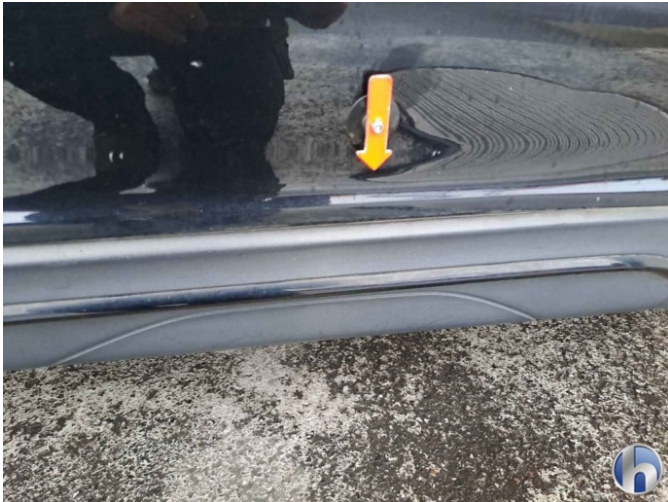
| component | Damage | Rep kind |
|---|---|---|
| 21. Diffusor | Damaged | Replace |

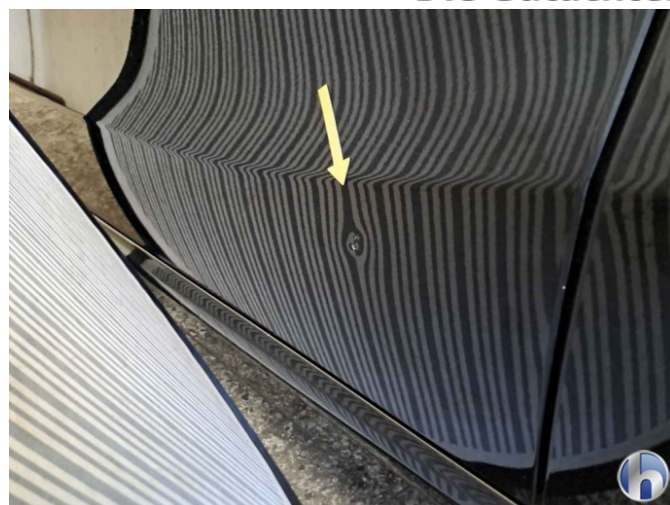
| component | Damage | Rep kind |
|---|---|---|
| 23. Front door - left | Damaged | Refurbish and paint |

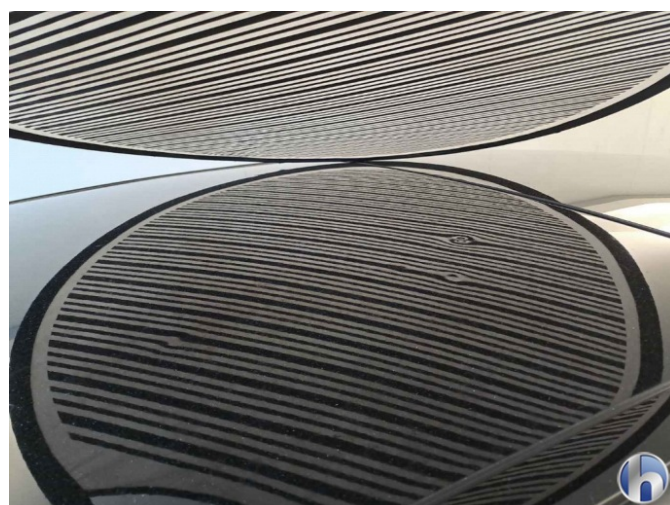
| component | Damage | Rep kind |
|---|---|---|
| 24. Dach mit 15 Dellen à 20mm-30mm | Hail damage | Refurbish and paint |

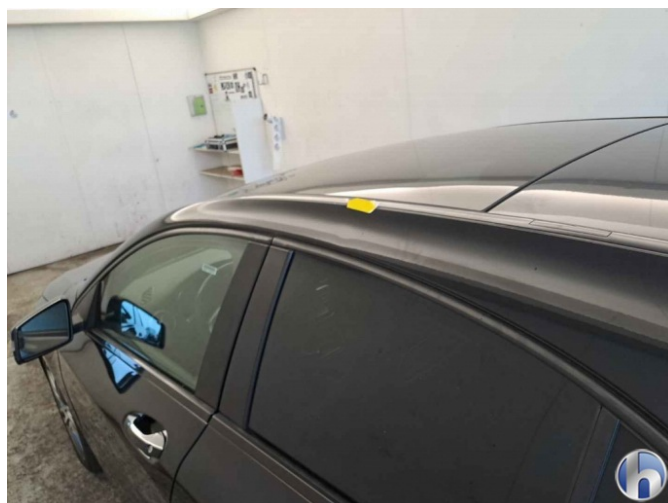
| component | Damage | Rep kind |
|---|---|---|
| 25. Dachleiste Rechts | Deformed | Replace |

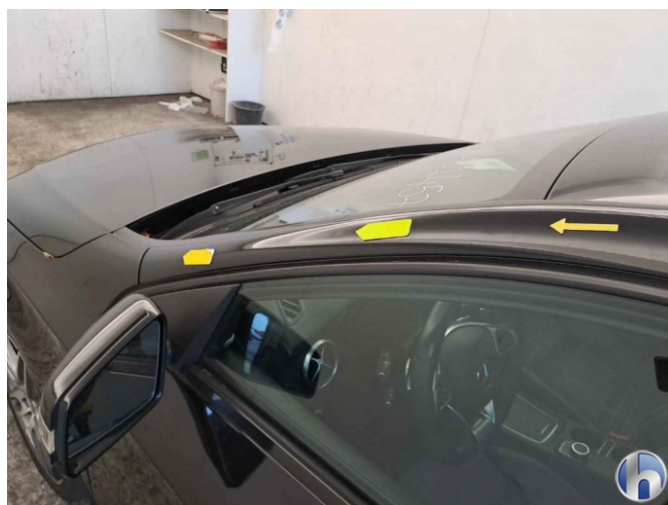
| component | Damage | Rep kind |
|---|---|---|
| 26. Dachleiste Links | Deformed | Replace |

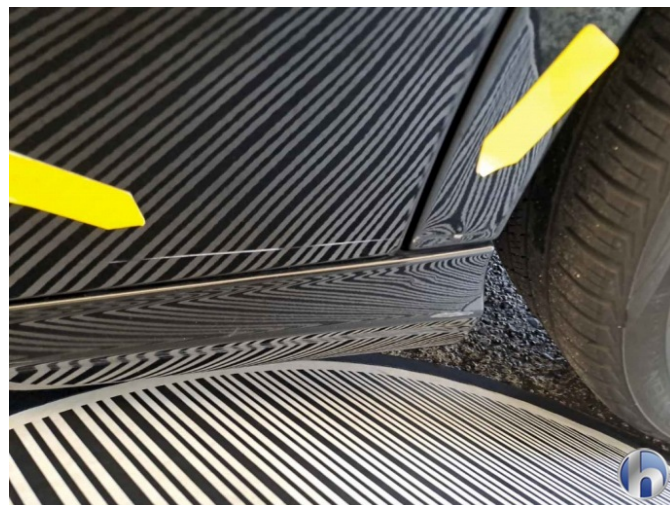
| component | Damage | Rep kind |
|---|---|---|
| 29. Sidewall - Rear - Left | Damaged | Refurbish and paint |

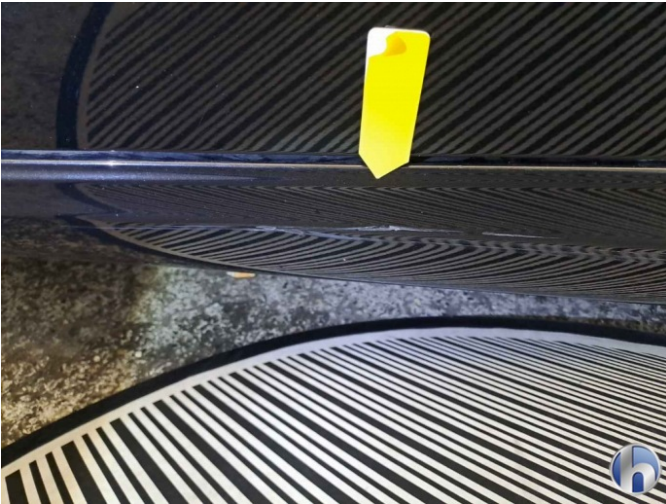
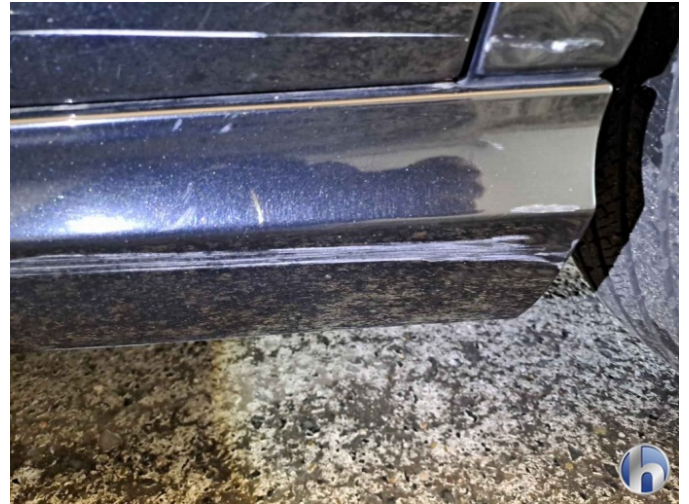
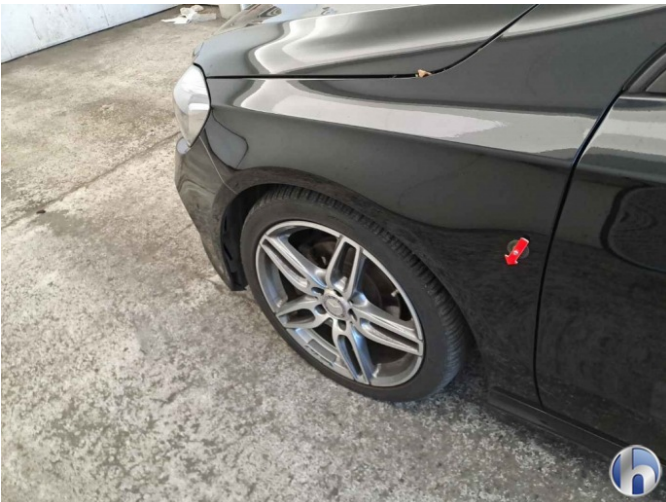
| component | Damage | Rep kind |
|---|---|---|
| 31. | Scrape | Replace |

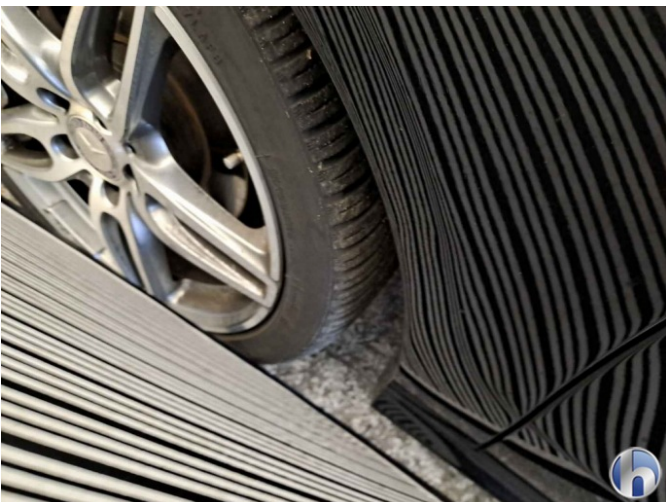
| component | Damage | Rep kind |
|---|---|---|
| 32. Front fender - left | Execution defect | Refurbish and paint |

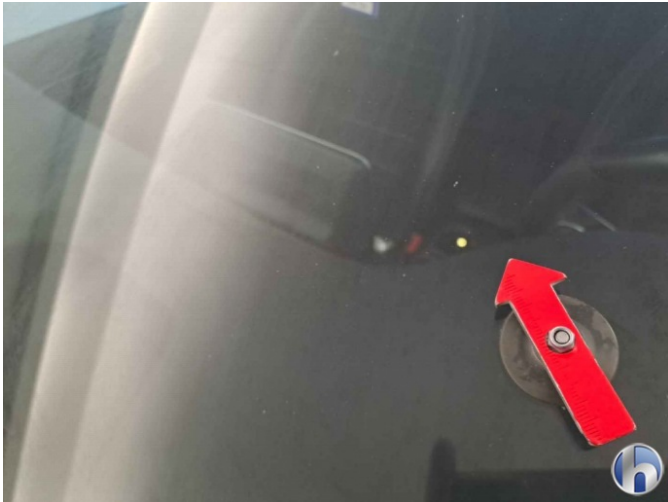
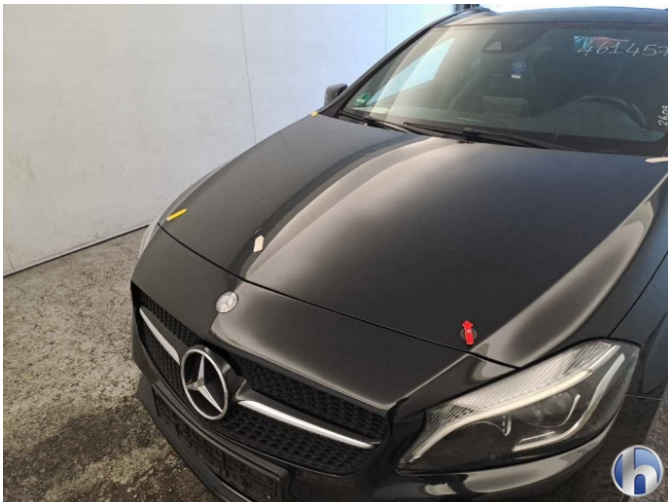
| component | Damage | Rep kind |
|---|---|---|
| 33. Windshield | Chipping from stones in field of view | Replace |

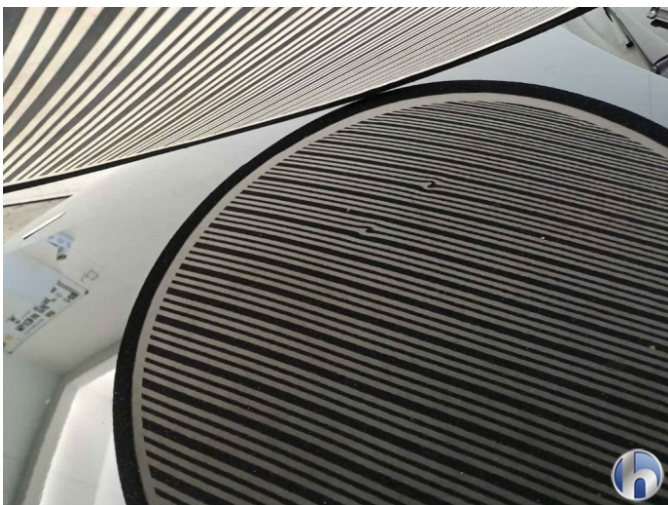
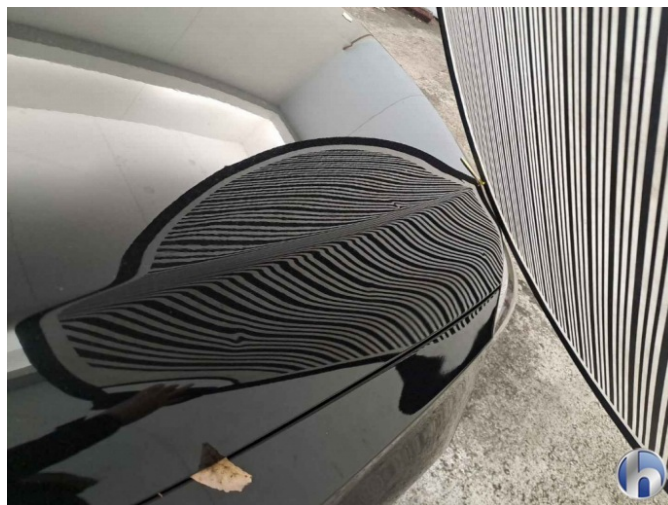
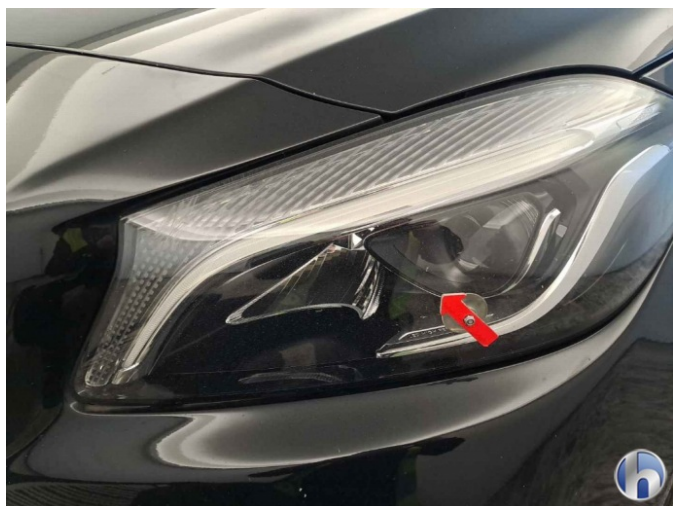
| component | Damage | Rep kind |
|---|---|---|
| 34. Motorhaube mit 30 Dellen à 20mm-30mm und einer Verformung mit Kratzer | Damaged | Refurbish and paint |

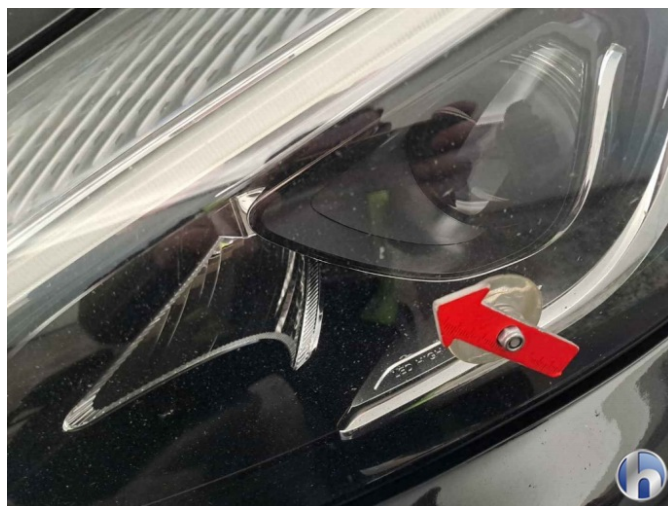
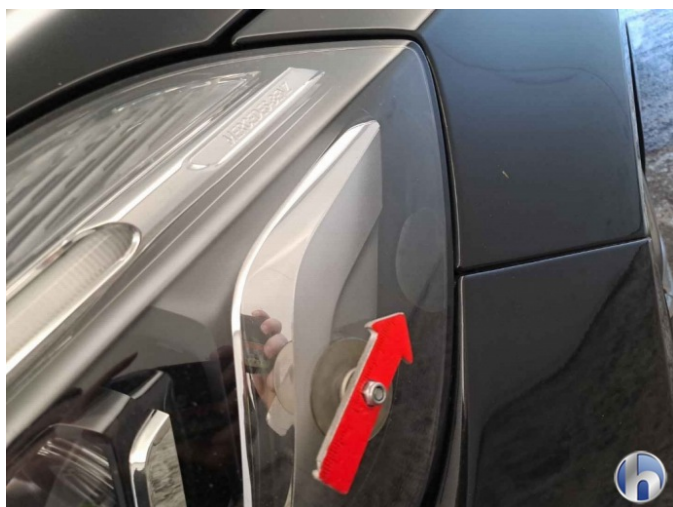
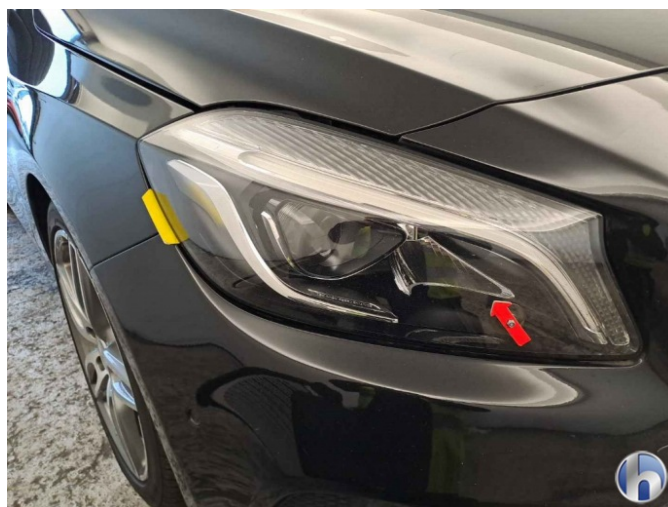
| component | Damage | Rep kind |
|---|---|---|
| 35. | Damaged | Replace |

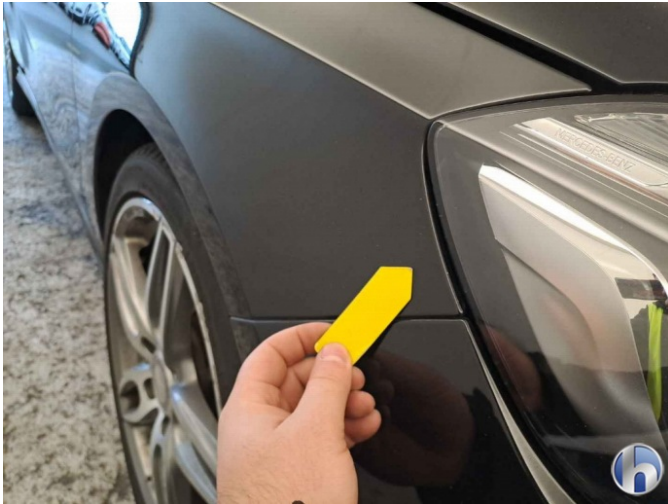
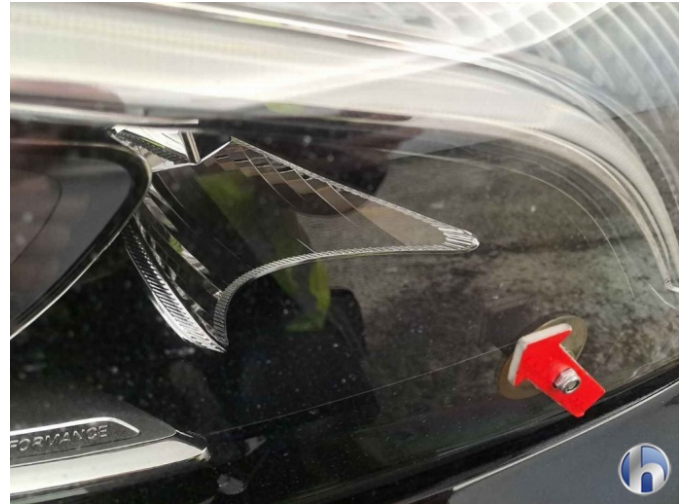
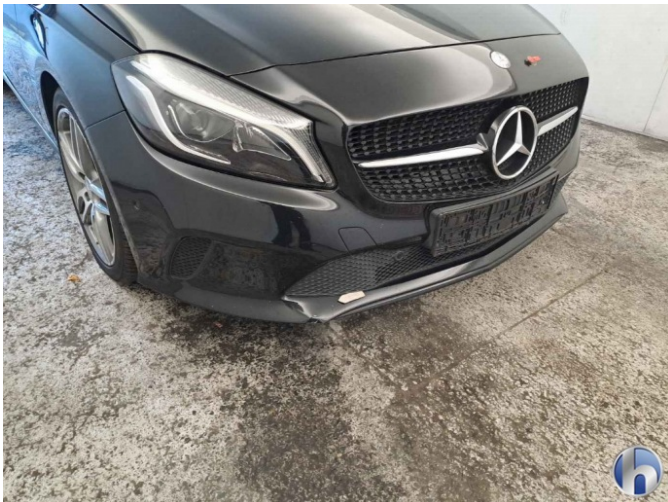
| component | Damage | Rep kind |
|---|---|---|
| 36. | Damaged | Replace |

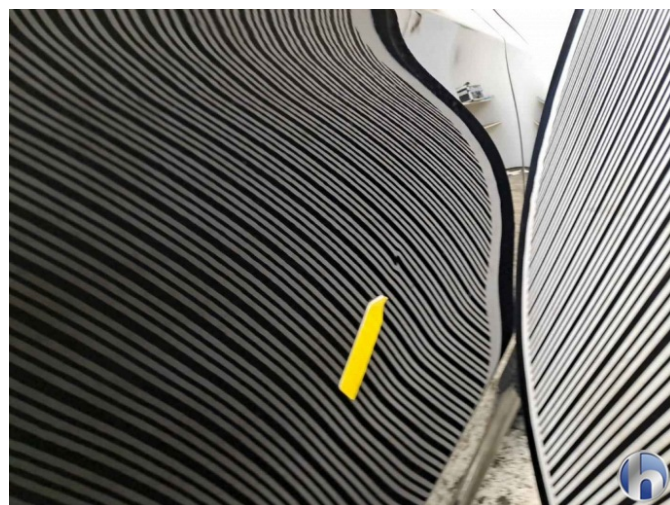
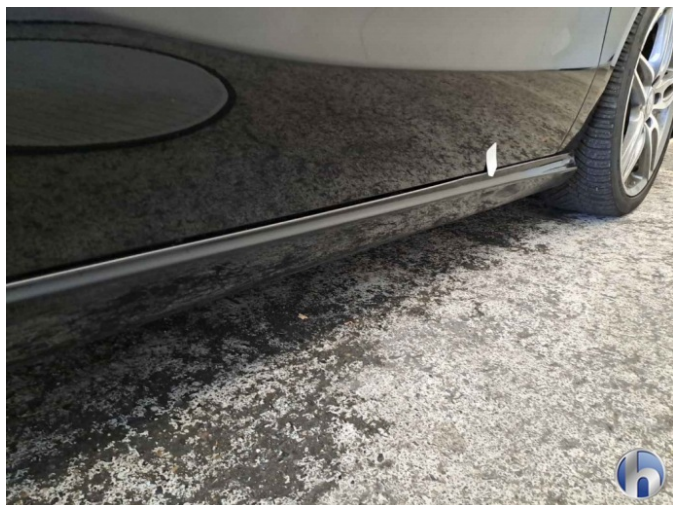
40. Front door - right

| 40. | Front door - right | Damaged | Refurbish and paint |

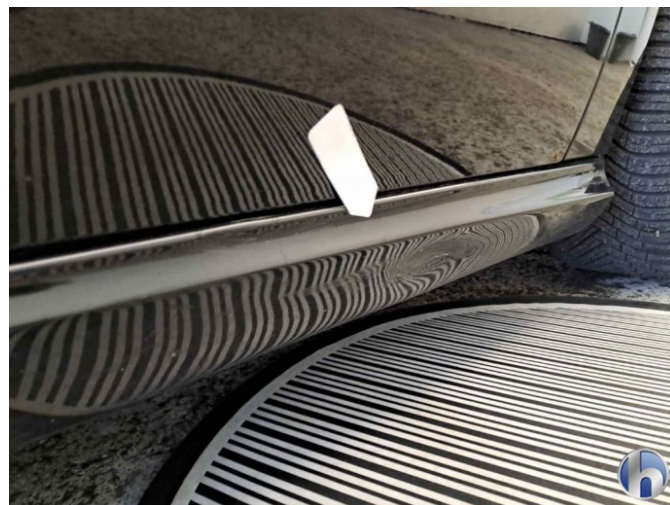
| 41. | | Damaged | Replace |

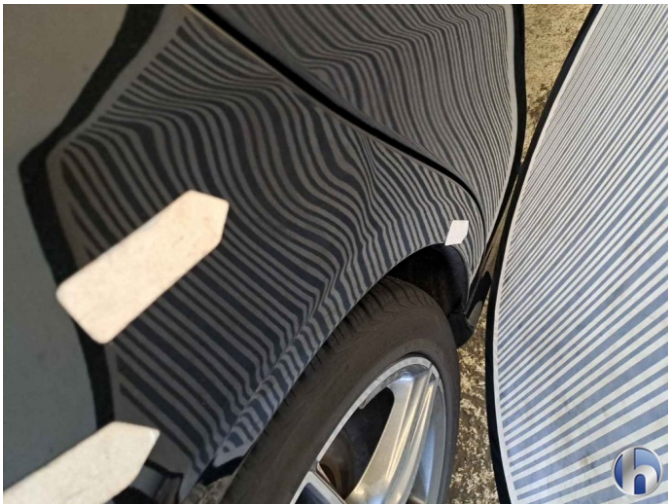
44. Sidewall - Rear - right

| 44. | Sidewall - Rear - right | Damaged | Refurbish and paint |

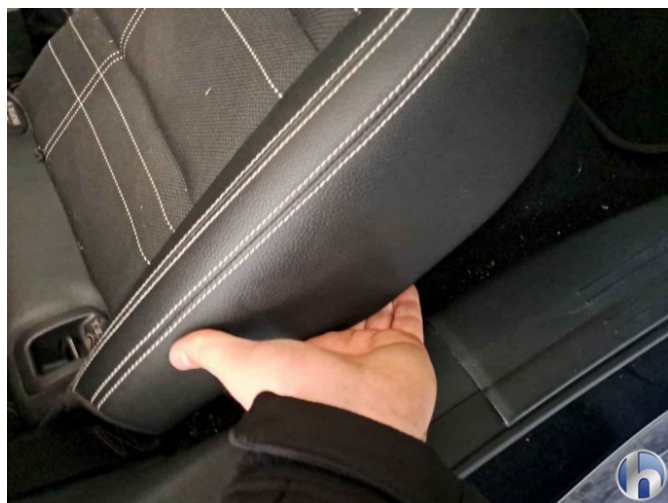
46. Sitzbank - Hinten: Kissen

| 46. | Sitzbank - Hinten: Kissen | Damaged | Replace |

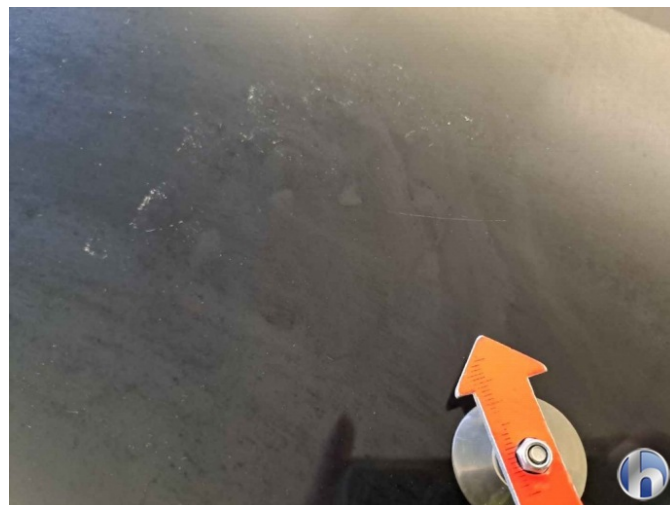
47. Sunroof

| 47. | Sunroof | Scratch(es) | Replace |

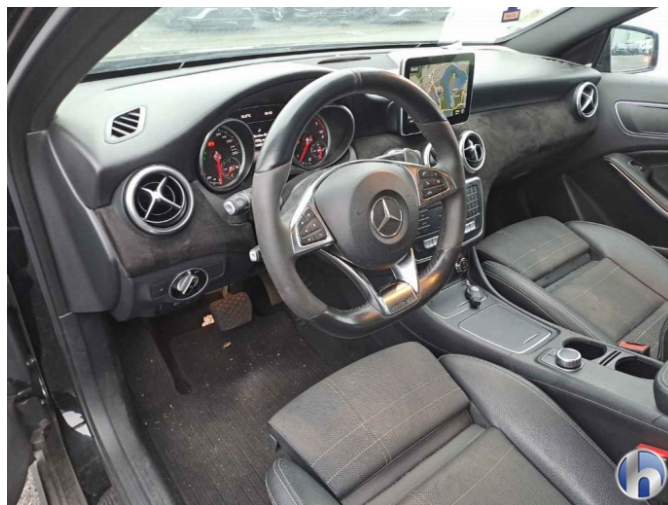
49. Sitz - Vorne - Links: Kissen

| 49. | Sitz - Vorne - Links: Kissen | Burn hole | Smart repair |

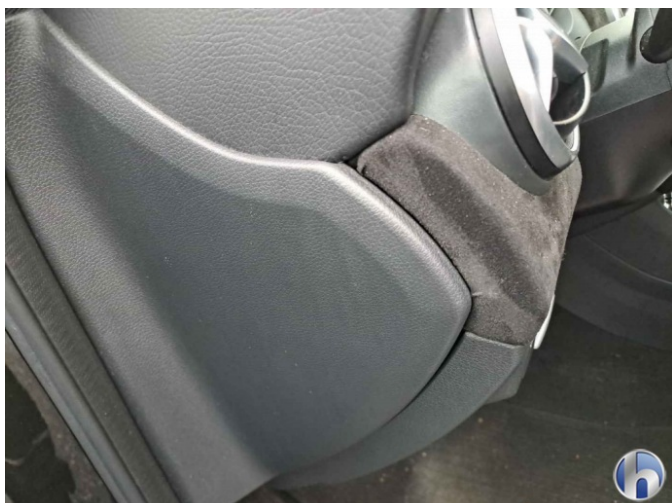
51. dashboard

| 51. | dashboard | Sticker | Replace |
