## status report

| <b>customer:</b> | <b>Bank 11, Neuss</b> |

| vehicle data | | | |
|---|---|---|---|
| <b>Mercedes-Benz C -Klasse Lim. C 220 CDI BlueEfficiency</b> | | | |
| Vehicle identification number | <b>WDD2040021A861718</b> | mileage read: | <b>215306 km</b> |

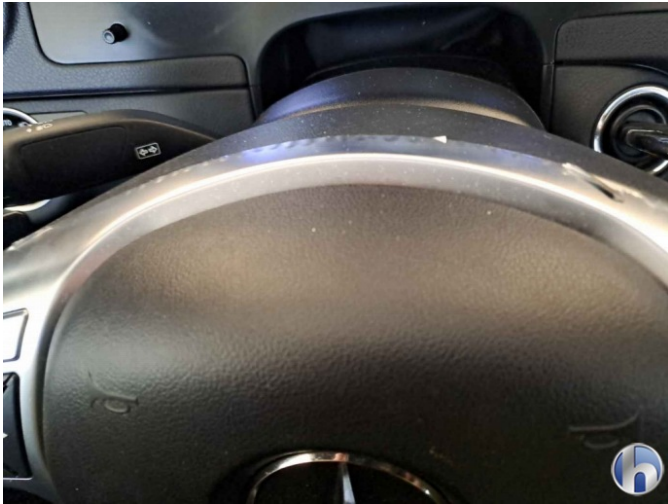
| component | Damage | Rep kind |
|---|---|---|
| 8. Lenkrad Spange | Damaged | Replace |

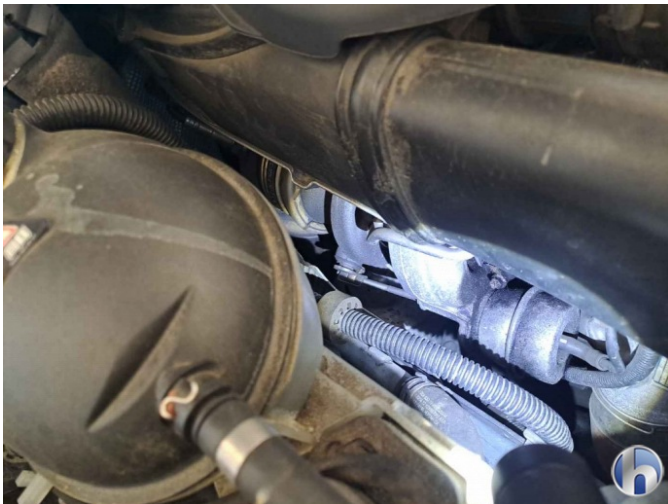
10. motor

| Performed testing technology | |
|---|---|
| <b>oil loss:</b> | The vehicle was inspected during the visit to an oil leak .<br>**motor. |

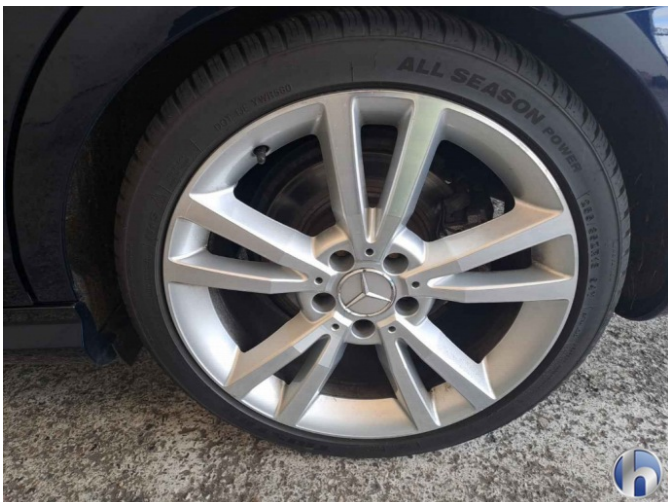
| component | Damage | Rep kind |
|---|---|---|
| 14. | Scratch(es) | Replace |

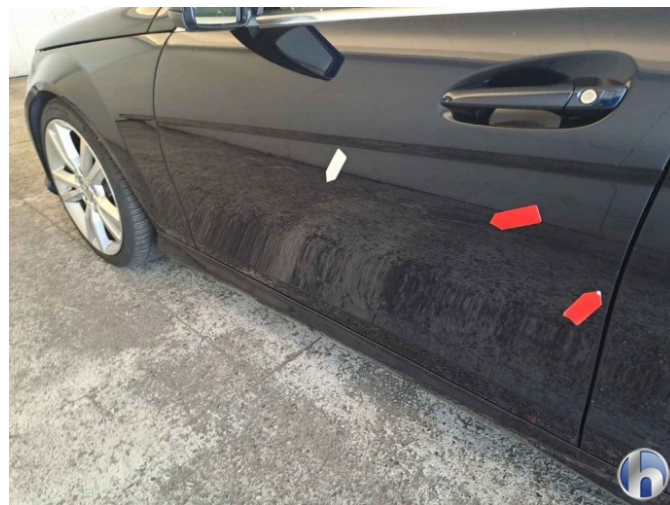
| component | Damage | Rep kind |
|---|---|---|
| 15. Front door - left | Damaged | Refurbish and paint |

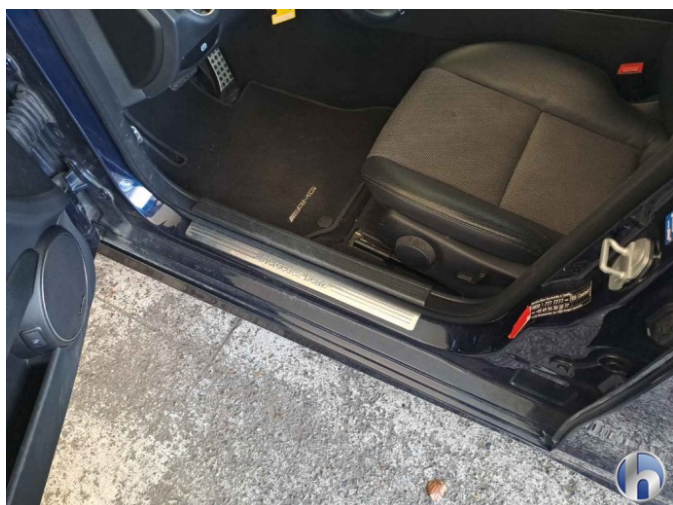
| component | Damage | Rep kind |
|---|---|---|
| 16. Türeinstieg Vorne - Links | Damaged | Refurbish and paint |

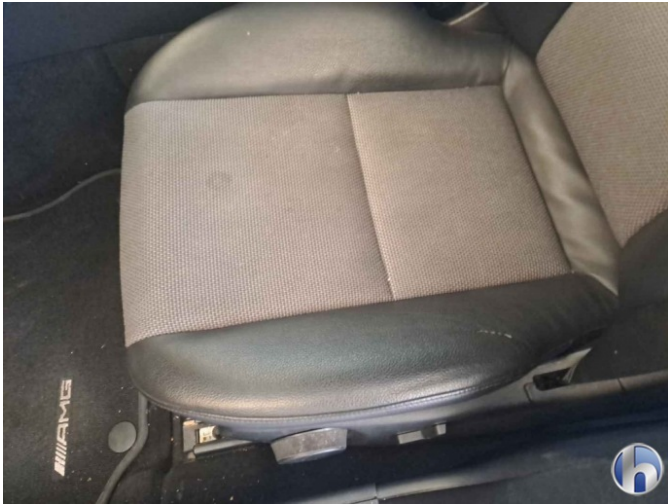
| component | Damage | Rep kind |
|---|---|---|
| 17. | Damaged | Replace |

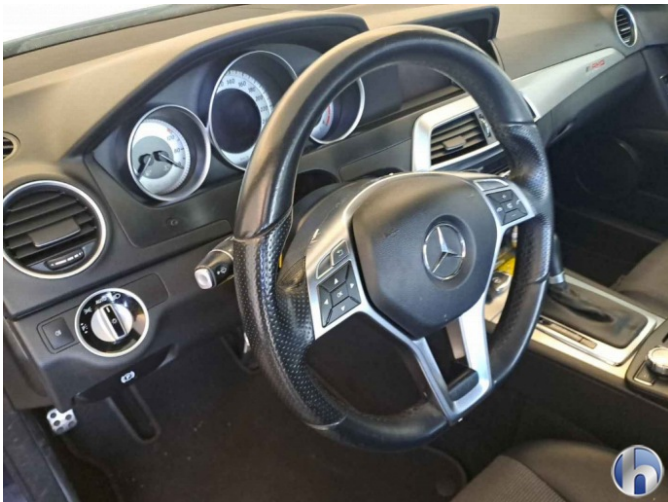
| component | Damage | Rep kind |
|---|---|---|
| 18. Steering wheel (leather) | Scrape | Replace |

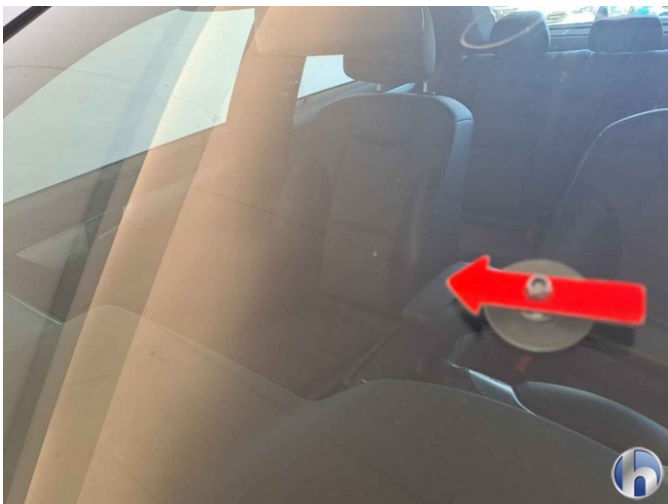
| component | Damage | Rep kind |
|---|---|---|
| 22. Windshield | Chipping from stones in field of view | Replace |

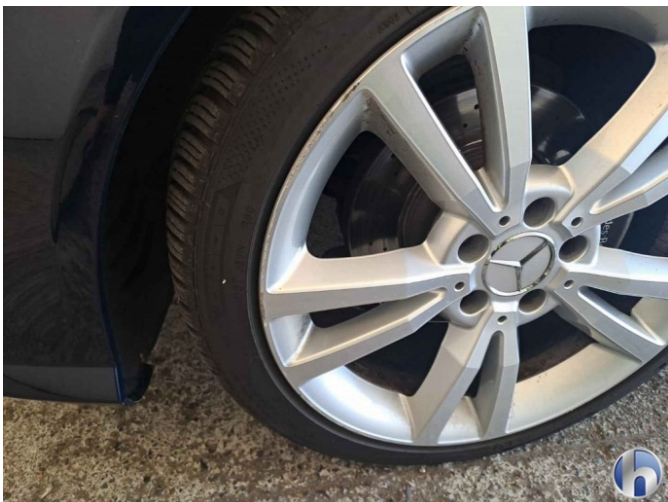
| component | Damage | Rep kind |
|---|---|---|
| 24. | Scratch(es) | Replace |

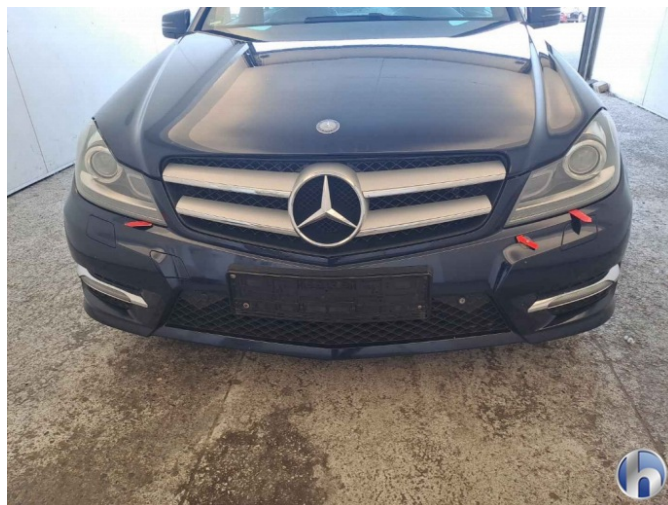
| component | Damage | Rep kind |
|---|---|---|
| 25. Scheinwerfer - Links | Scratch(es) | Replace |

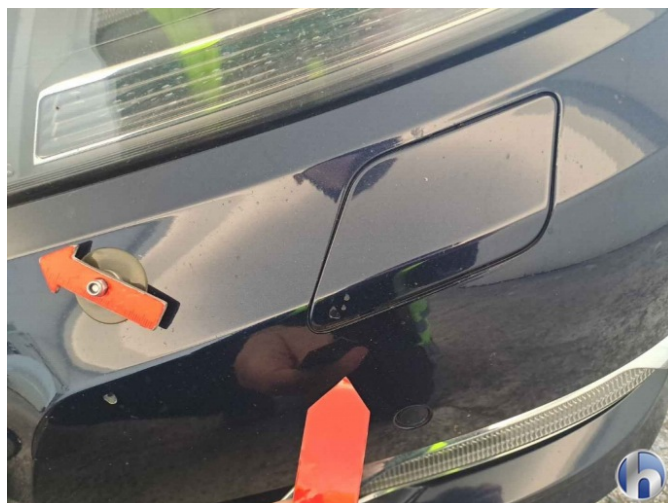
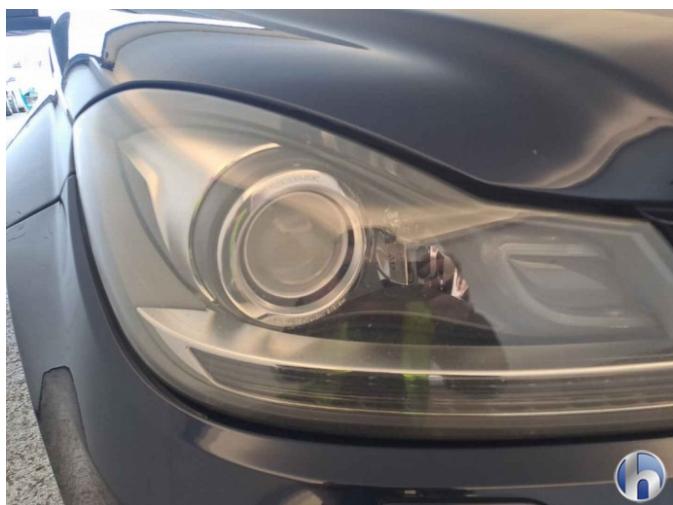
| component | Damage | Rep kind |
|---|---|---|
| 26. Front bumper | Execution defect | Paint |

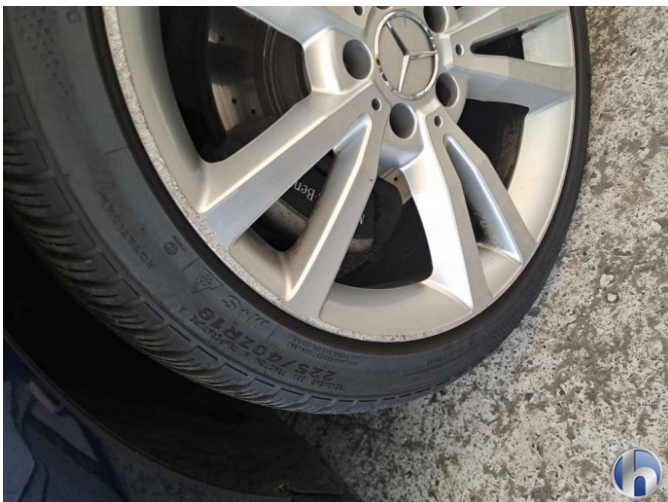
| component | Damage | Rep kind |
|---|---|---|
| 29. | Scratch(es) | Replace |

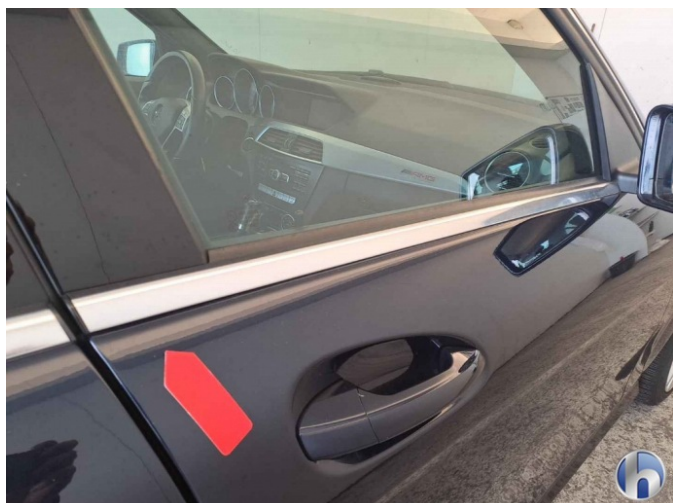
| component | Damage | Rep kind |
|---|---|---|
| 30. Front door - right | Damaged | Refurbish and paint |

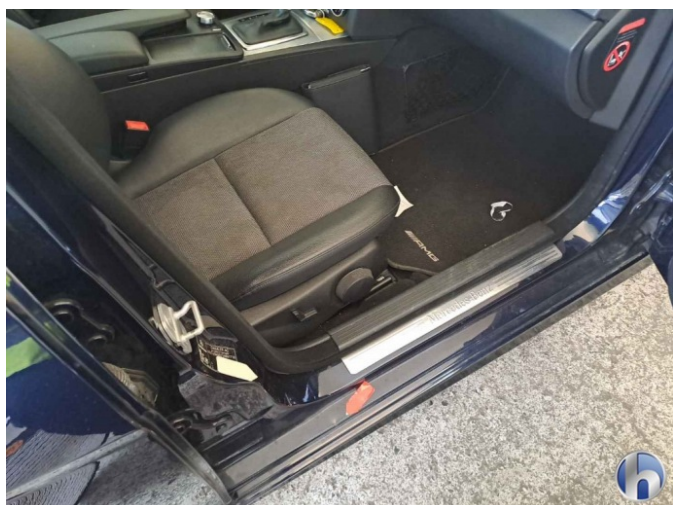
| component | Damage | Rep kind |
|---|---|---|
| 31. | Damaged | Replace |

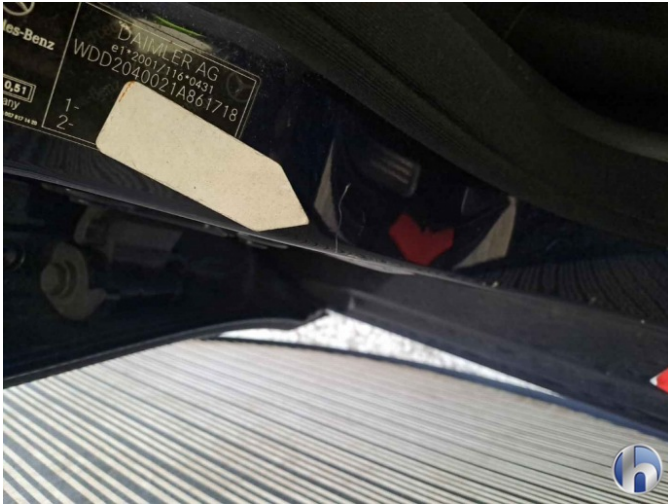
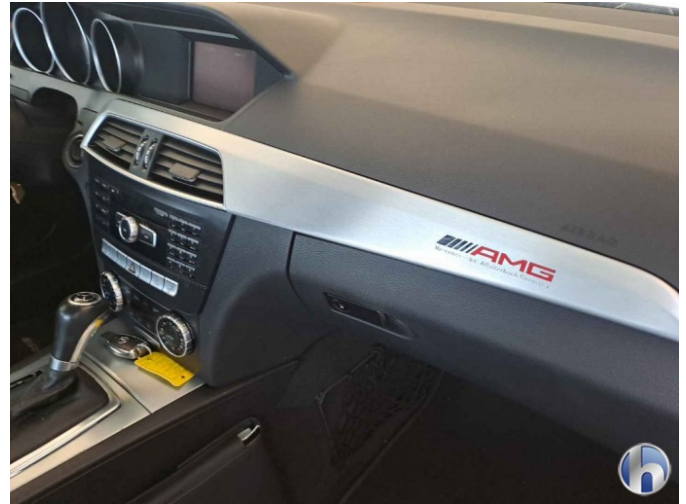
| component | Damage | Rep kind |
|---|---|---|
| 32. Türeinstieg Vorne - Rechts | Damaged | Refurbish and paint |
