## status report

**customer:** Bank 11, Neuss  
**contract number:** 369723170  
**reference:**

#### Mercedes-Benz E -Klasse Lim. E 350 CDI 4Matic

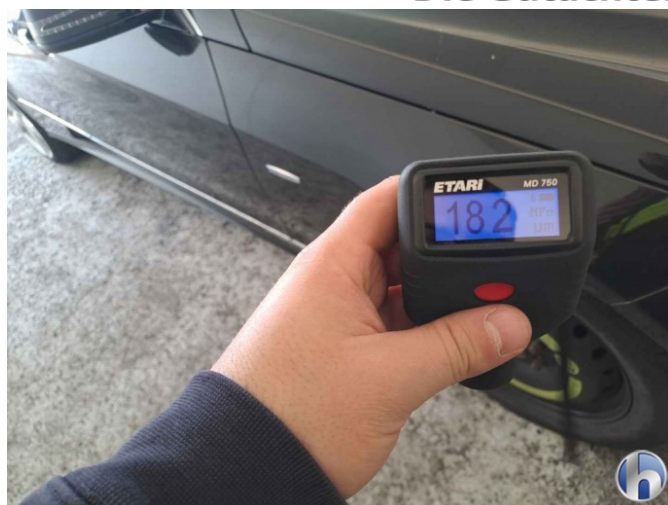
2. Front fender - right

| 40. | Front fender - right | Execution defect | Paint |

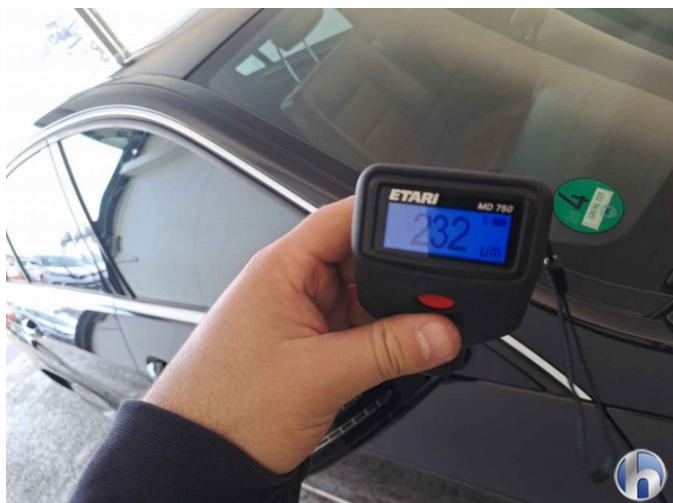
3. A-pillar Front - right

| 42. | A-pillar Front - right | Execution defect | Refurbish and paint |

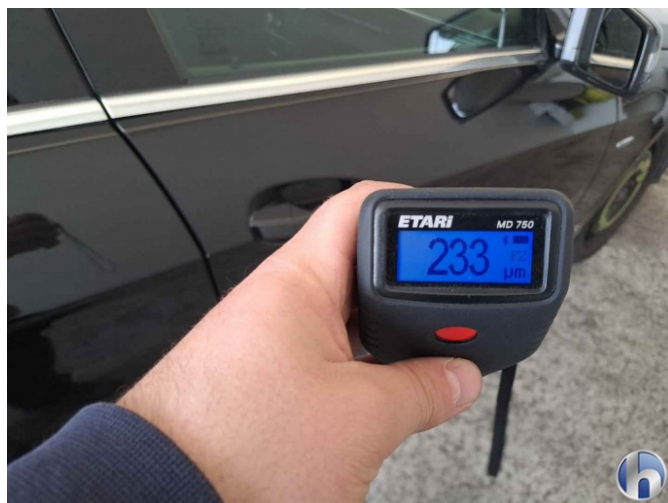
4. Front door - right

| 78. | Front door - right | Execution defect | Refurbish and paint |

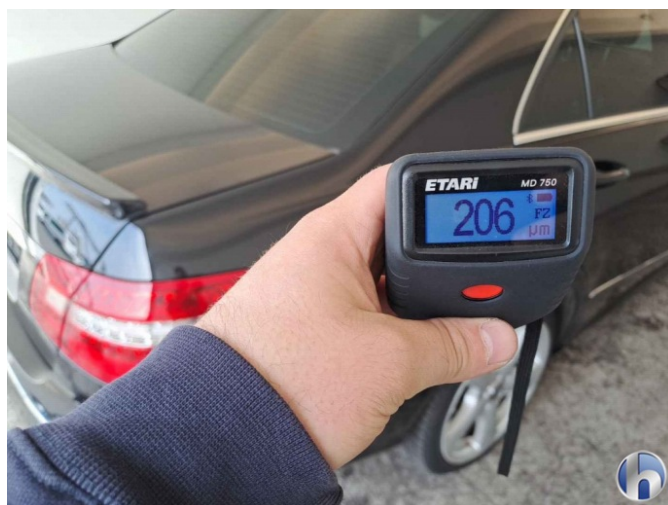
6. Sidewall - Rear - right

| 47. | Sidewall - Rear - right | Execution defect | Refurbish and paint |

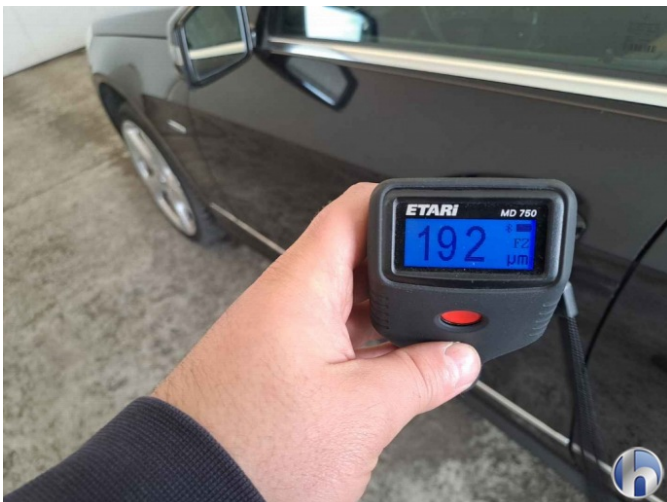
11. Front door - left

| 74. | Front door - left | Execution defect | Refurbish and paint |

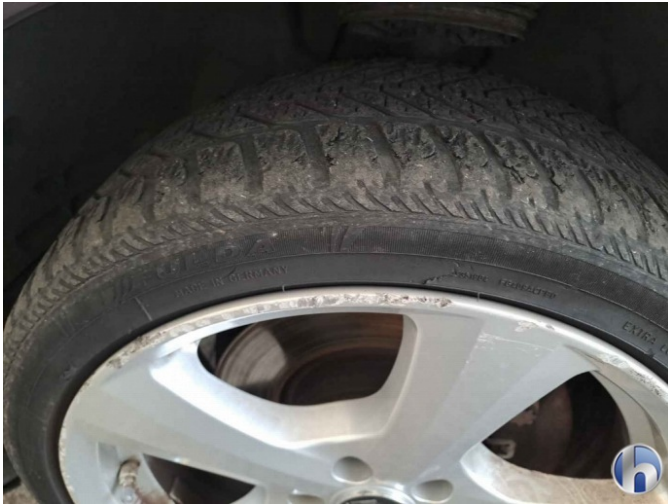
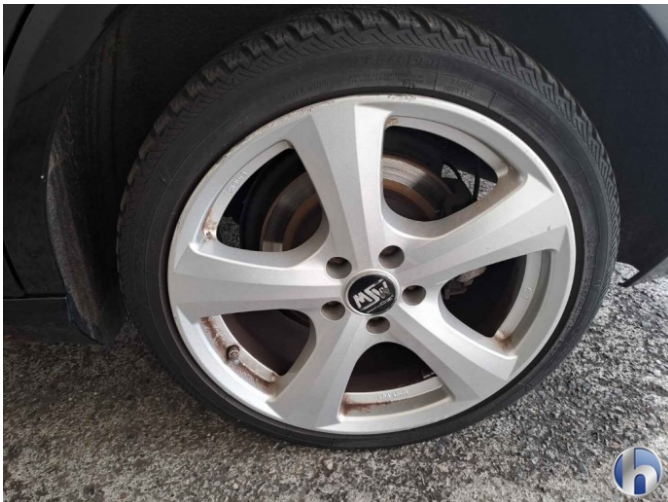
| component | Damage | Rep kind |
|---|---|---|
| 20. tire front - left | Damaged | Replace |

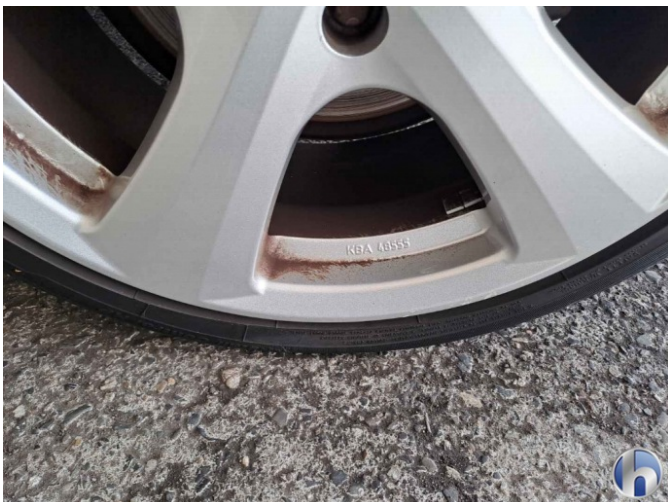
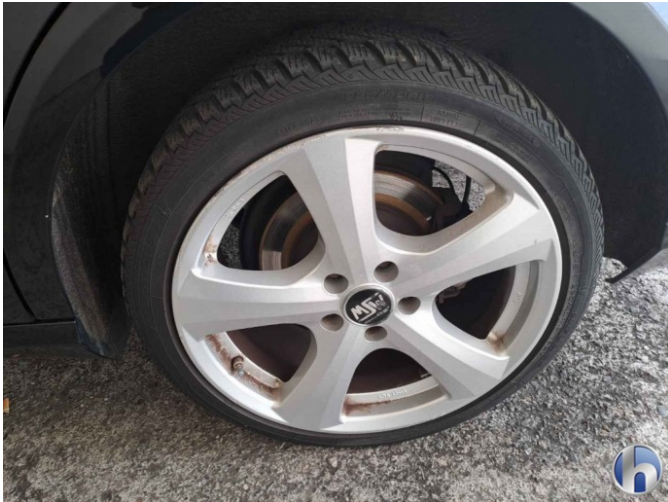
| component | Damage | Rep kind |
|---|---|---|
| 21. Rim rear - left | Scratch(es) | Smart repair |

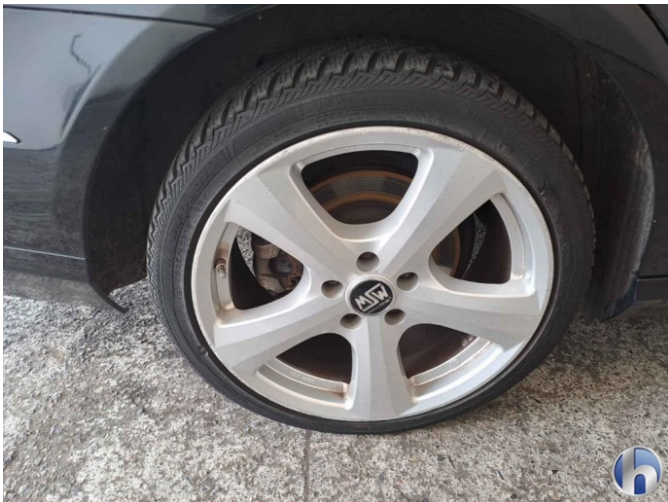
| component | Damage | Rep kind |
|---|---|---|
| 22. tire rear - left | Damaged | Replace |

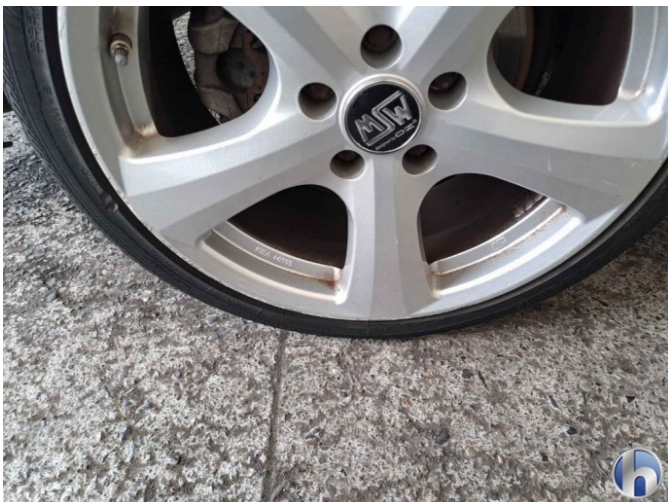
| component | Damage | Rep kind |
|---|---|---|
| 23. Rim rear - right | Damaged | Replace |

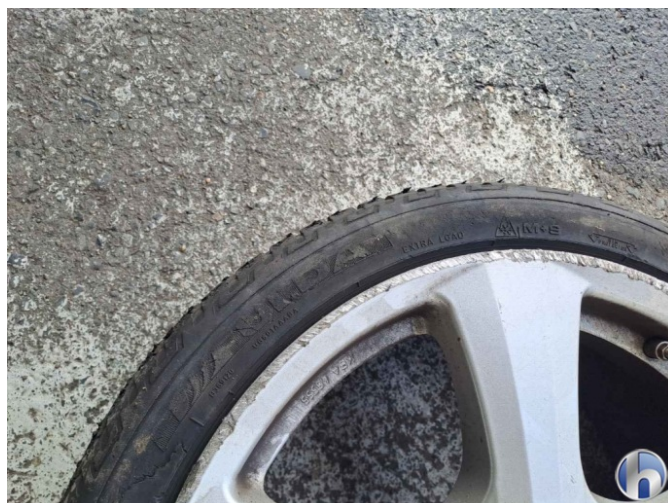
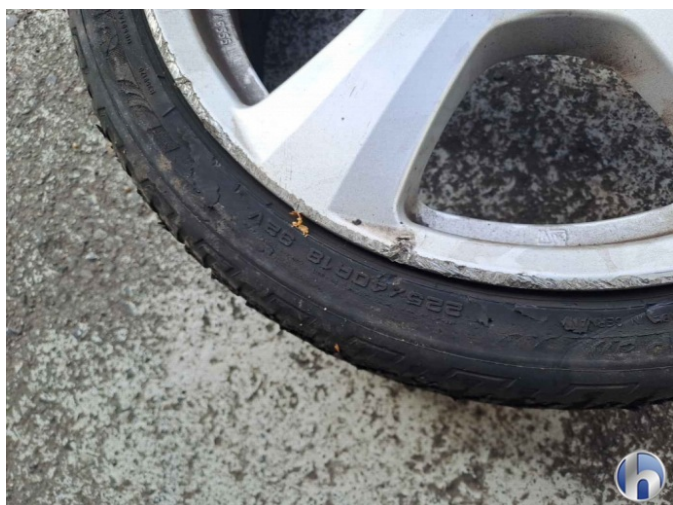
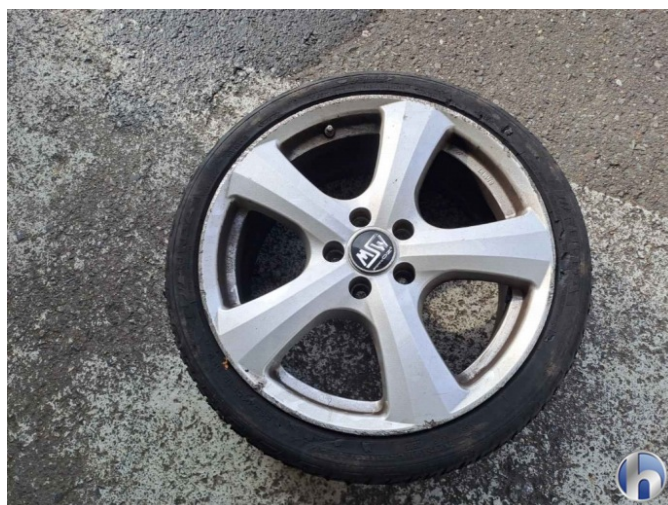
| component | Damage | Rep kind |
|---|---|---|
| 26. | Damaged | Replace |

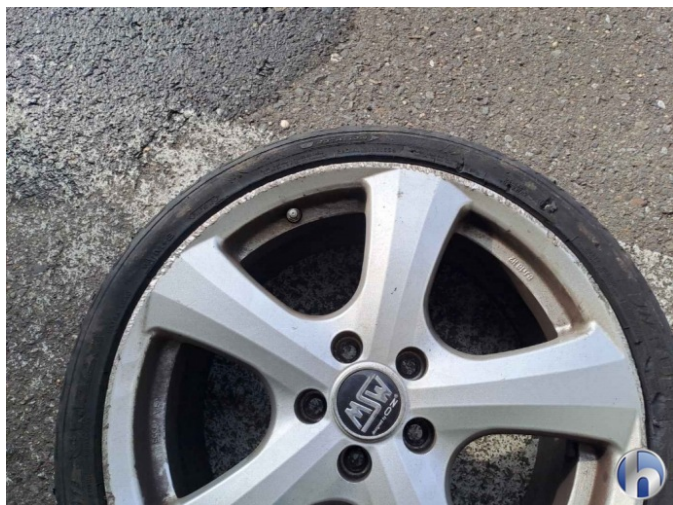
| component | Damage | Rep kind |
|---|---|---|
| 27. | Damaged | Replace |

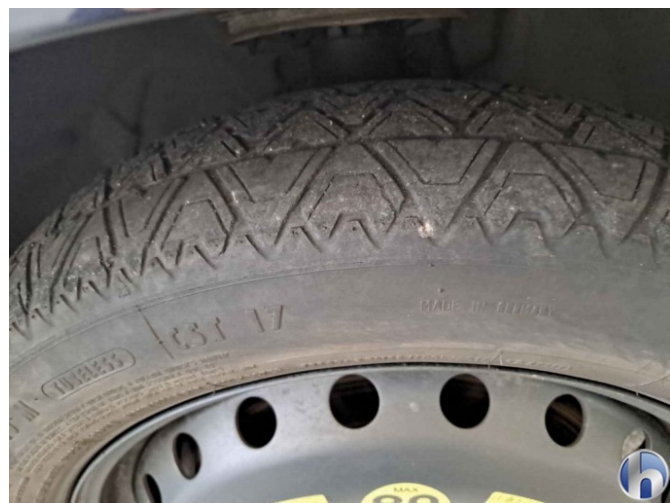
| component | Damage | Rep kind |
|---|---|---|
| 28. tire front - right | Worn | Replace |

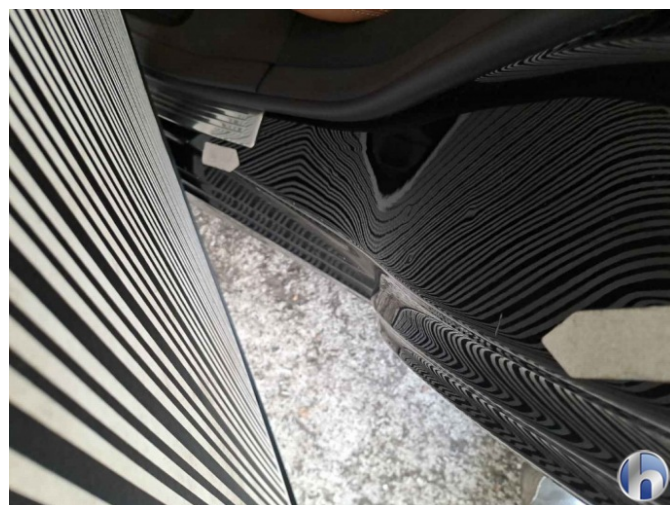
| component | Damage | Rep kind |
|---|---|---|
| 30. Türeinstieg Hinten - Links | Damaged | Refurbish and paint |

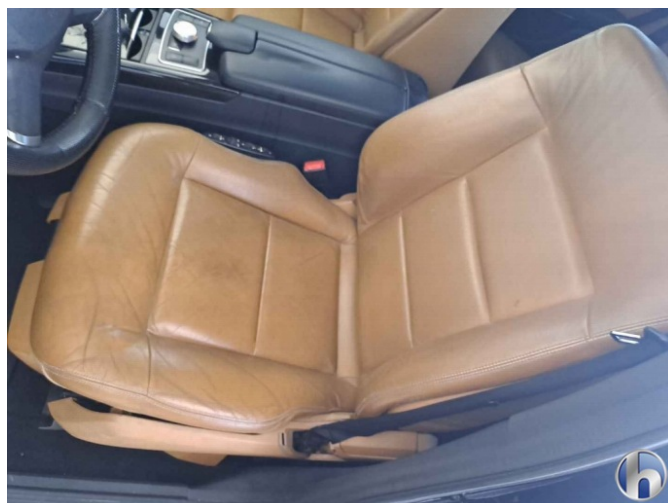
| component | Damage | Rep kind |
|---|---|---|
| 32. | Wear and tear | acceptable |

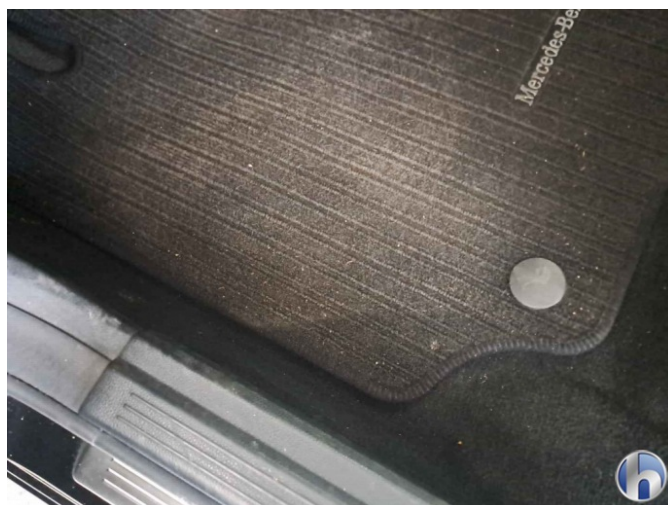
| component | Damage | Rep kind |
|---|---|---|
| 33. | Burn hole | Replace |

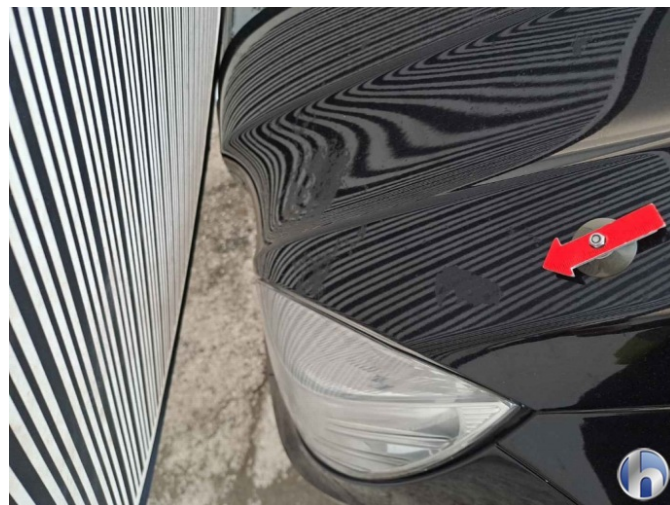
| component | Damage | Rep kind |
|---|---|---|
| 36. hood | Execution defect | Refurbish and paint |

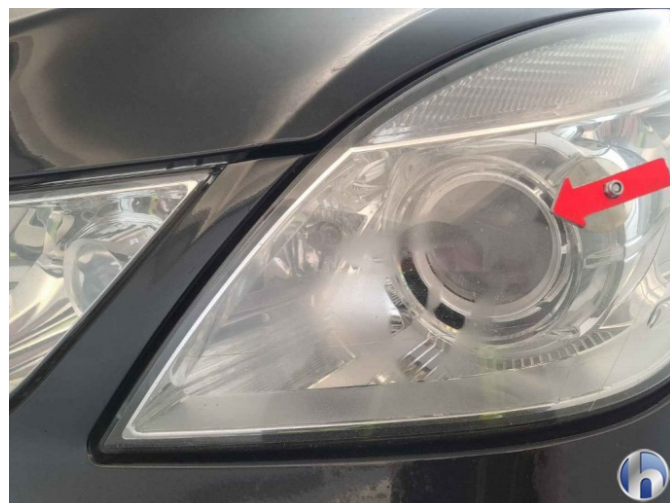
| component | Damage | Rep kind |
|---|---|---|
| 37. Scheinwerfer - Links | Damaged | Replace |

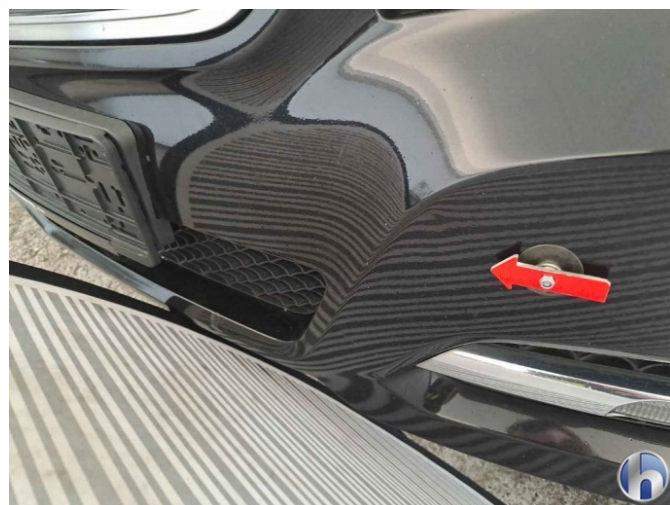
| component | Damage | Rep kind |
|---|---|---|
| 38. Front bumper | Execution defect | Replace |

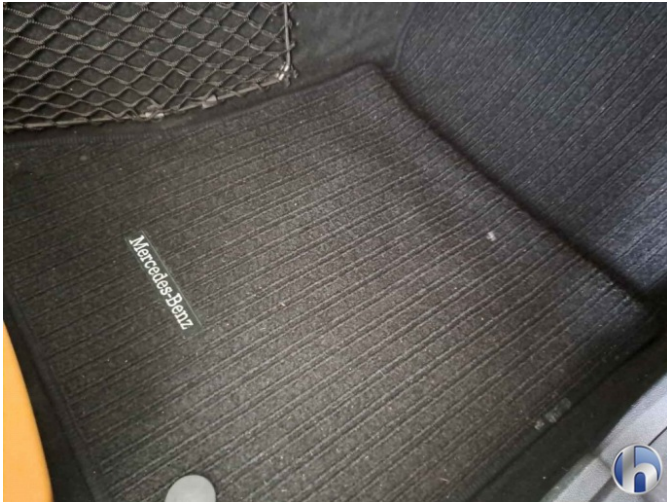
| 43. | | Clearance not exact | Replace |

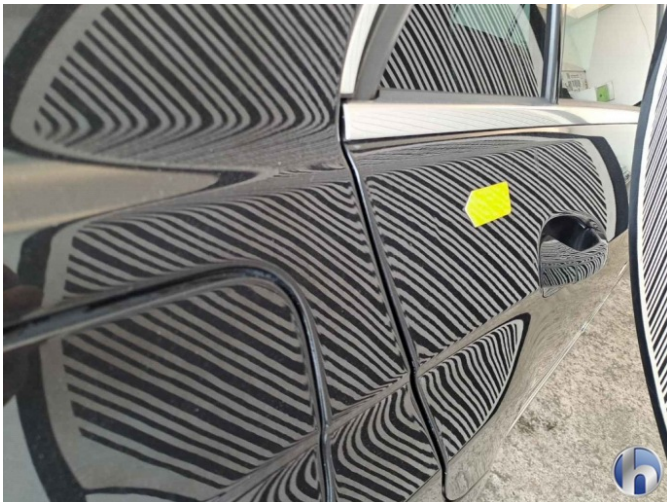
45. Door Rear - right

| 45. | Door Rear - right | Execution defect | Refurbish and paint |

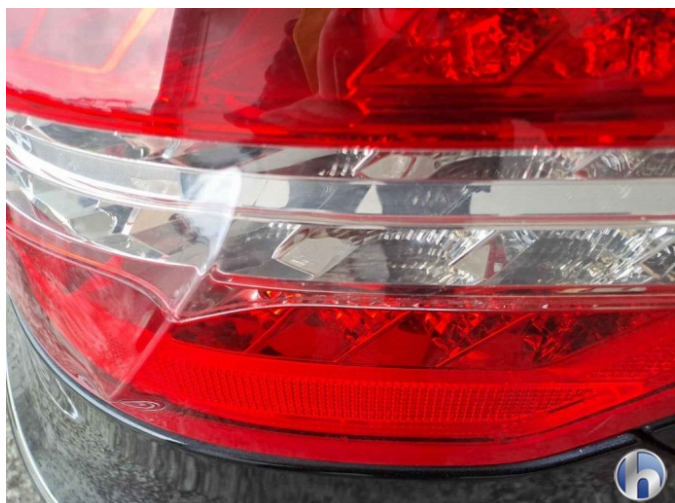
48. Taillight right

| 48. | Taillight right | Crack | Replace |

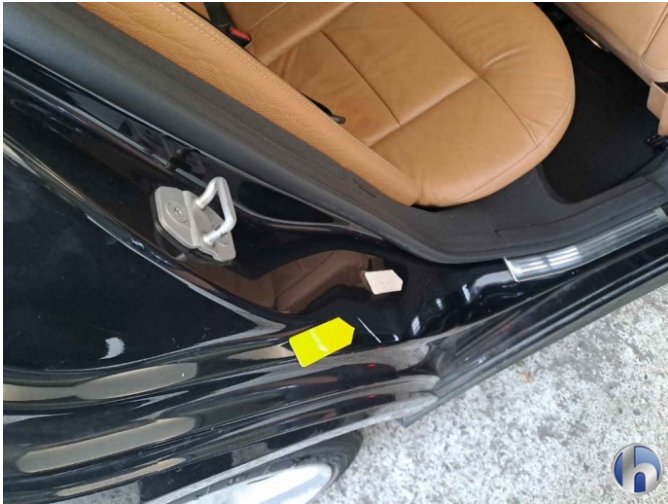
| 50. | | Damaged | Replace |

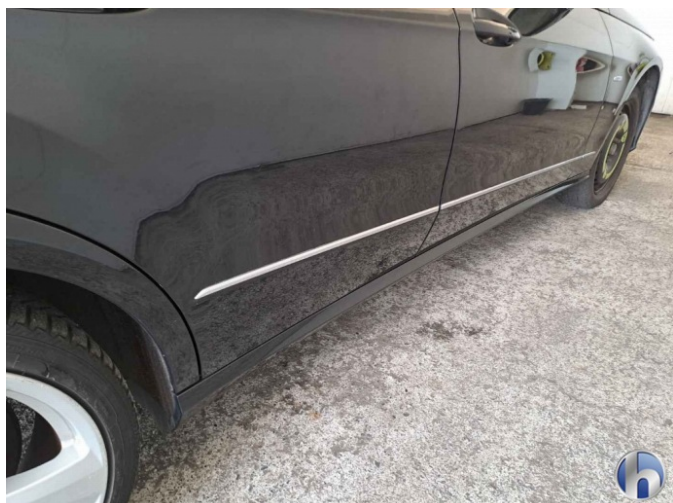
54. Zierleiste Vorne - Mitte

| 54. | Zierleiste Vorne - Mitte | Scratch(es) | Replace |

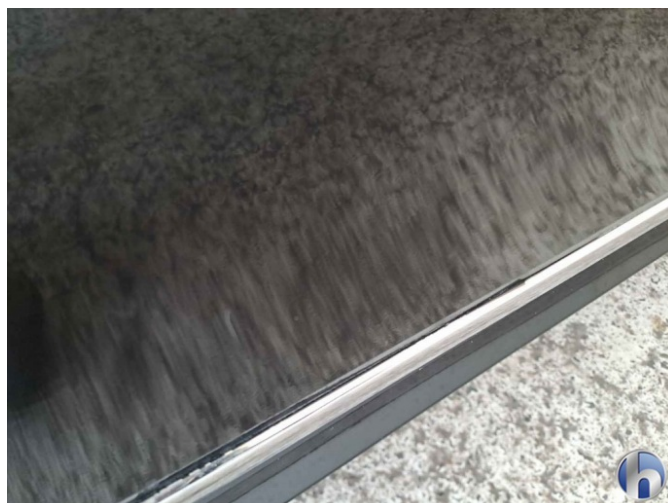
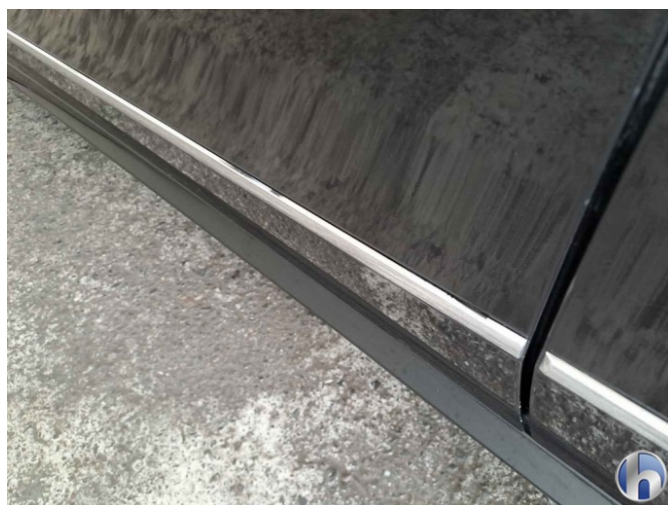
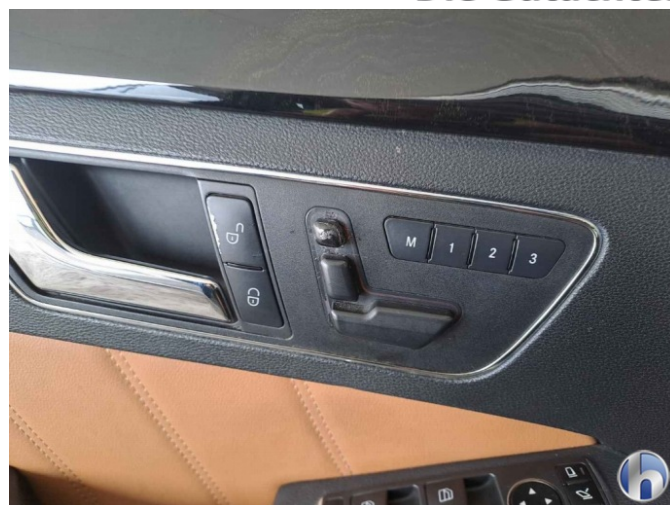
55. Karosserie Außen Zierleisten

| 55. | Karosserie Außen Zierleisten | Damaged | Replace |

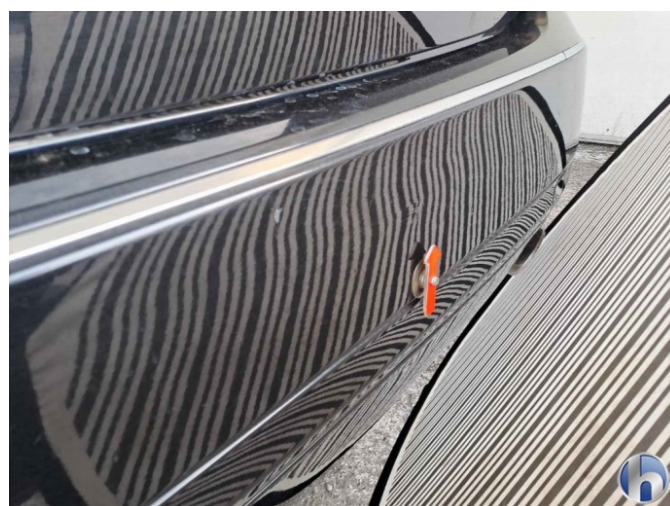
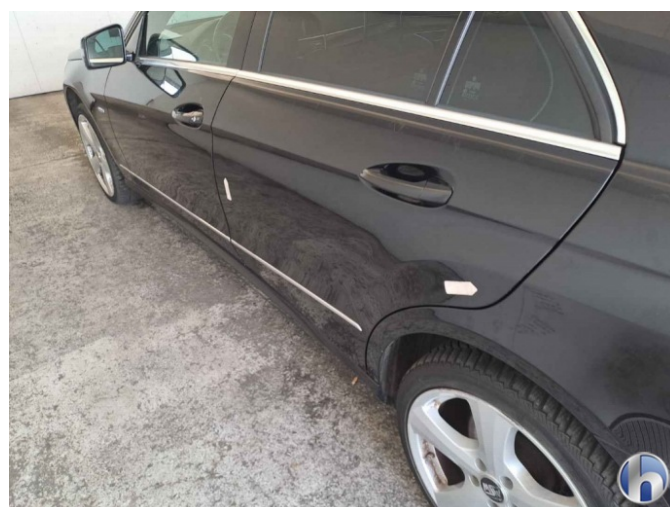
58. Rear bumper

| 58. | Rear bumper | Damaged | Replace |

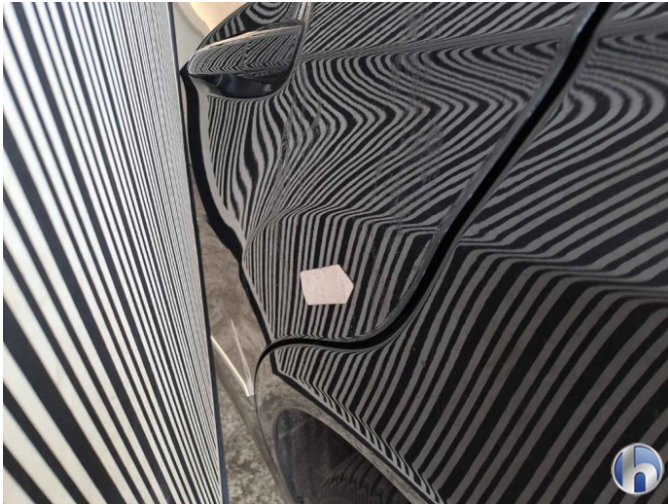
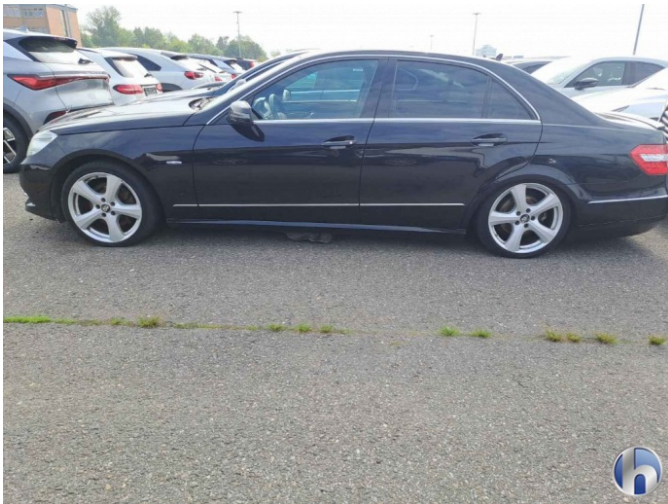
59. Rear door - left

| 59. | Rear door - left | Execution defect | Refurbish and paint |

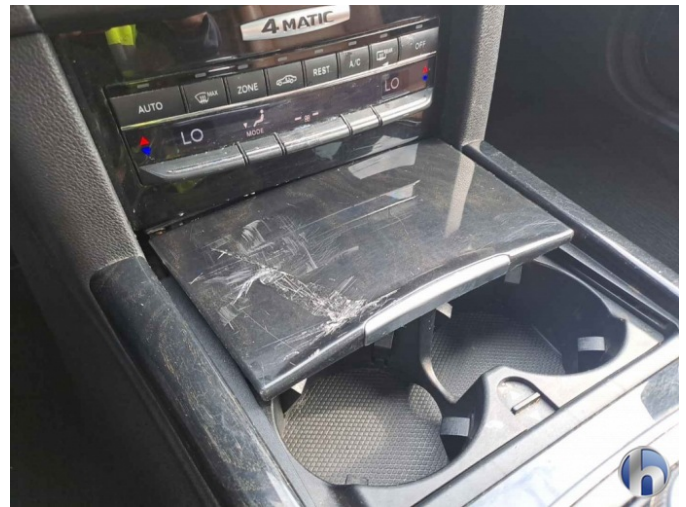
| 62. | | Display damage | Replace |

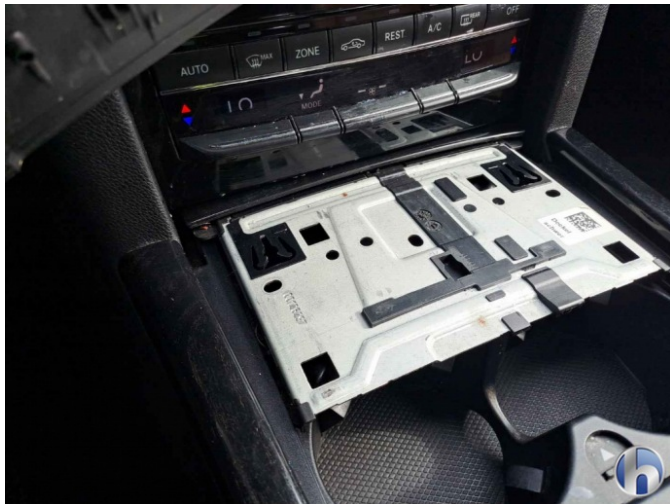
63. center console - flap

| 63. | center console - flap | Damaged | Replace |

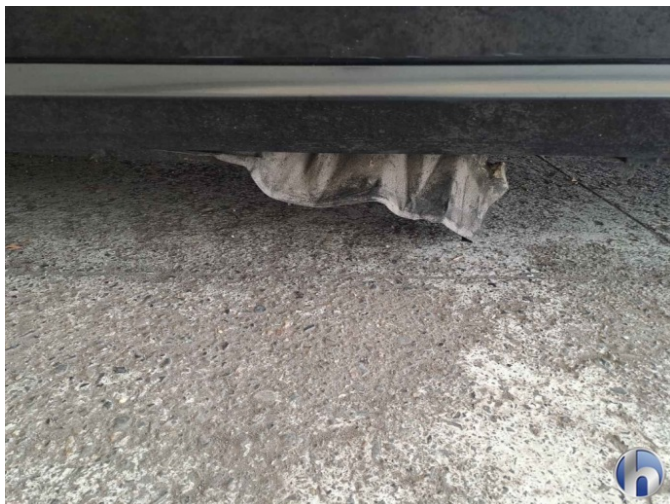
64. exterior body

| 64. | exterior body | Damaged | |

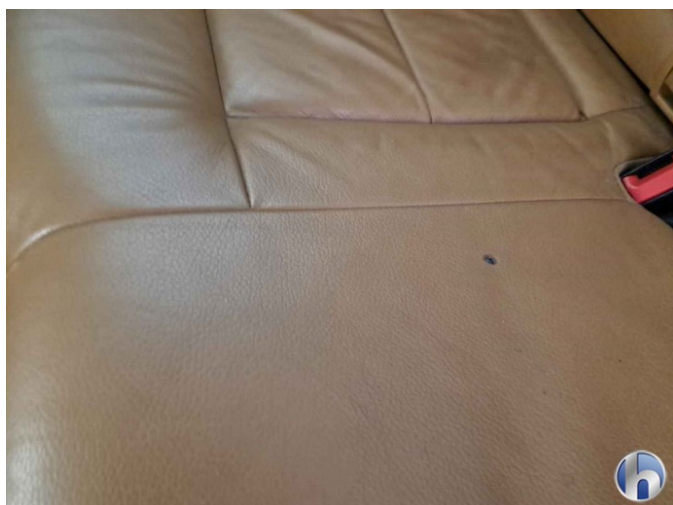
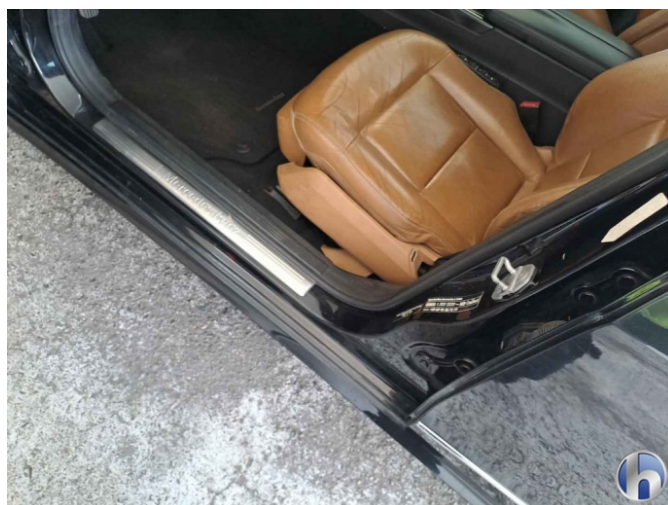
| 69. | | Burn hole | Replace |

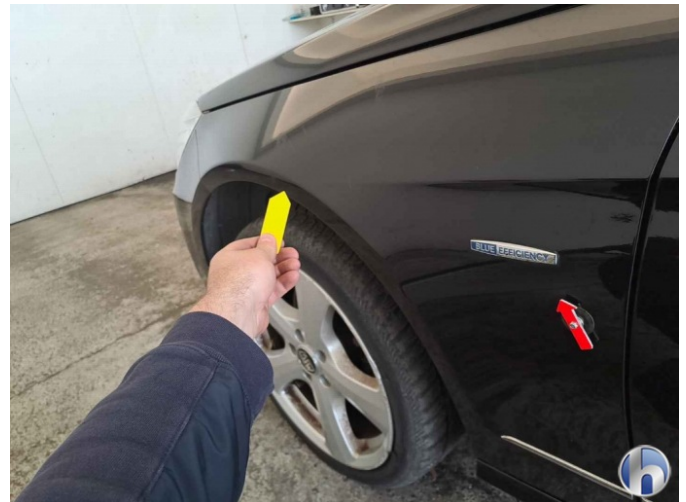
| 72. | | Damaged | Replace |

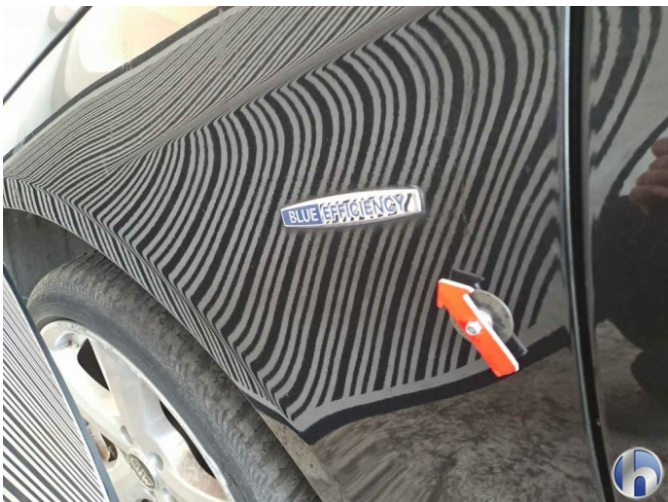
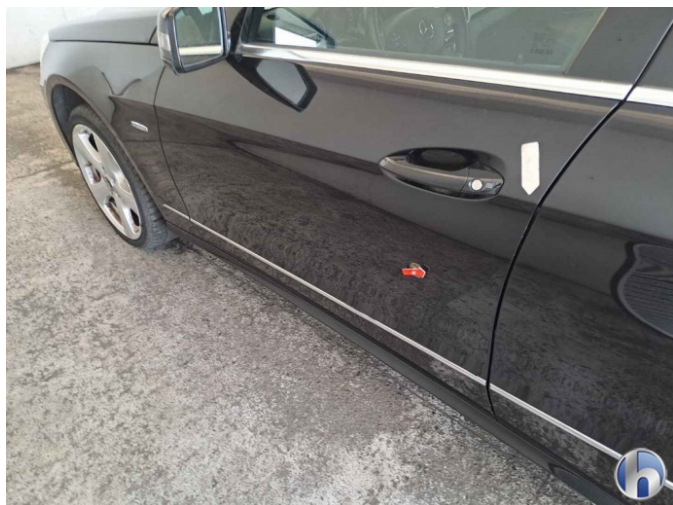
73. Front fender - left

| 73. | Front fender - left | Execution defect | Paint |

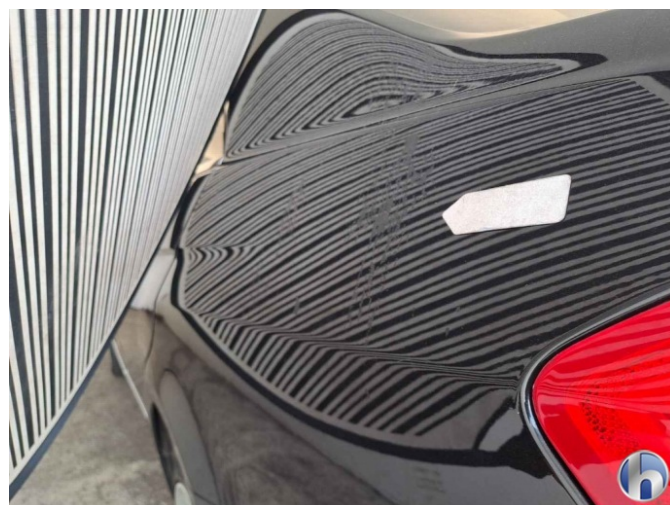
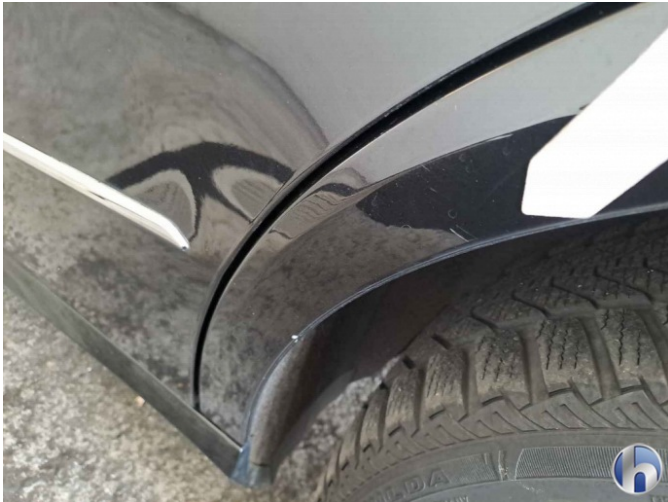
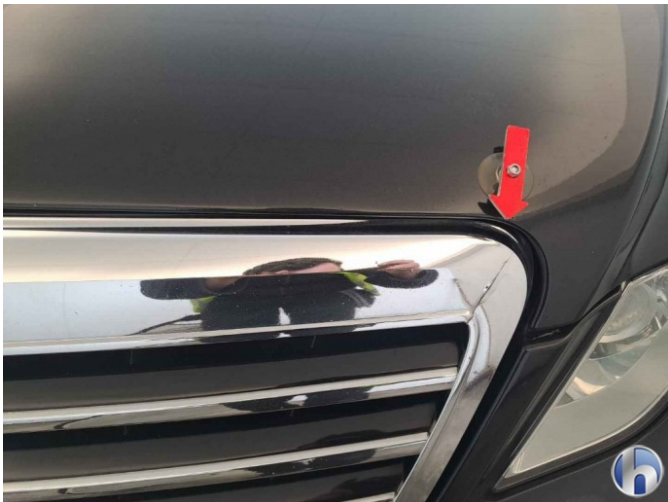
76. Sidewall - Rear - Left

| 76. | Sidewall - Rear - Left | Execution defect | Refurbish and paint |

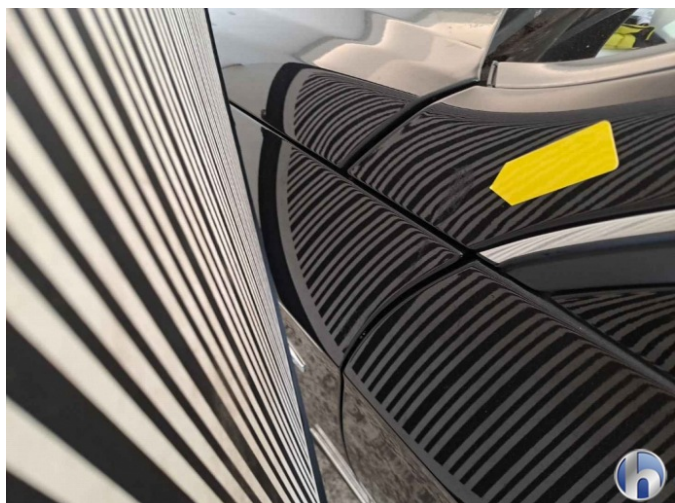
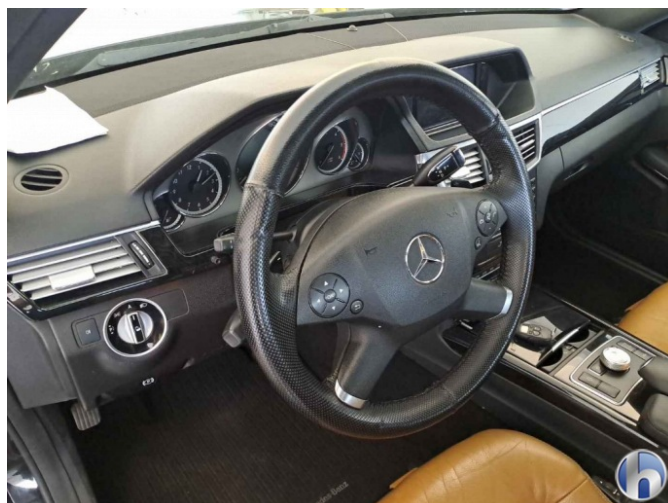
79. A-pillar Front - Left

| 79. | A-pillar Front - Left | Execution defect | Refurbish and paint |
