Expertise

Protocol number: 41716547  
Order number / reference: 25226594  
Inspection date: 26 Sept 2025

| Manufacturer: Mercedes-Benz | Model: Vito 111 CDI Lang |

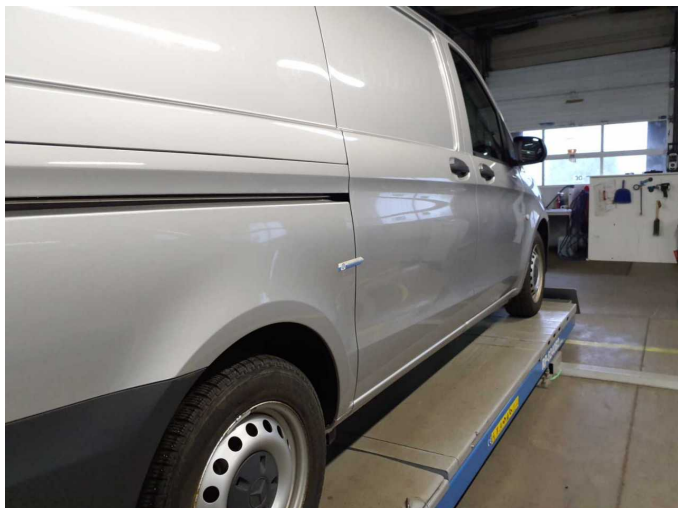
**Accident 1:** Side right

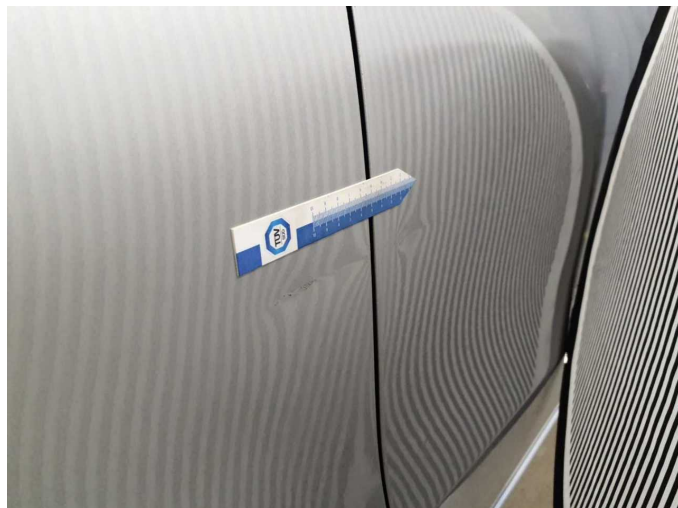
**Accident 1: Side right**

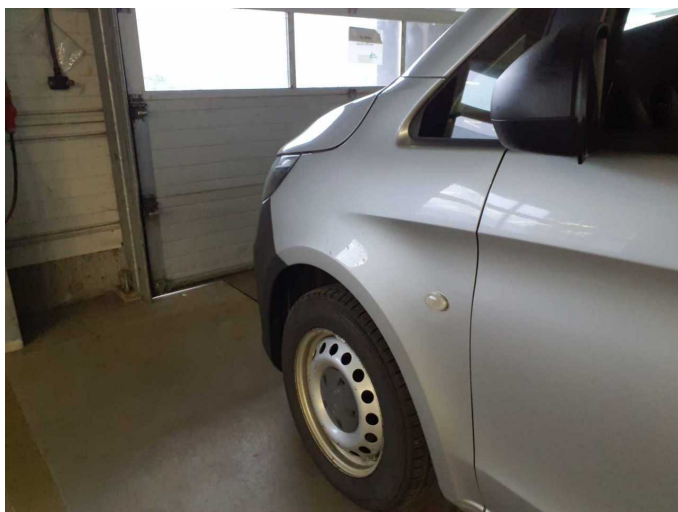
**Accident 1: Side right**
