Expertise

Protocol number: 41657139
Order No. / Reference: 25233557
Inspection date: 23 Sept 2025

Manufacturer: Ford

Model: Transit Connect 240 L2 Trend

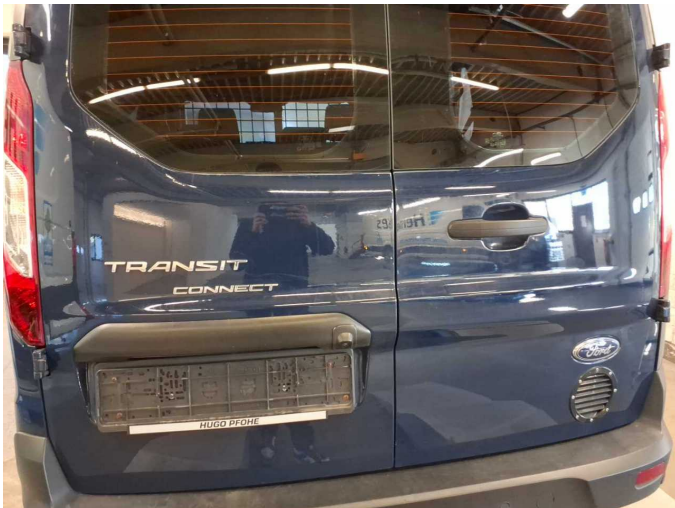
Damage 8: Body: Body (Klebereste) - Glued / labelled - De-glue / neutralise

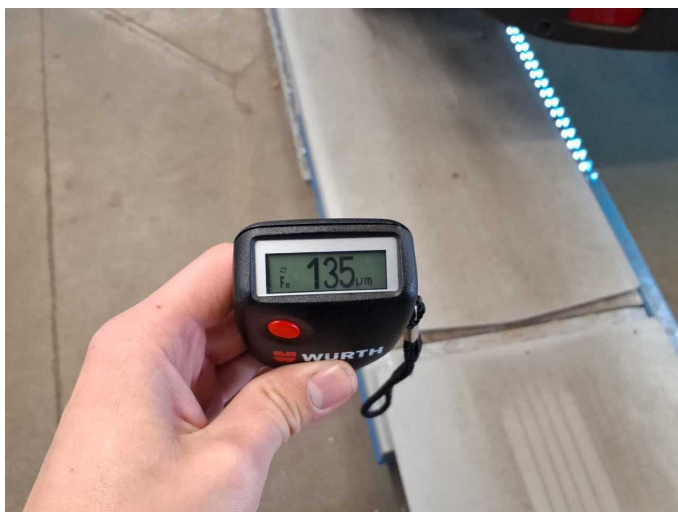
Repainting 1: Boot lid / rear door
