Expertise

Protocol number: 41825225
Order number / reference: 25118792
Inspection date: 26 Sept 2025

Manufacturer: Ford	Model: Transit 350 L3H3 VA Kasten LKW Trend
VIN: WF0EXXTTREKS27432

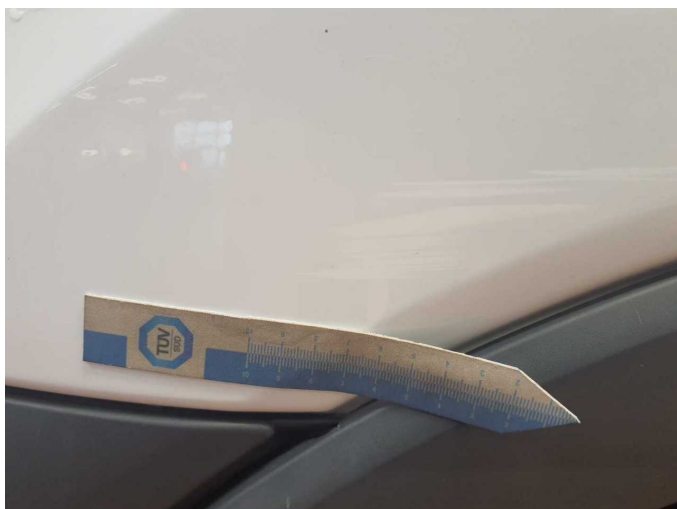
Accident 1: Rear, Side right

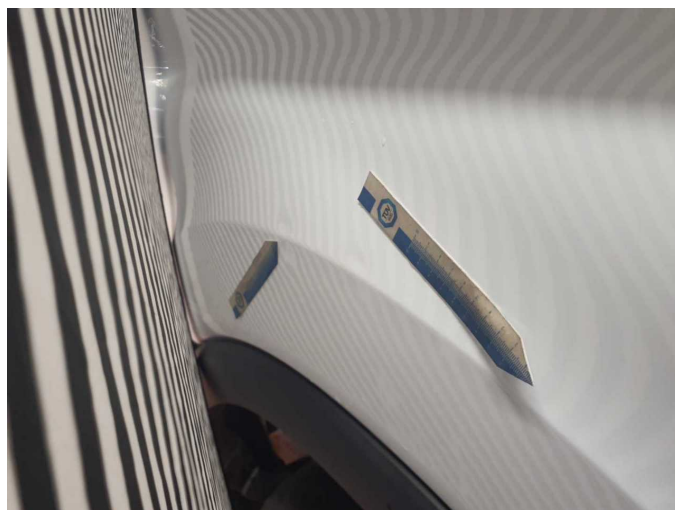
Accident 1: Rear, Side right

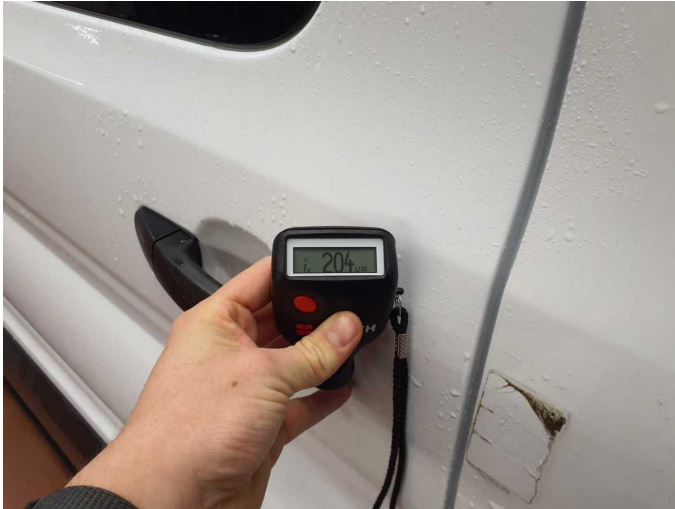
- Side panel - rear right side, Professionally carried out, Invoice of repair done Non-existent
- Door - rear right side, Professionally carried out, Invoice of repair done Non-existent

Repainting 2: Door - rear right side
