Expertise

Protocol number: 41578980
Order No. / Reference: 25196527
Inspection date: 16 Sept 2025

Manufacturer: Ford	Model: Transit 350 L3H2 Lkw VA Trend
VIN: WF0EXXTTREMC80398

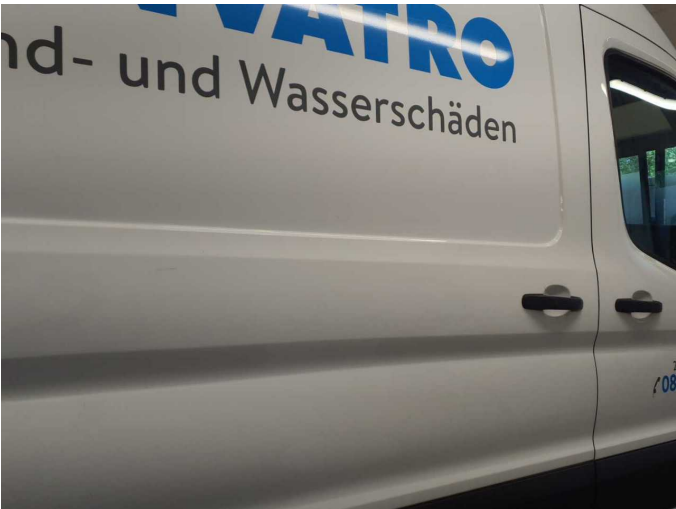
Repainting 1: Door - rear right side
