Expertise

Protocol number: 41617635
Order No. / Reference: 25185717
Inspection date: 18 Sept 2025

Manufacturer: Ford	Model: Mondeo Turnier 2.0 EcoBlue ST-Line
VIN: WF0FXXWPCFNS70496

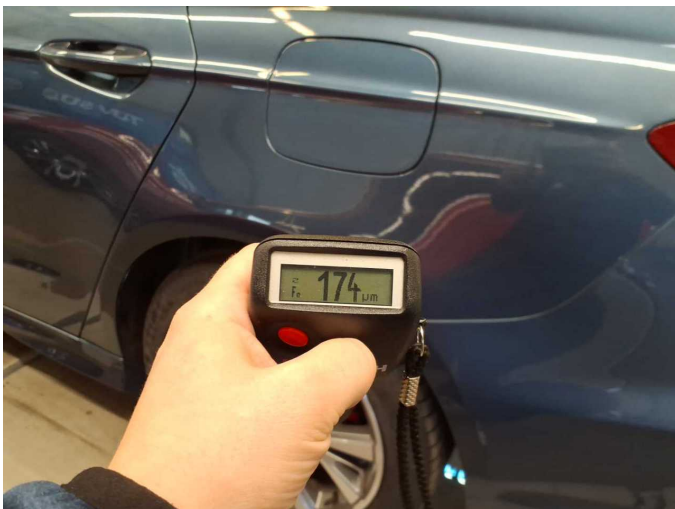
Repainting 1: Mudguard - left side, Side panel - rear left side, Door - rear left side, Door - front left side

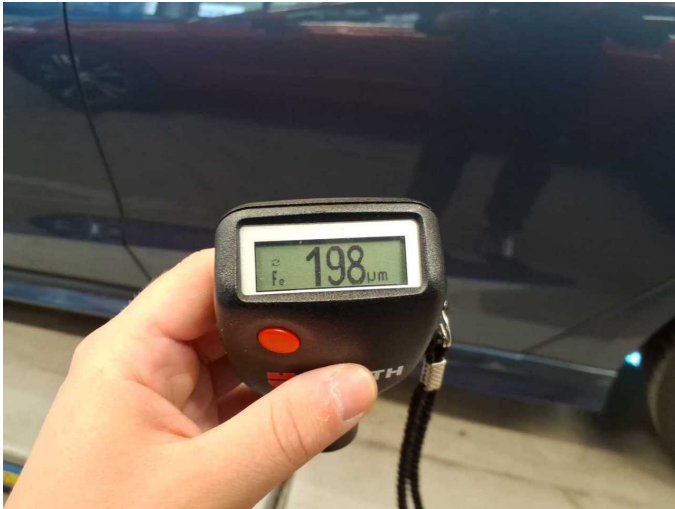
Repainting 1: Mudguard - left side, Side panel - rear left side, Door - rear left side, Door - front left side

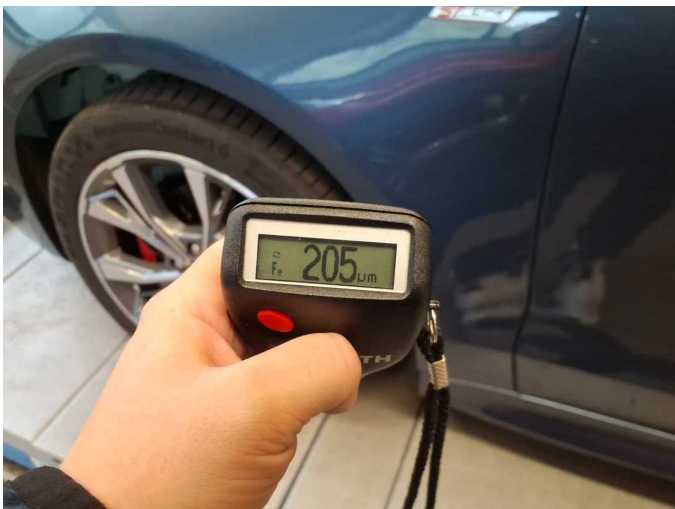
Repainting 1: Mudguard - left side, Side panel - rear left side, Door - rear left side, Door - front left side
