## status report

**customer:** Bank 11, Neuss  
**contract number:** 1121995530  
**reference:**

#### Ford S-MAX Vignale

| Vehicle identification number | <b>WF0JXXWPCJKE00355</b> | mileage read: | <b>138750 km</b> |

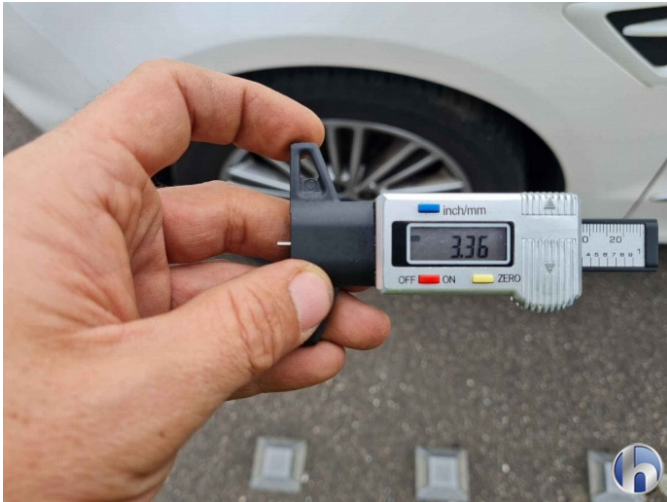
| component | Damage | Rep kind |
|---|---|---|
| 1. tire front - left | Worn | Replace |

1. tire front - left

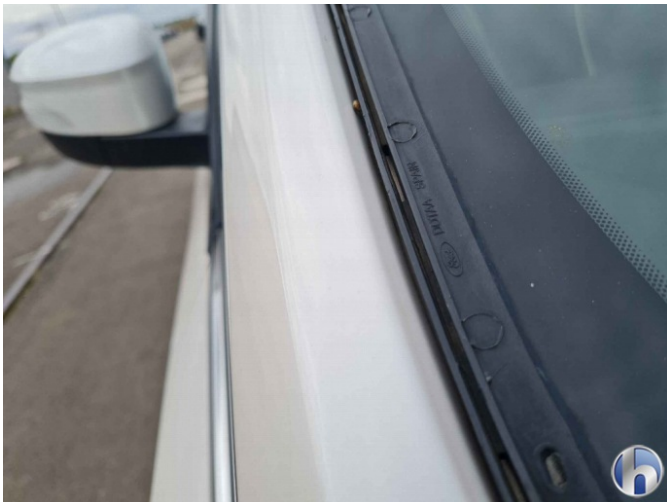
| component | Damage | Rep kind |
|---|---|---|
| 2. Frontscheibenleiste links und rechts | Missing | Replace |

2. Frontscheibenleiste links und rechts

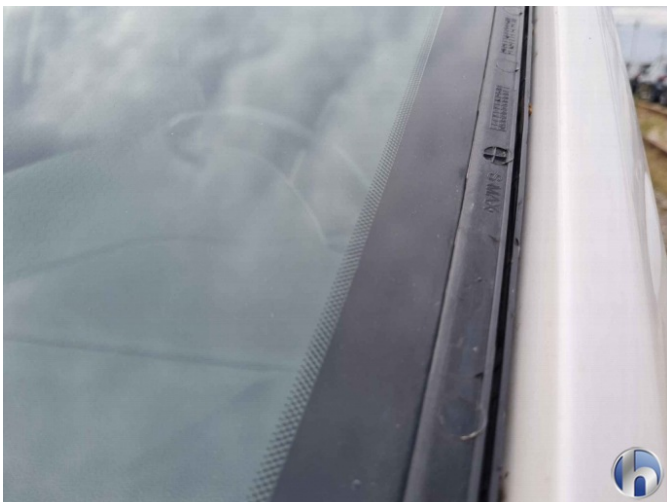
2. Frontscheibenleiste links und rechts

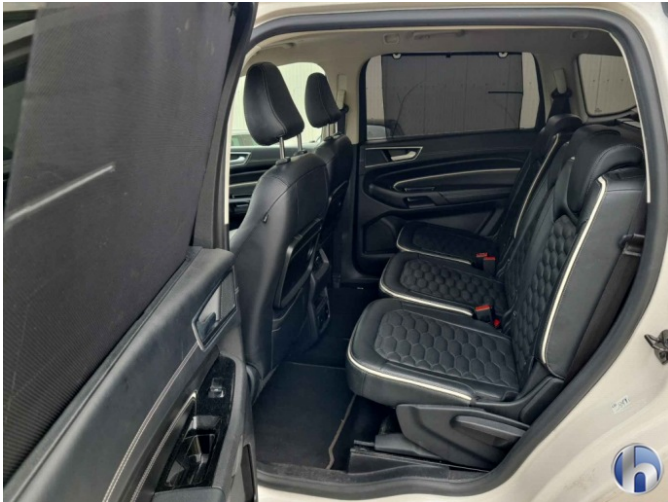
| component | Damage | Rep kind |
|---|---|---|
| 3. Kofferraum und Innenraum | Wear and tear | acceptable |

3. Kofferraum und Innenraum

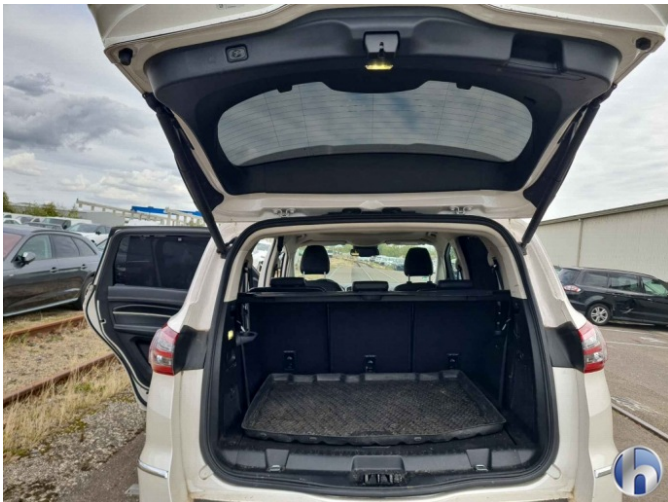
3. Kofferraum und Innenraum

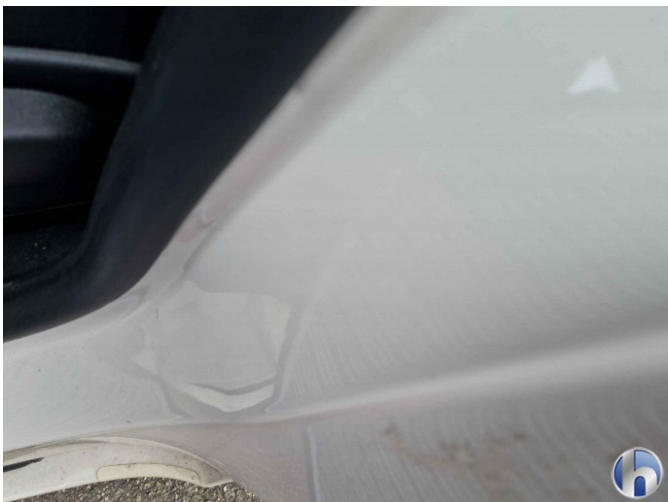
| component | Damage | Rep kind |
|---|---|---|
| 4. Türeinstieg Hinten - Links | Damaged | Refurbish and paint |

4. Türeinstieg Hinten - Links

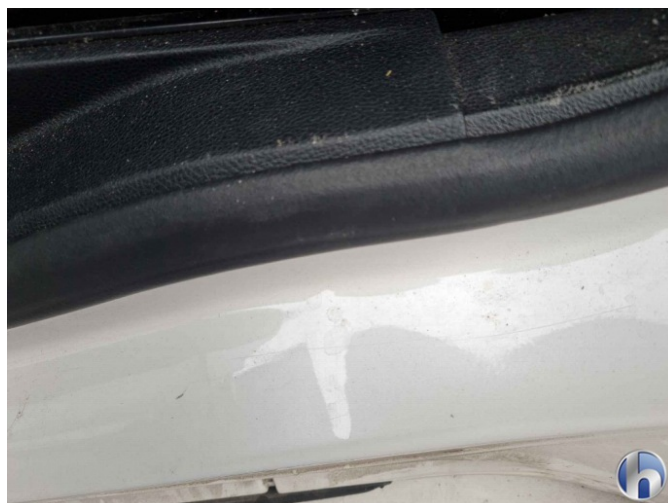
4. Türeinstieg Hinten - Links

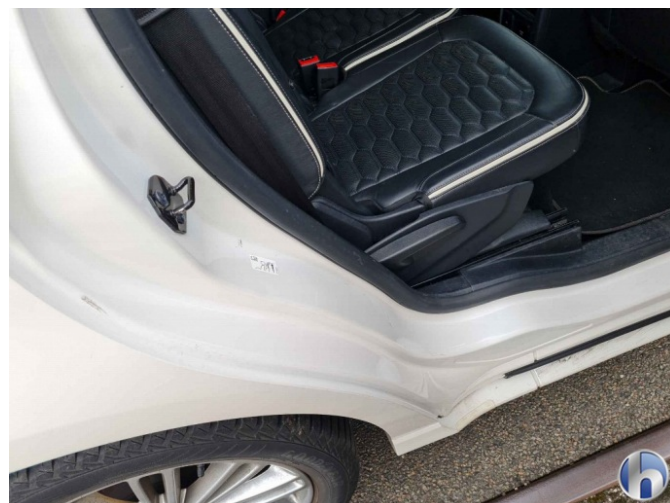
| component | Damage | Rep kind |
|---|---|---|
| 6. Türeinstieg Hinten - Rechts | Damaged | Refurbish and paint |

6. Türeinstieg Hinten - Rechts

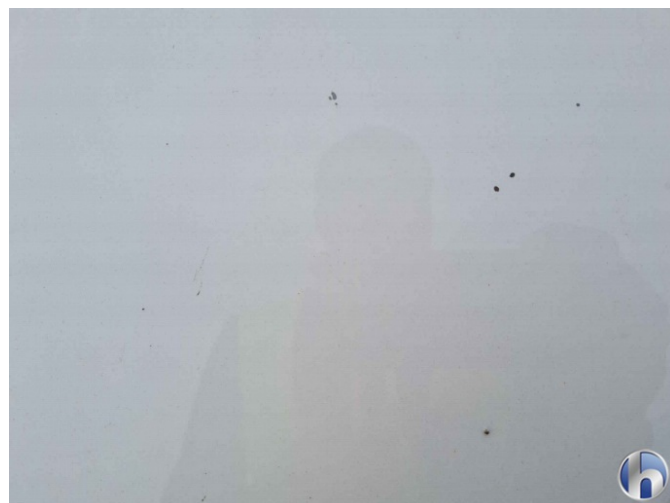
| component | Damage | Rep kind |
|---|---|---|
| 8. hood | Rust | Paint |

8. hood

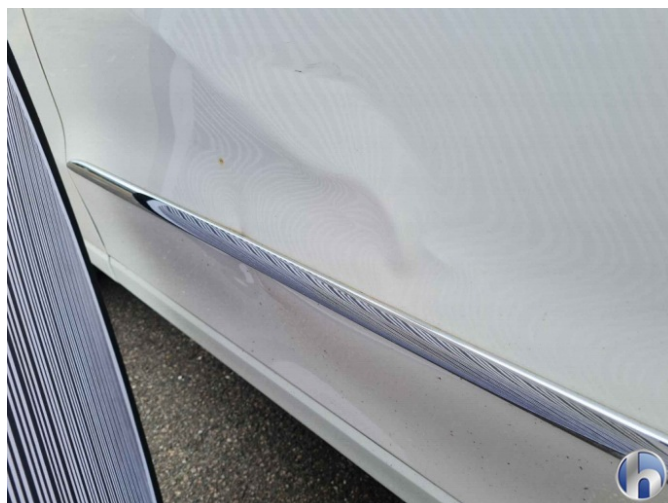
| component | Damage | Rep kind |
|---|---|---|
| 10. Fahrzeug links | Accident damage | Replace |

10. Fahrzeug links

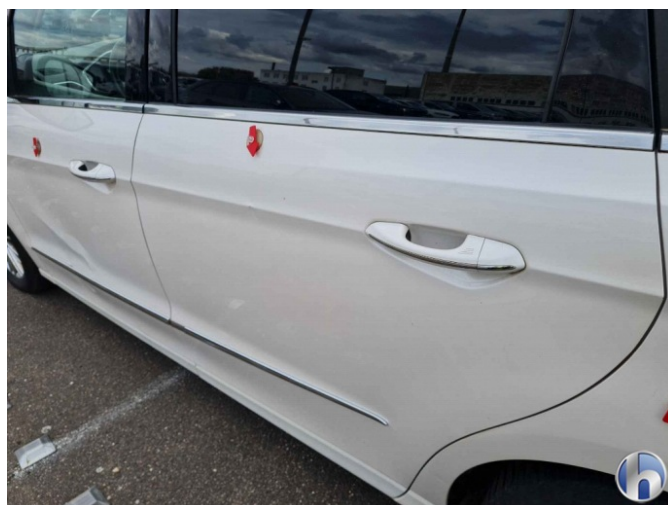
10. Fahrzeug links

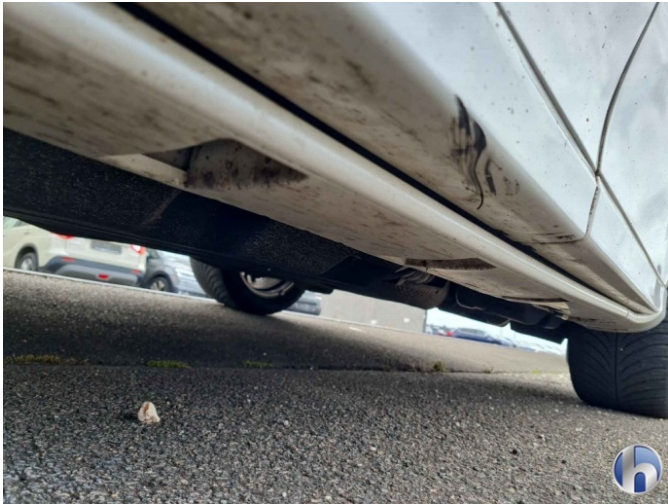
10. Fahrzeug links

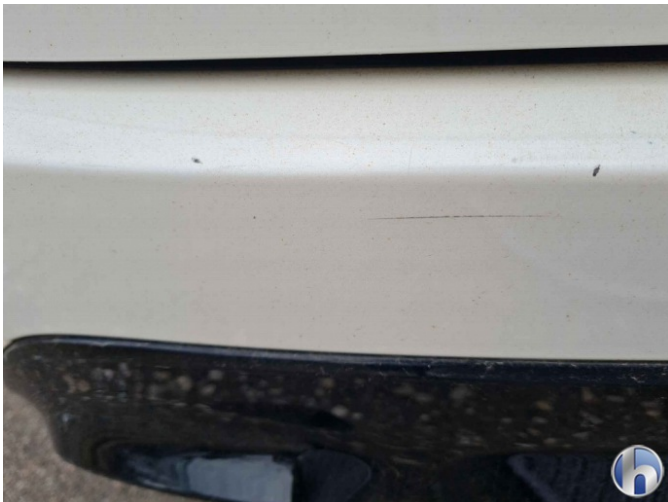
11. Rear bumper

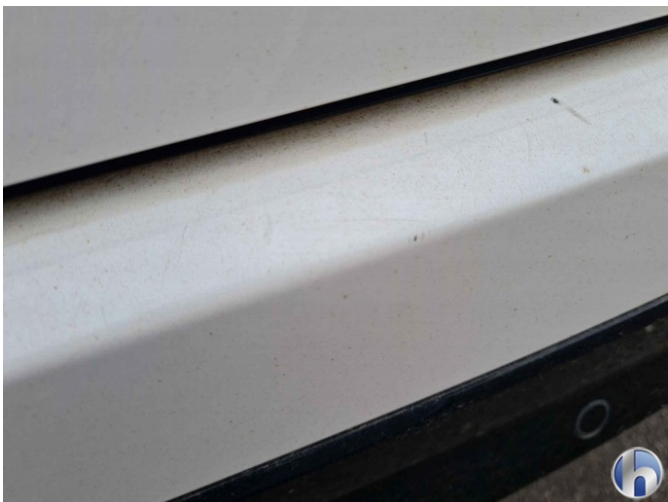
11. Rear bumper

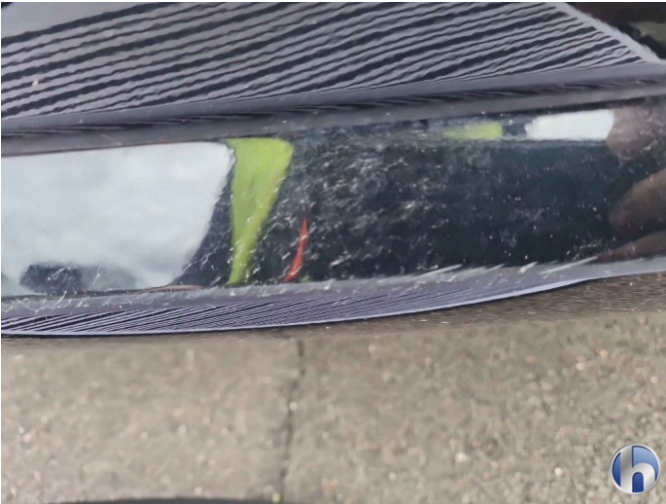
11. Rear bumper

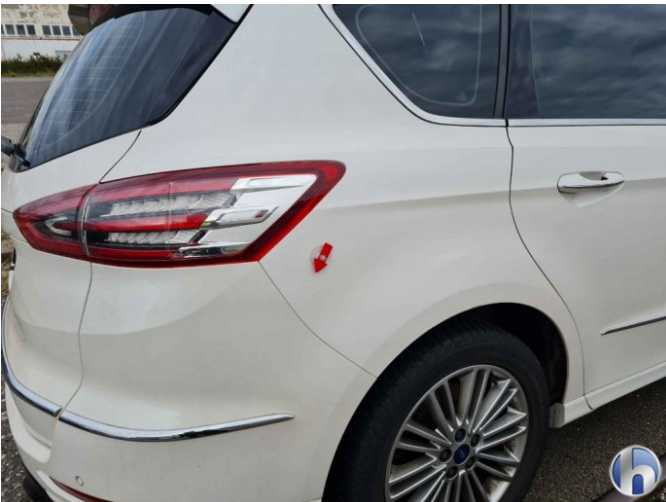
12. Sidewall - Rear - right

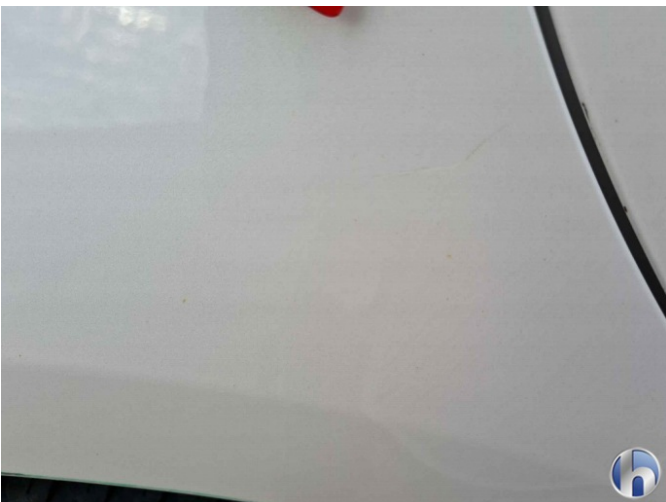
12. Sidewall - Rear - right

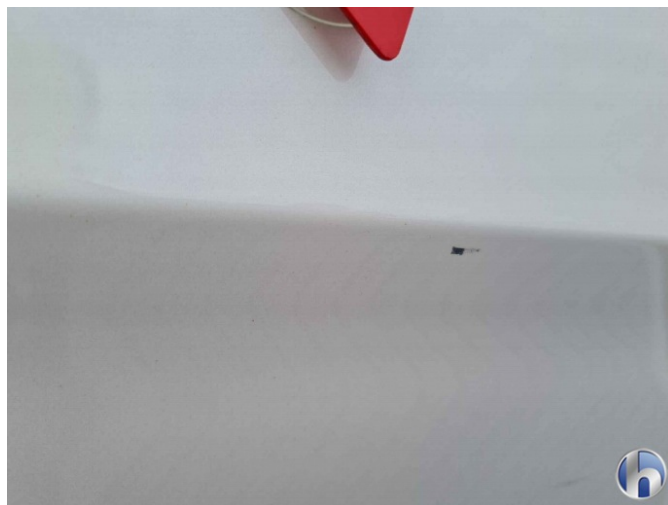
13. Door Rear - right

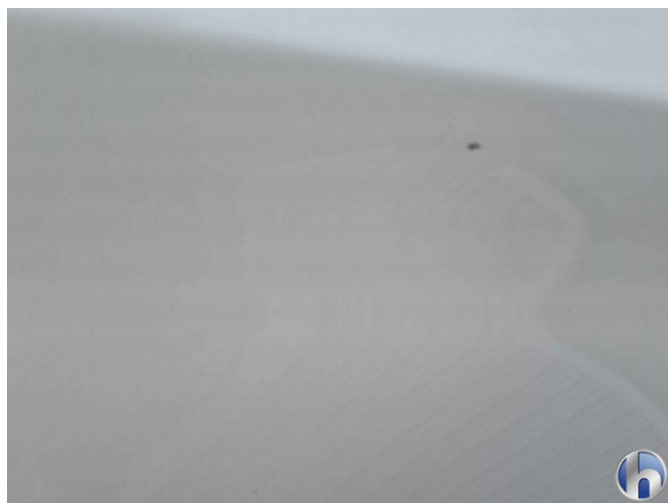
13. Door Rear - right

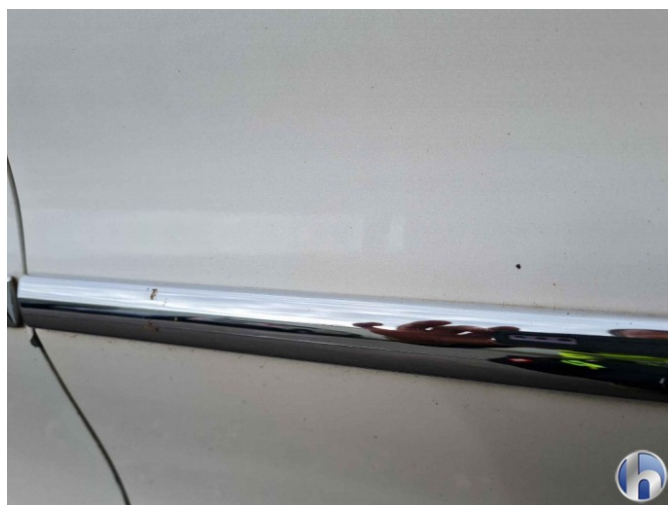
14. Front door - right

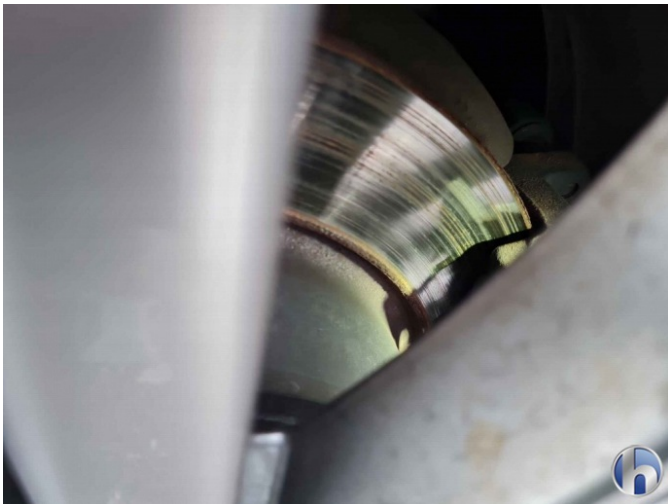
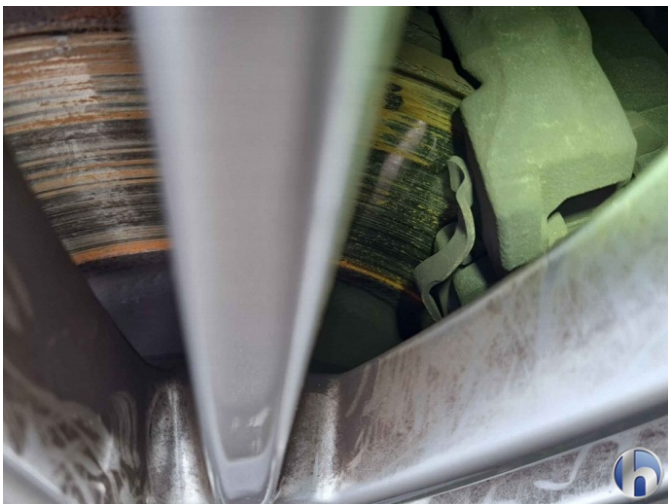
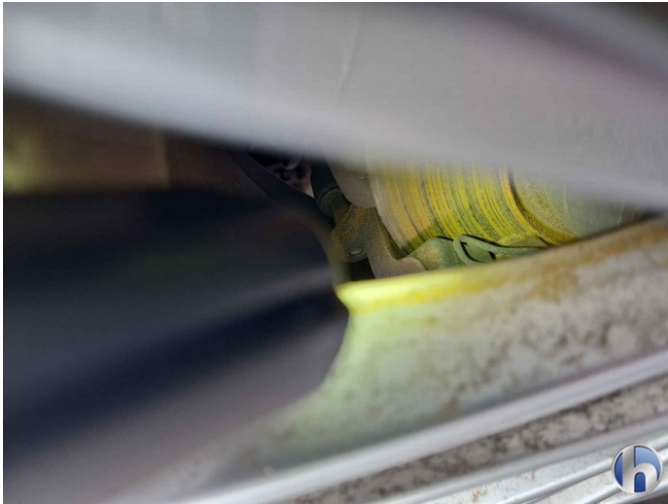
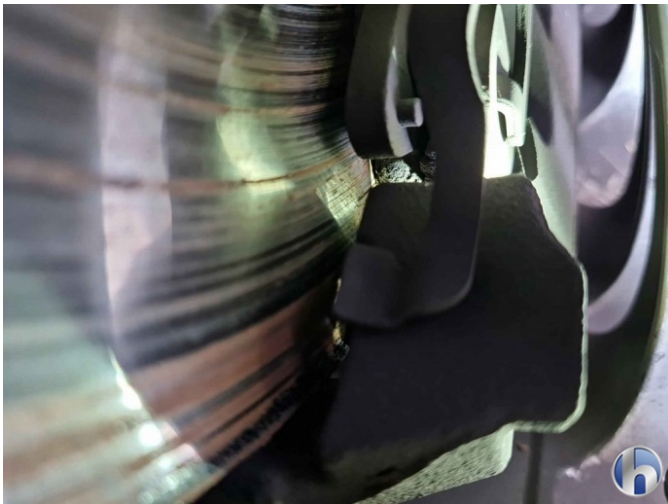
| component | Damage | Rep kind |
|---|---|---|
| 17. brake system | Not okay | Replace |
