Expertise

Protocol number: 39768565  
Order No. / Reference: 24769021  
Inspection date: 13 May 2025

Manufacturer: Ford

Model: Focus Turnier 1.5 EcoBlue Start-Stopp-System Aut. ACTIVE

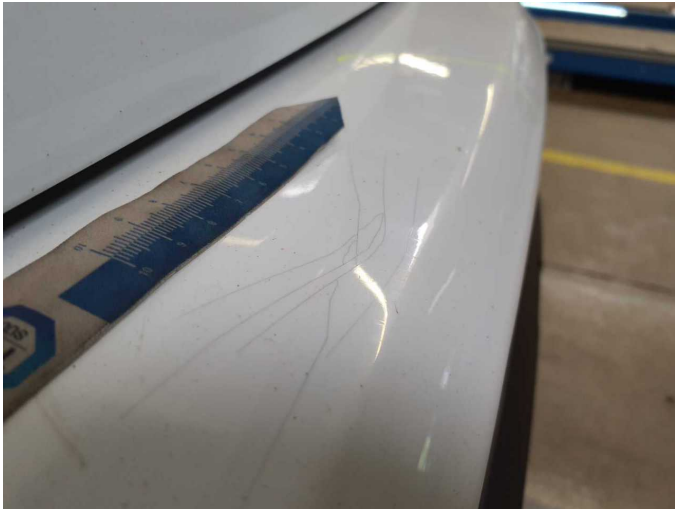
| No. | Component group | Description |
|---|---|---|
| 10 | Rear bumper | Rear bumper (verformt) - Scratched - Repair and paint |

**Damage 10:** Rear bumper: Rear bumper (verformt) - Scratched - Repair and paint

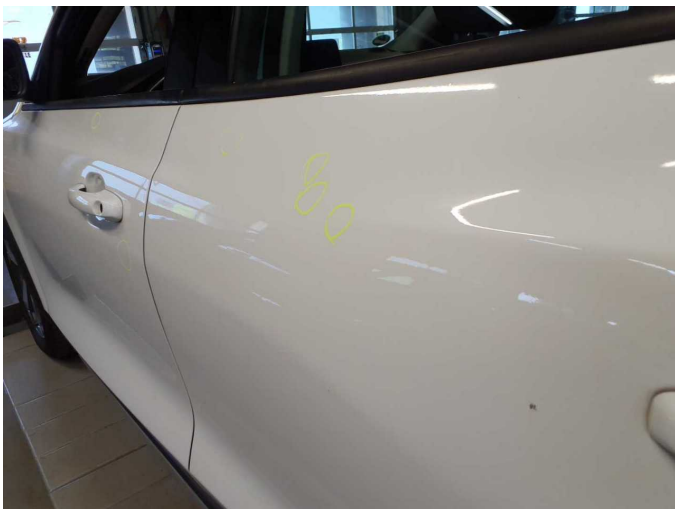
| No. | Component group | Description |
|---|---|---|
| 11 | Door - rear left side | Door - Dent / paintcoat damage - Repair and paint |

**Damage 11:** Door - rear left side: Door - Dent / paintcoat damage - Repair and paint

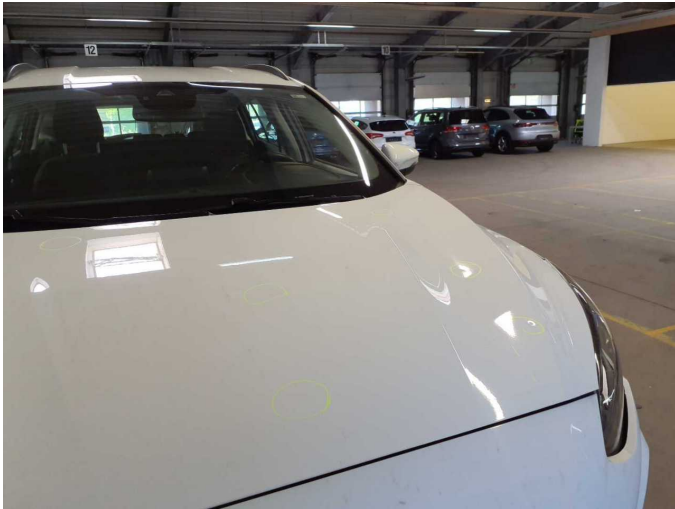
| No. | Component group | Description |
|---|---|---|
| 12 | Body | Body - Damage by hail - repair according to calculation |

Fahrzeug hat starken Hagelschaden.

**Damage 12:** Body: Body - Damage by hail - repair according to calculation

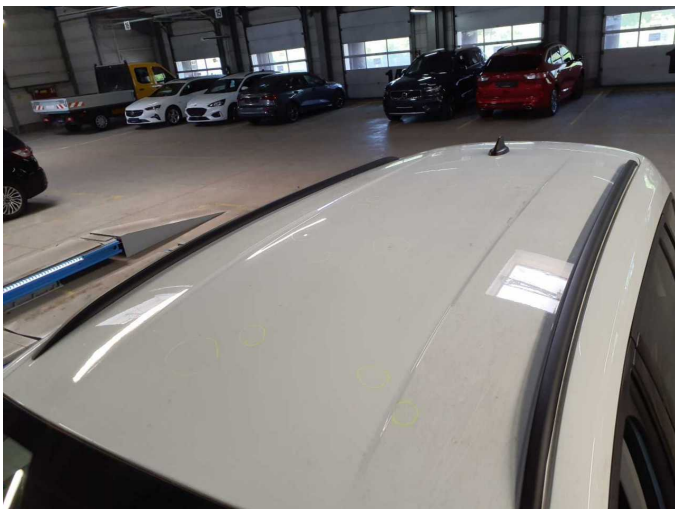
**Damage 12:** Body: Body - Damage by hail - repair according to calculation

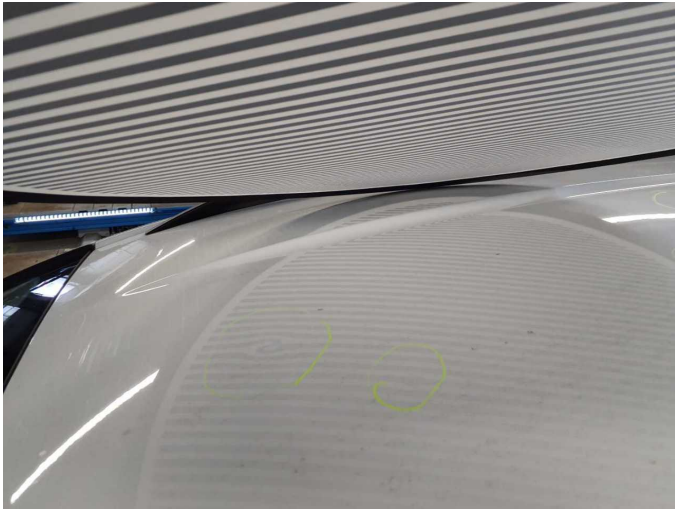
**Damage 12:** Body: Body - Damage by hail - repair according to calculation

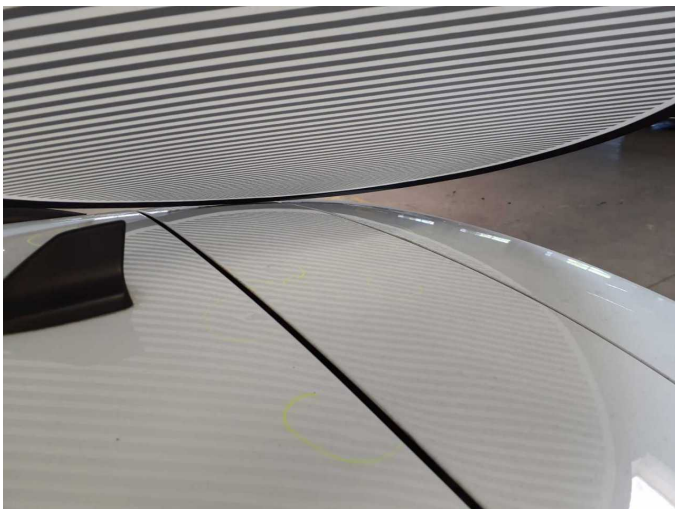
**Damage 12:** Body: Body - Damage by hail - repair according to calculation

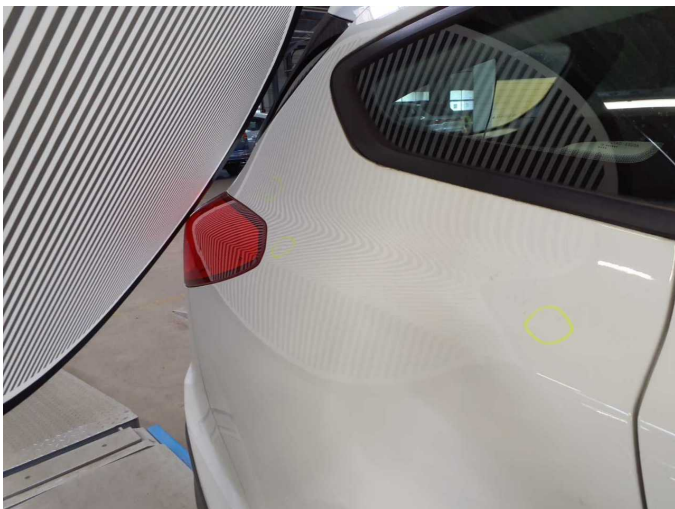
**Damage 12:** Body: Body - Damage by hail - repair according to calculation

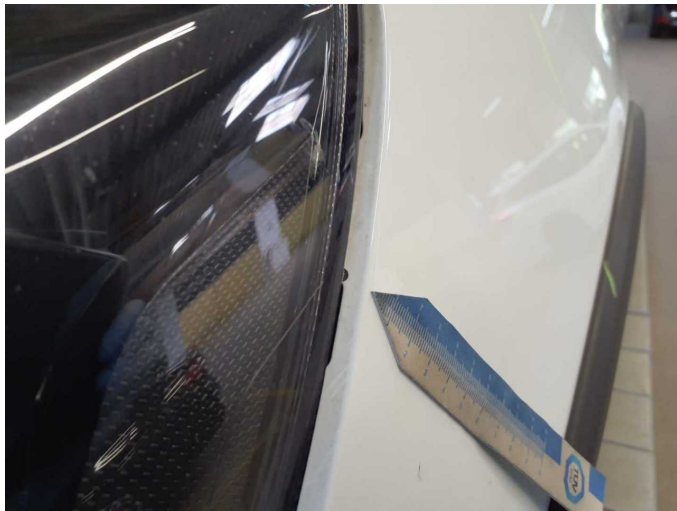
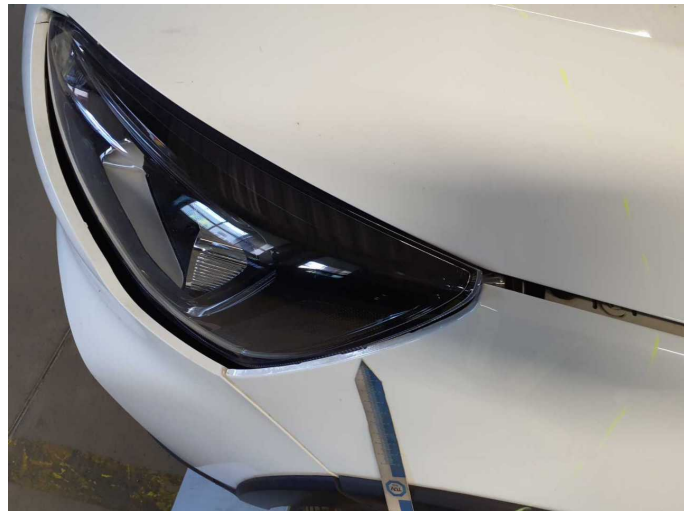
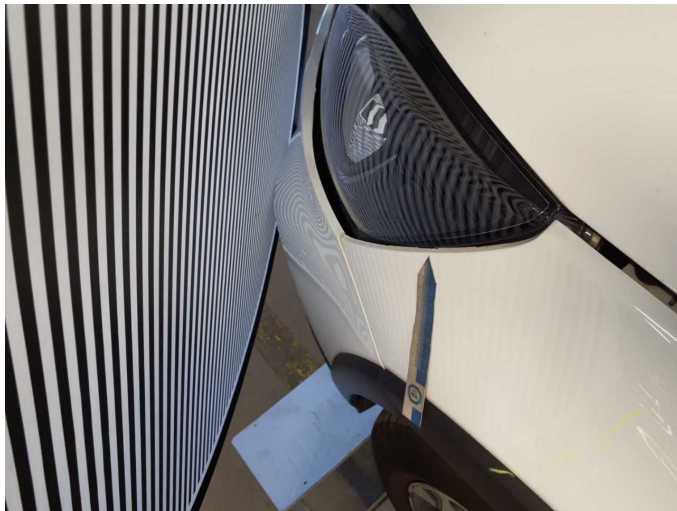
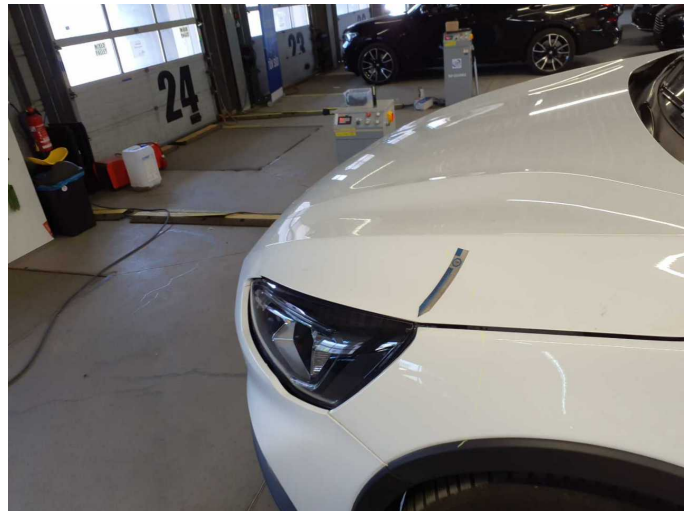
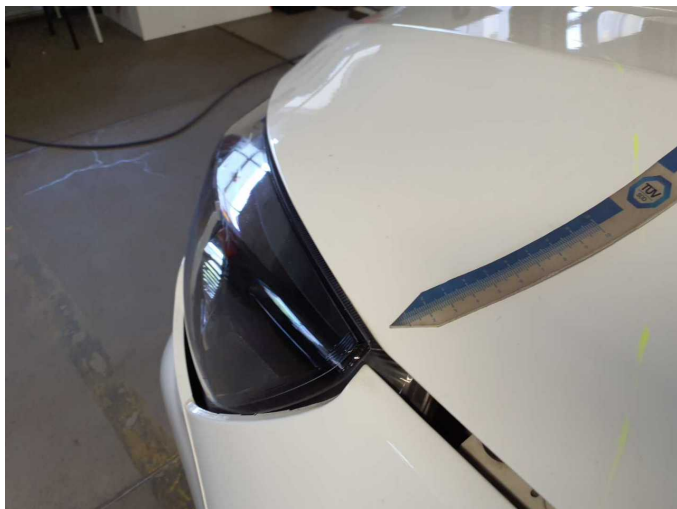
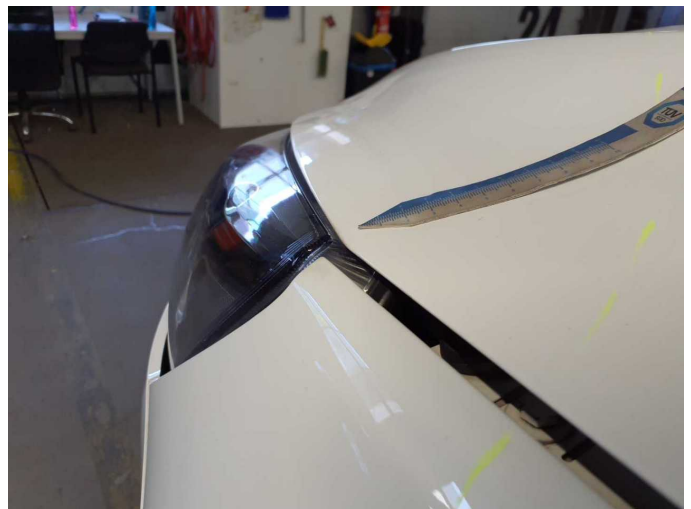
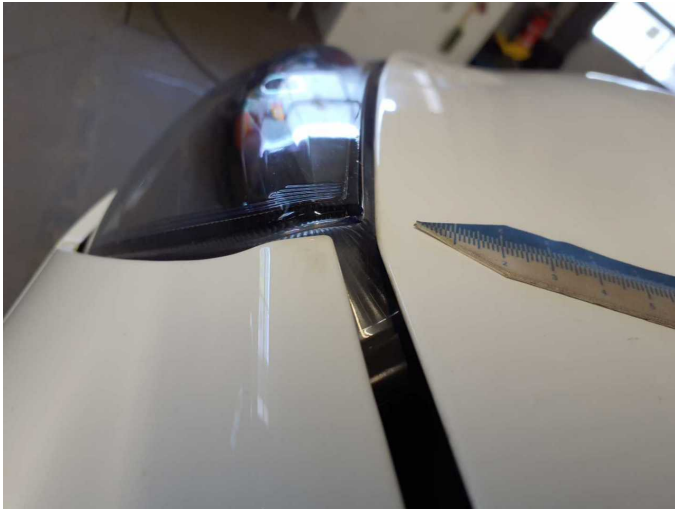
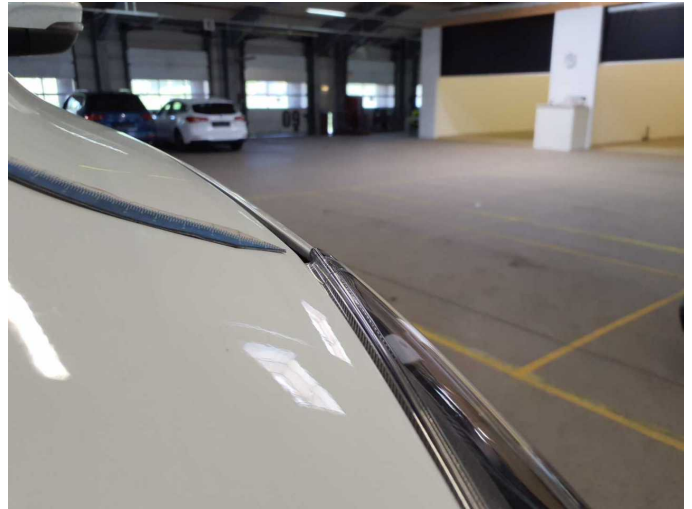
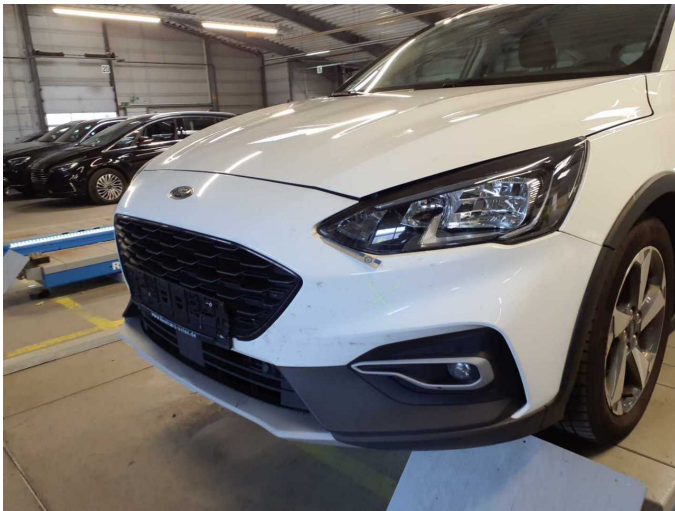
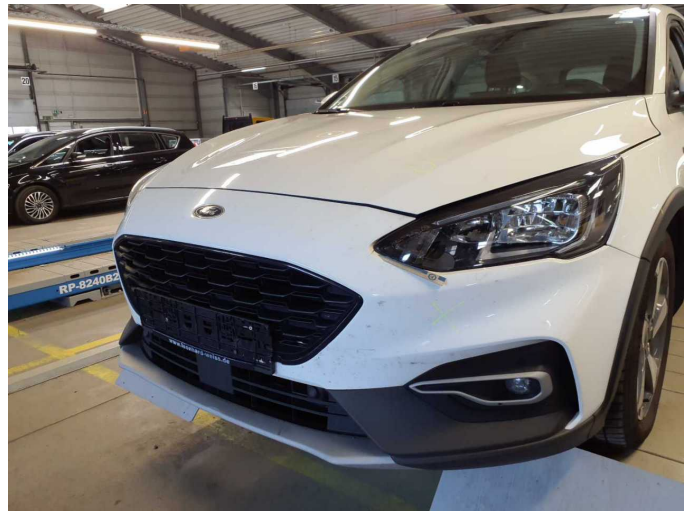
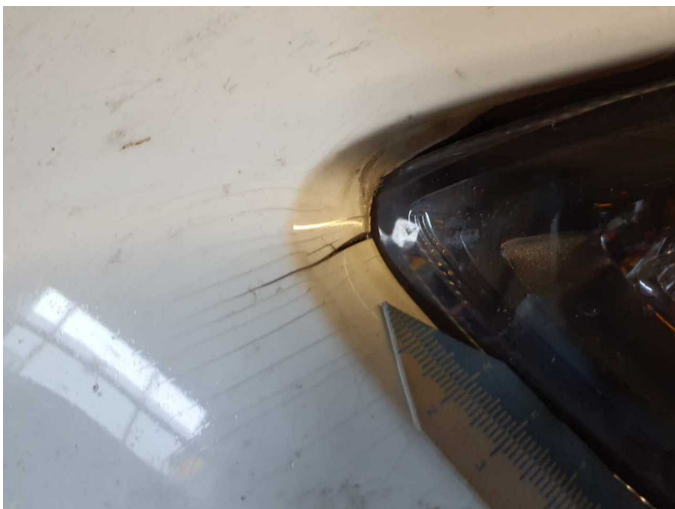
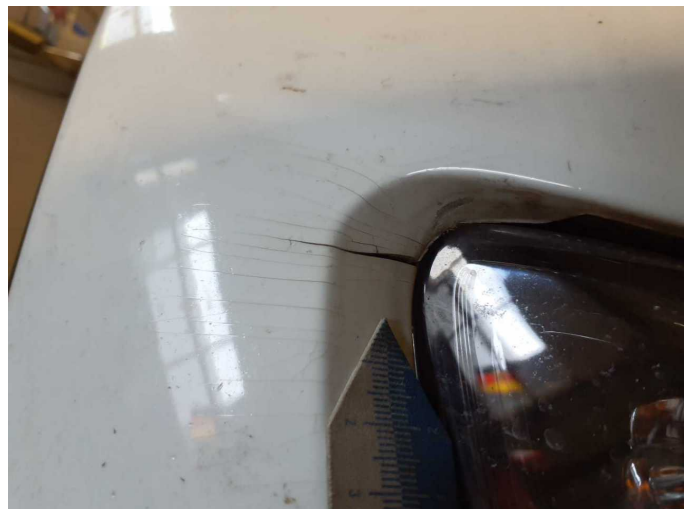
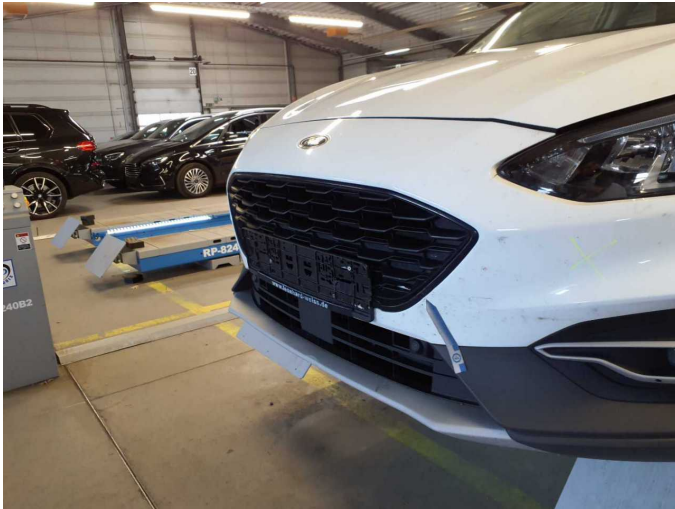
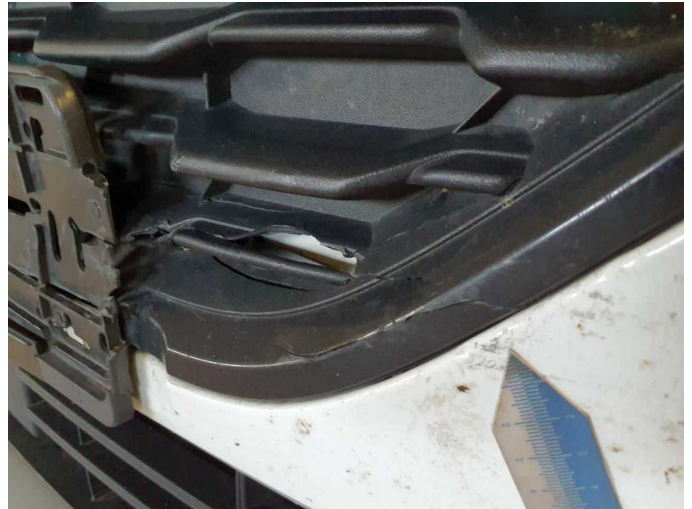
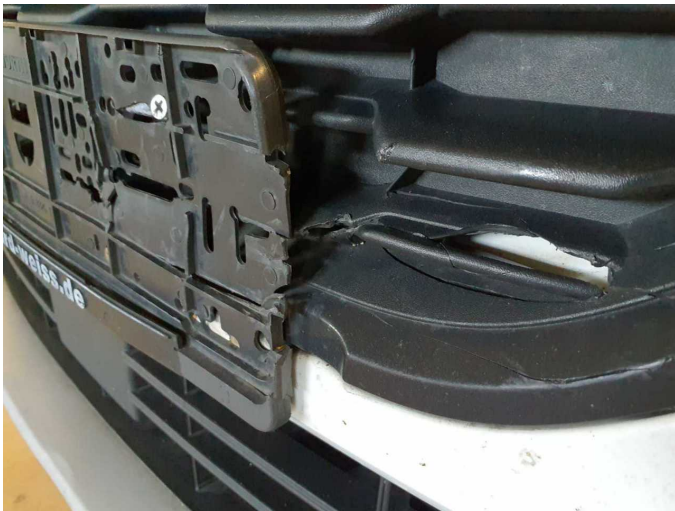
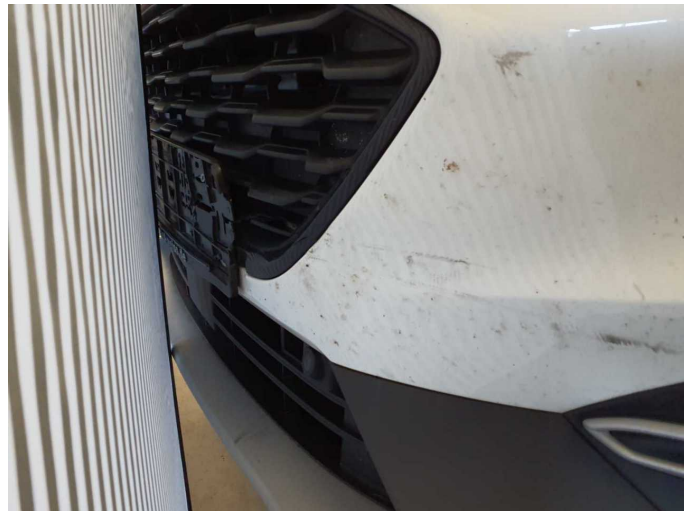
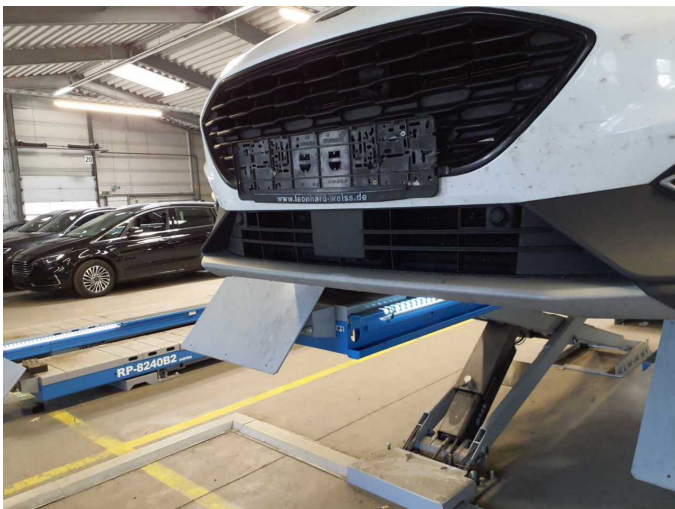
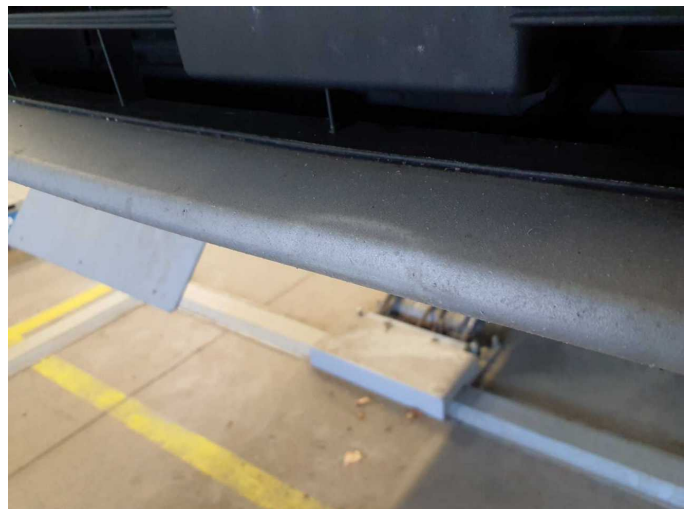
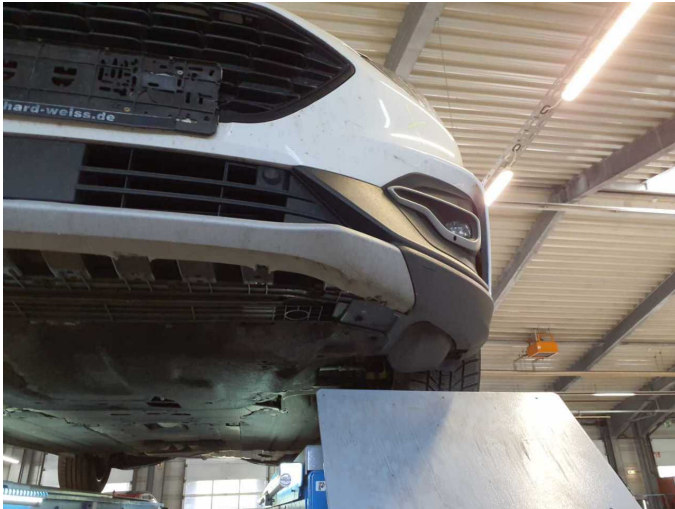
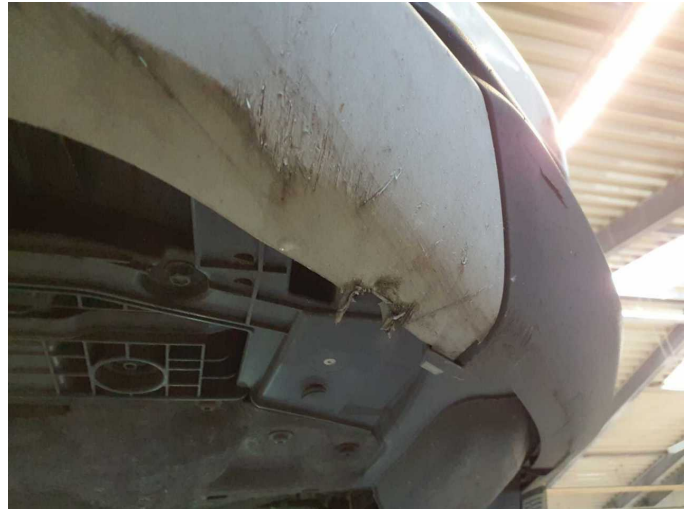
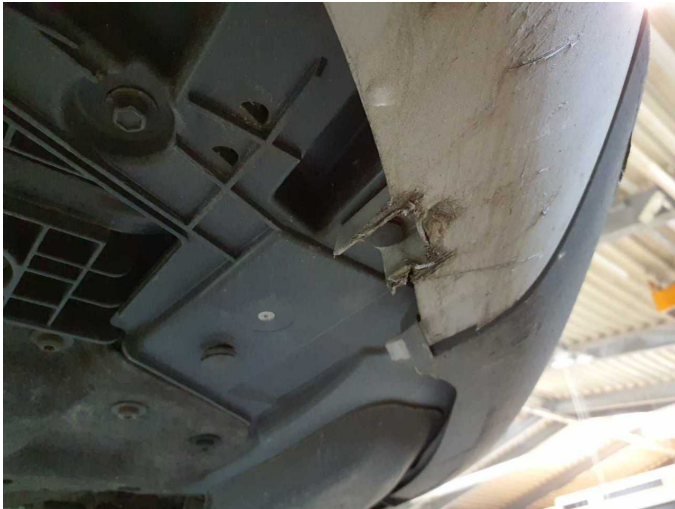
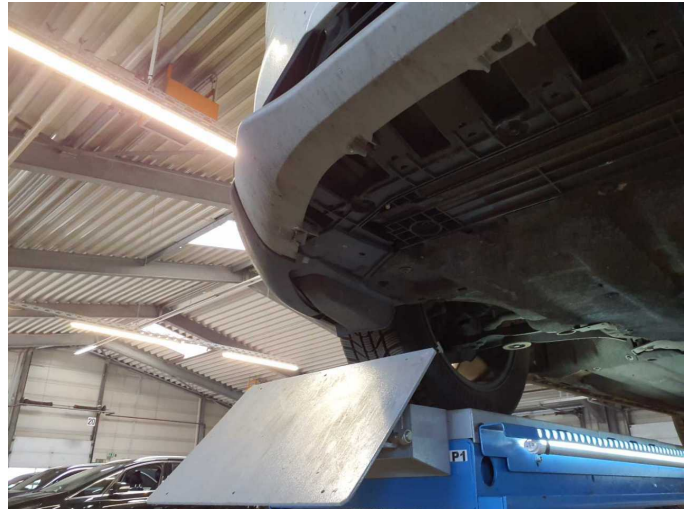
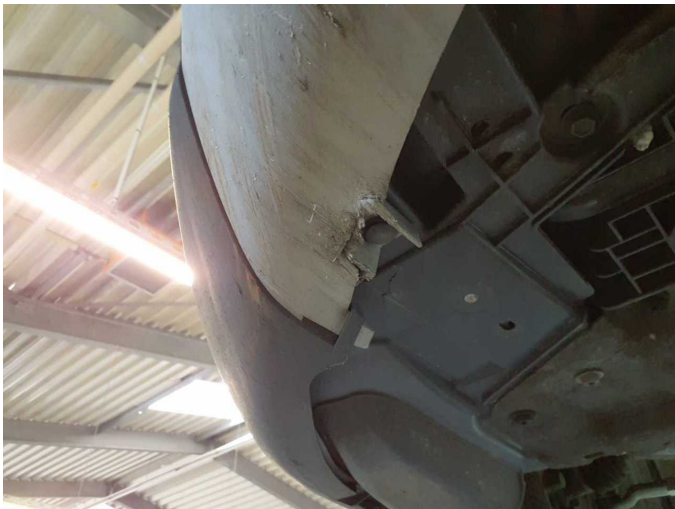
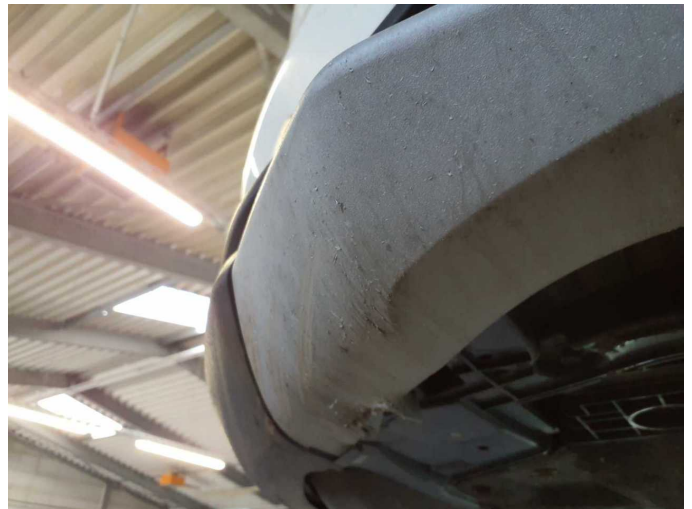
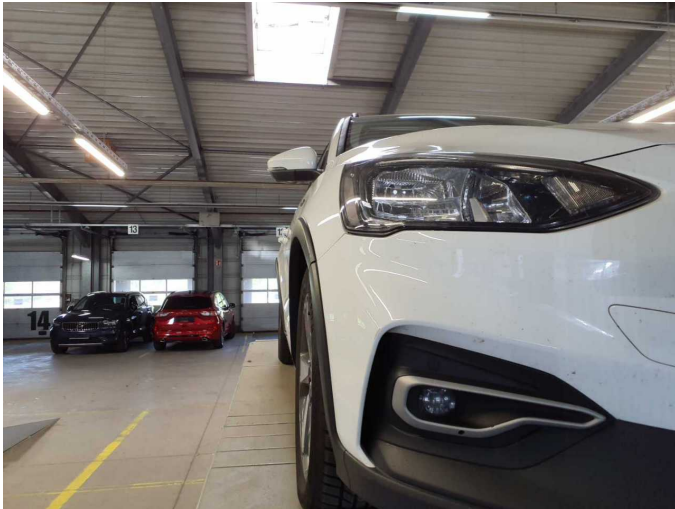
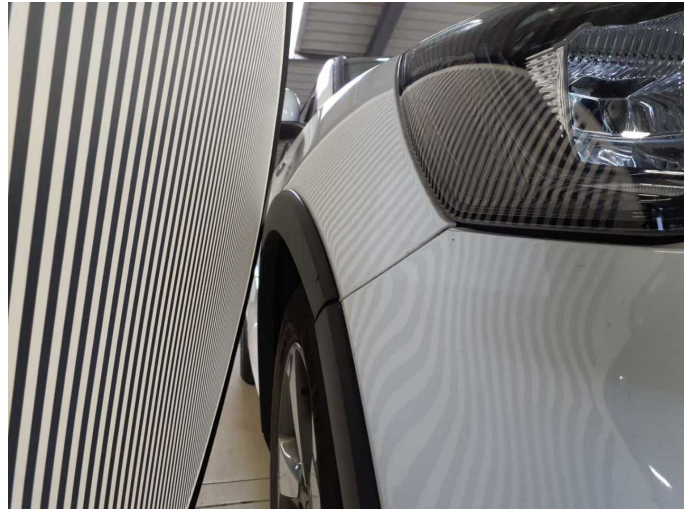
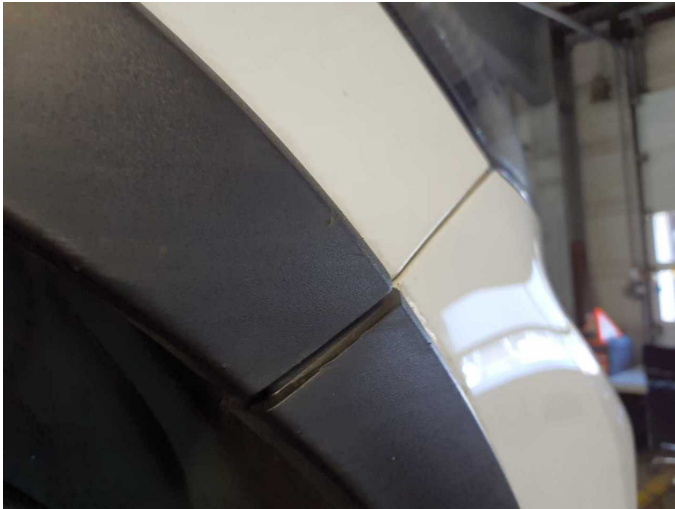
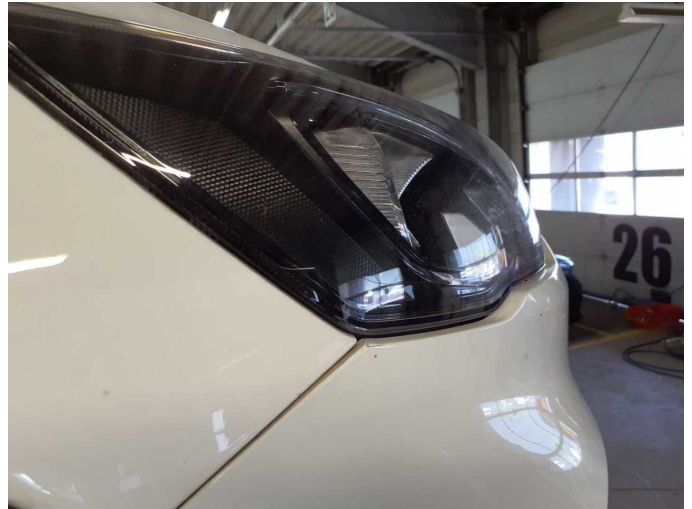
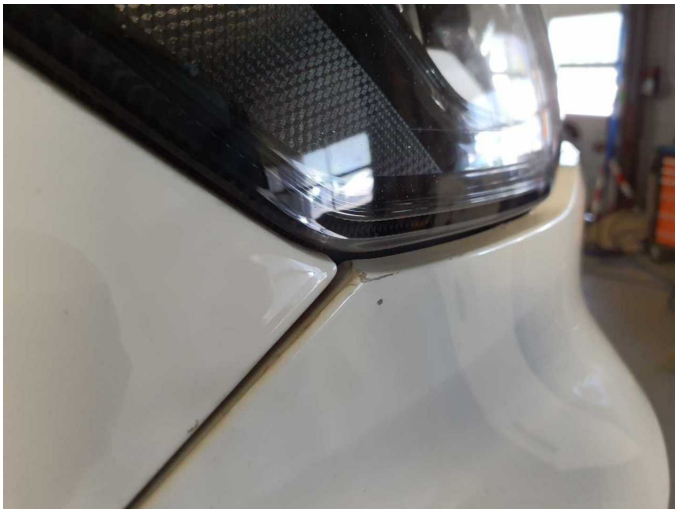
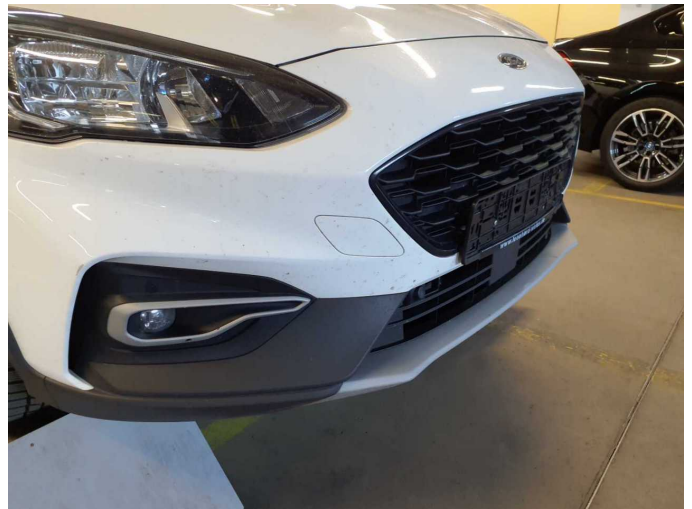
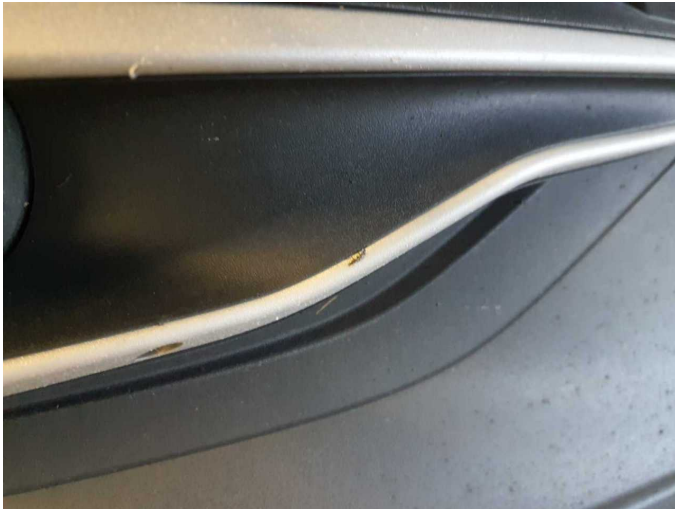
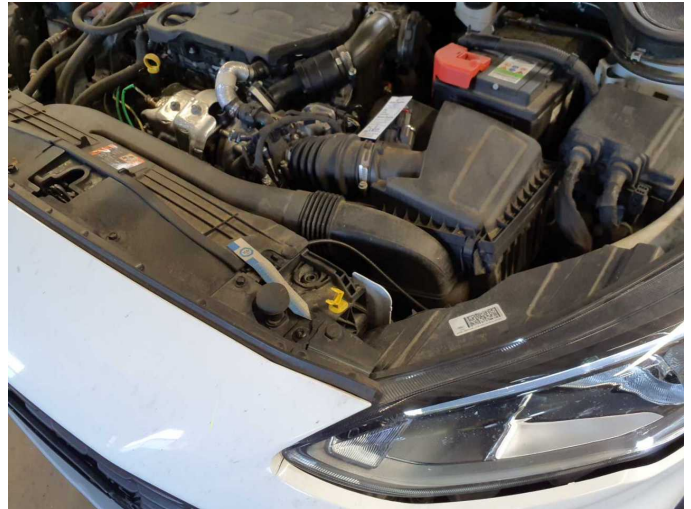
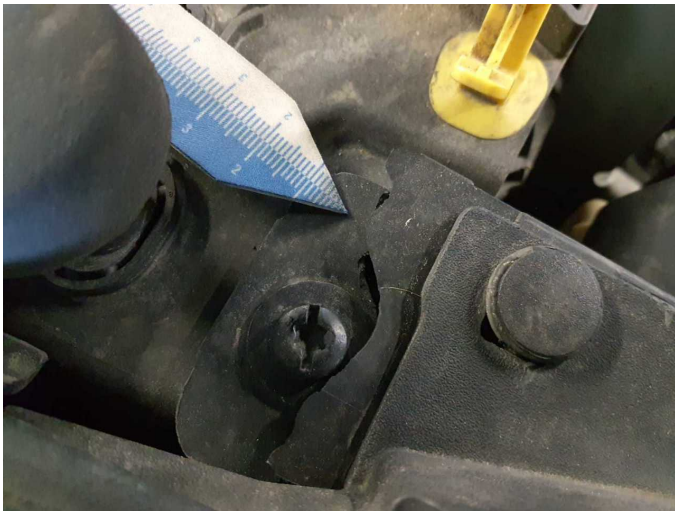
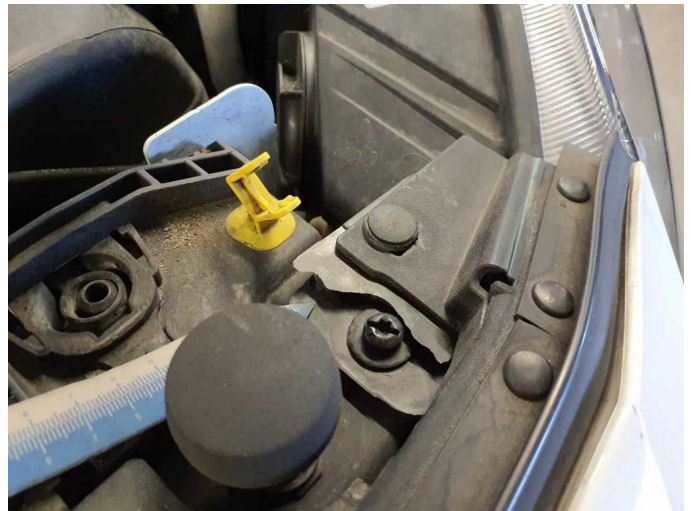
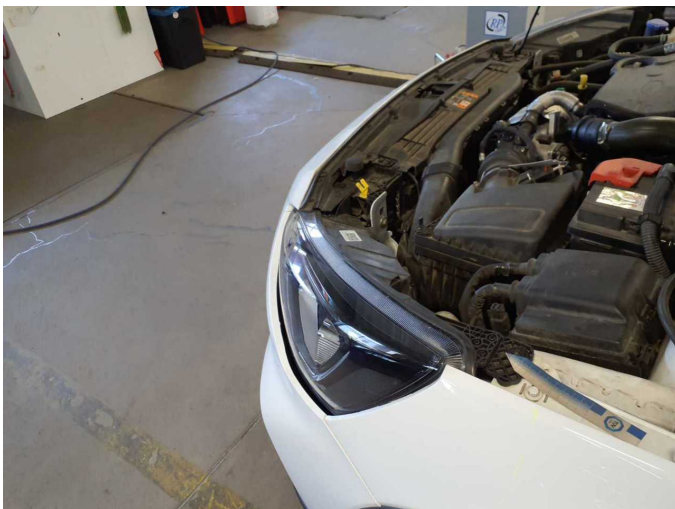
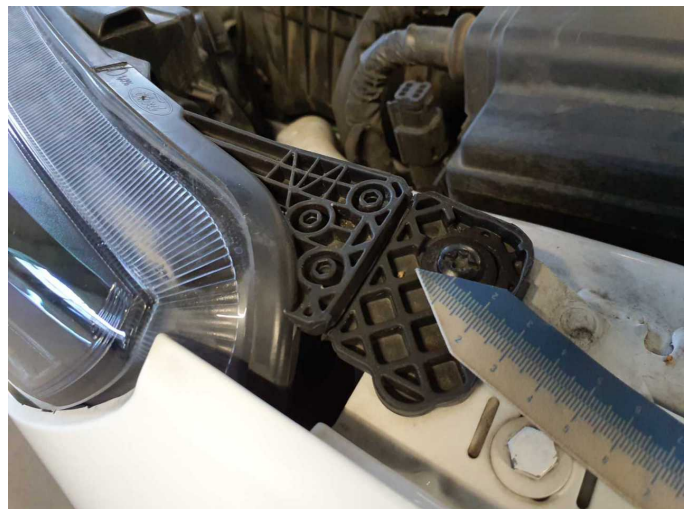
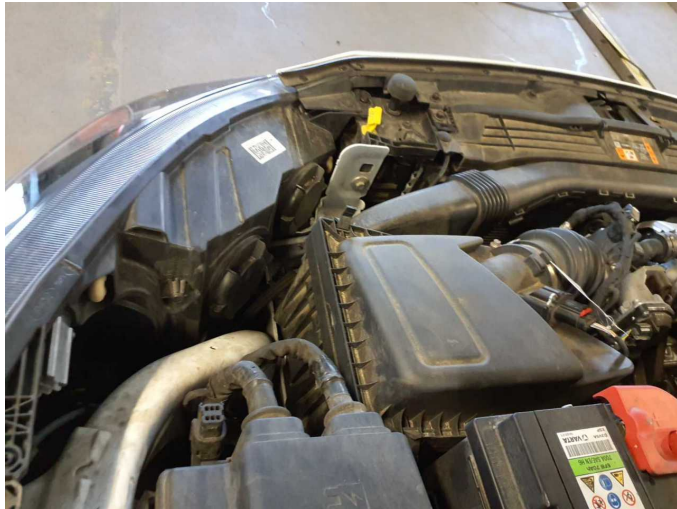
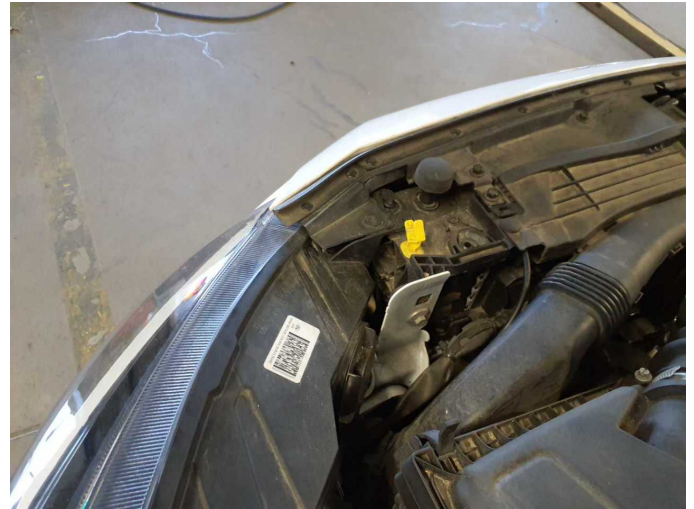
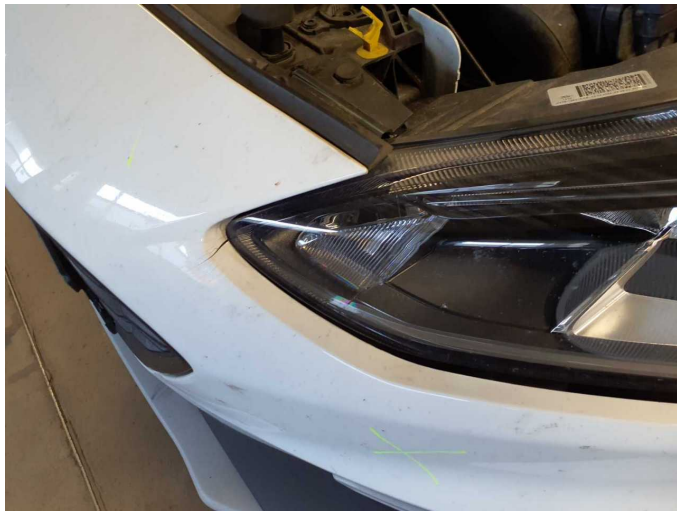
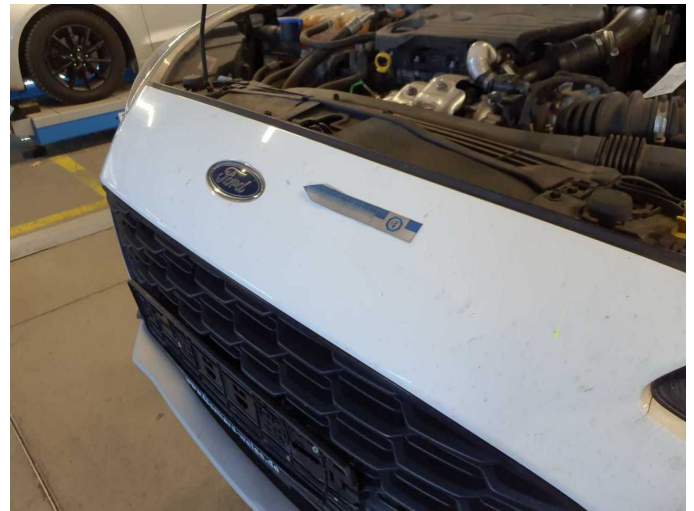
**Accident 1:** Front, Side - left

**Accident 1: Front, Side - left**

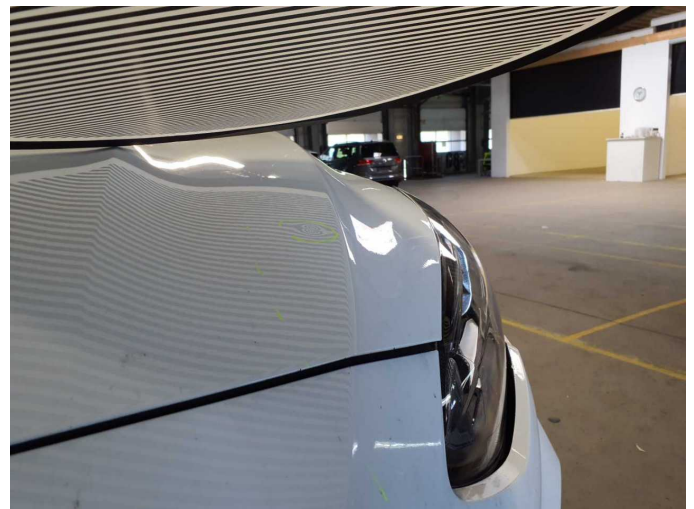
**Accident 1: Front, Side - left**

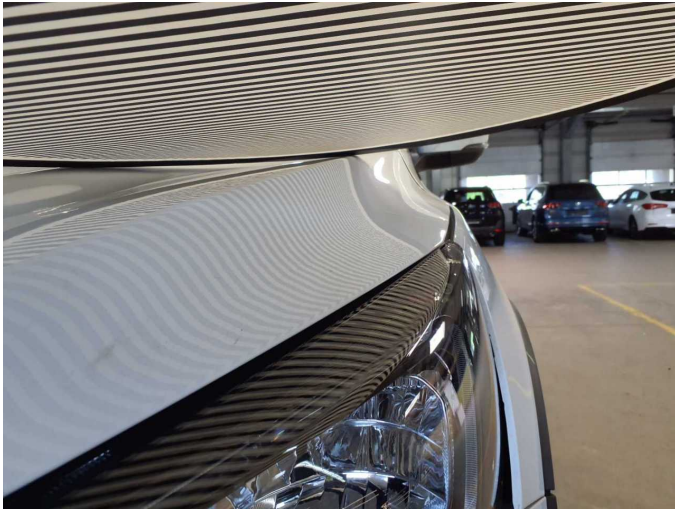
**Accident 1: Front, Side - left**

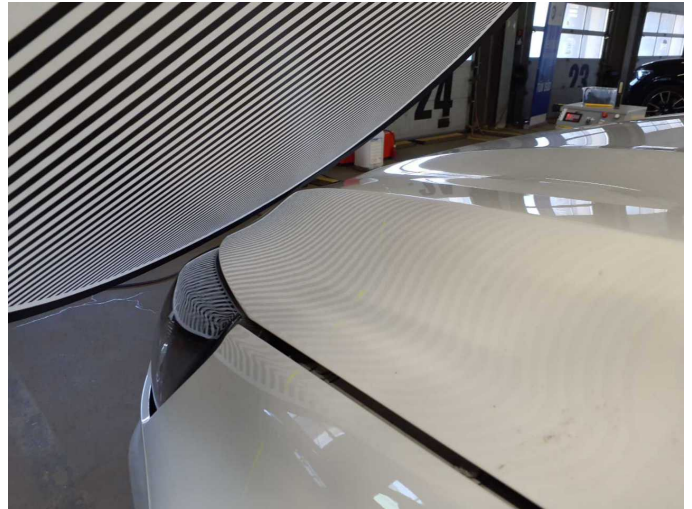
**Accident 1:** Front, Side - left

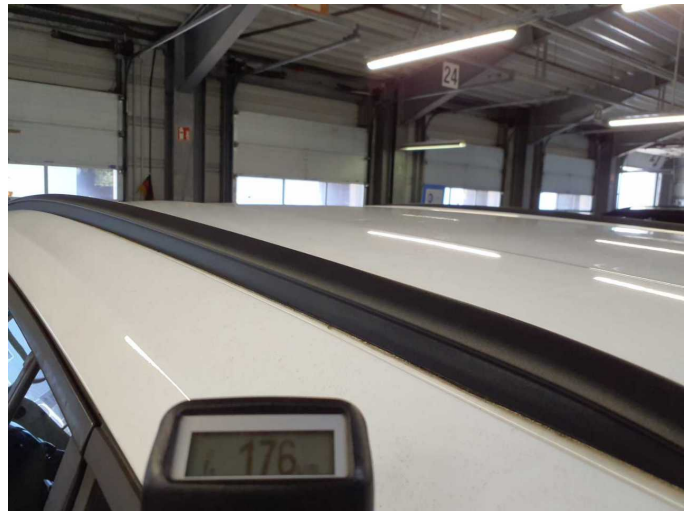
**Repainting 1:** Roof rail - left side

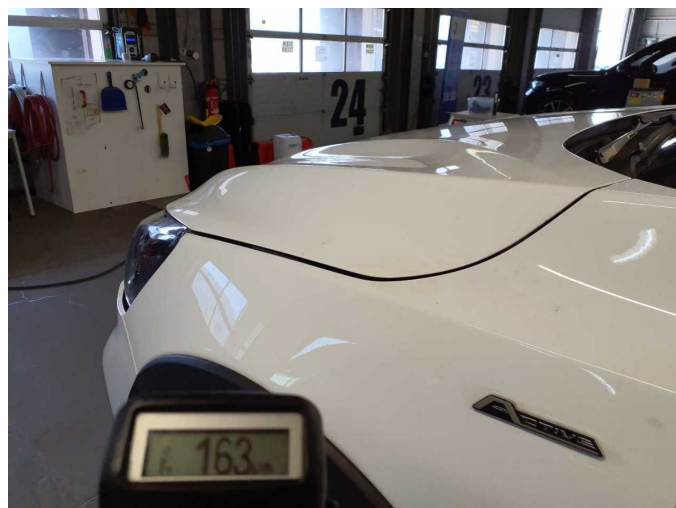
**Repainting 3: Mudguard - left side**

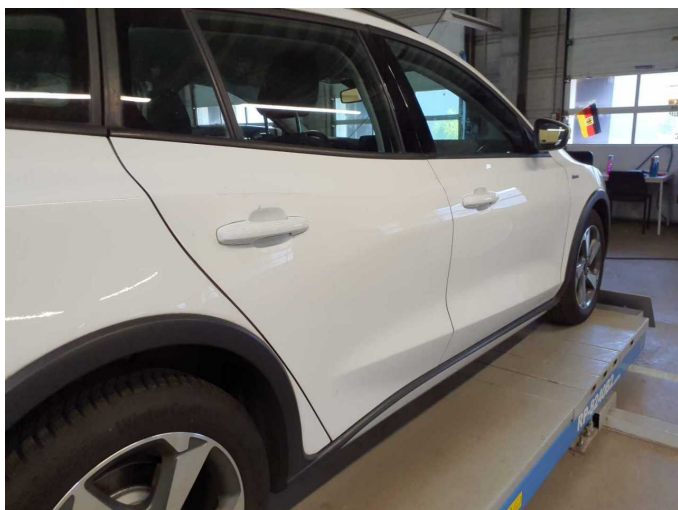
**Repainting 5: Door - rear left side**

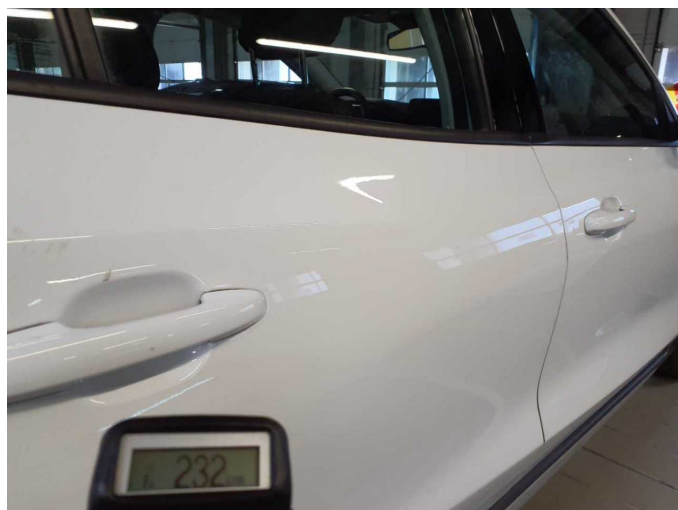
**Repainting 6:** Door - rear right side

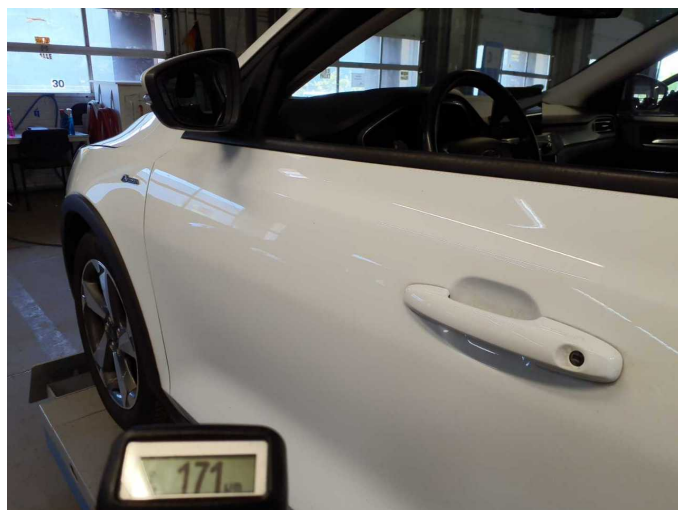
**Repainting 7:** Door - front left side
