Expertise

Protocol number: 41666784
Order No. / Reference: 25212609
Inspection date: 19 Sept 2025

Manufacturer: Ford	Model: Focus Turnier 1.5 EcoBlue Start-Stopp-System Aut. COOL&CONNECT
VIN: WF0PXXGCHPNM80117

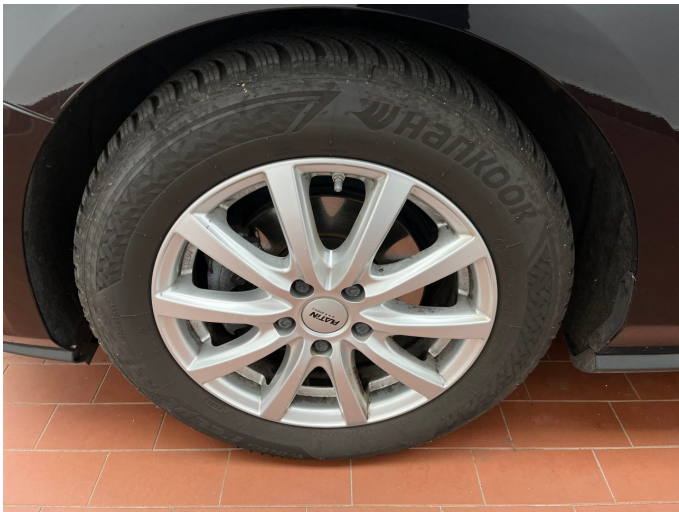
Figure 12: Mounted tyres

#	Tyre size	Type of tyre	Manufacturer	Tread depth
1)	205/60 R16 92H	Winter tyres on Light alloy	Hankook	5mm / 5mm
2)	205/60 R16 92H	Winter tyres on Light alloy	Hankook	6mm / 6mm

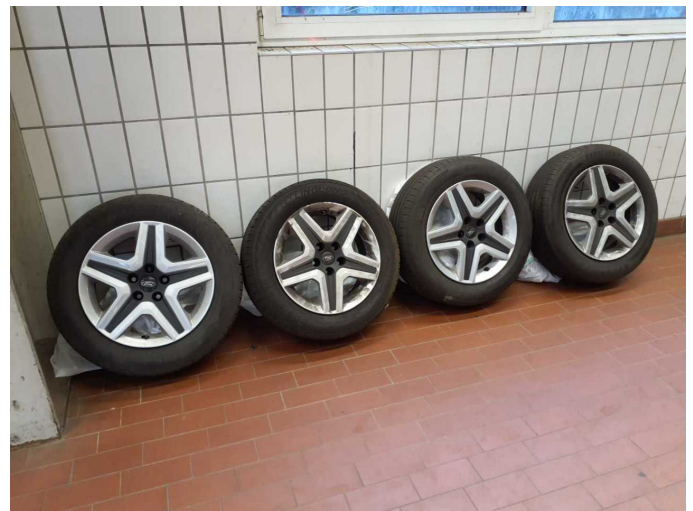
Figure 16: Additional tyres

#	Tyre size	Type of tyre	Manufacturer	Tread depth
1)	205/60 R16 96V	Summer tyres on Steel rim with wheel cover	unterschiedliche Hersteller	5mm / 5mm
2)	205/60 R16 96V	Summer tyres on Steel rim with wheel cover	unterschiedliche Hersteller	0mm / 0mm

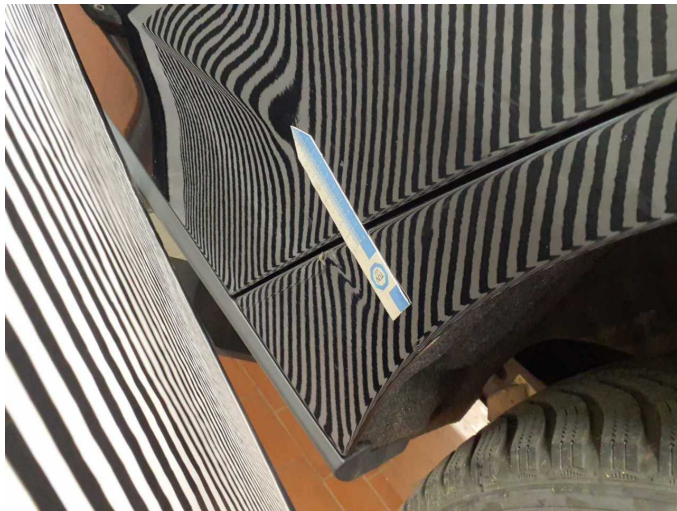
Accident 1: Side - left

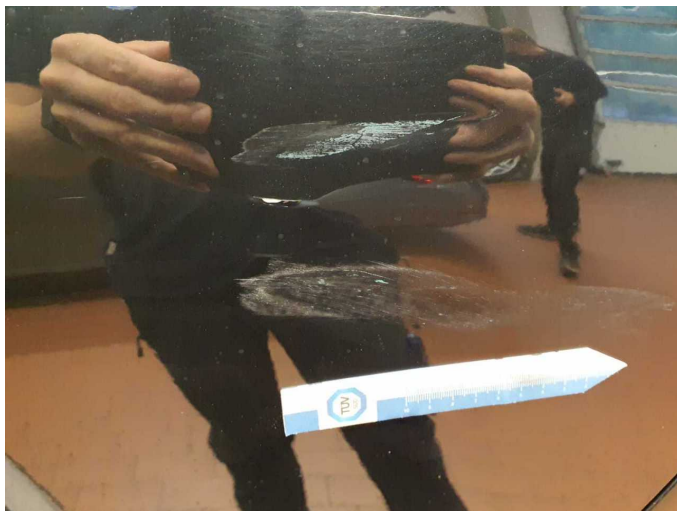
Accident 1: Side - left

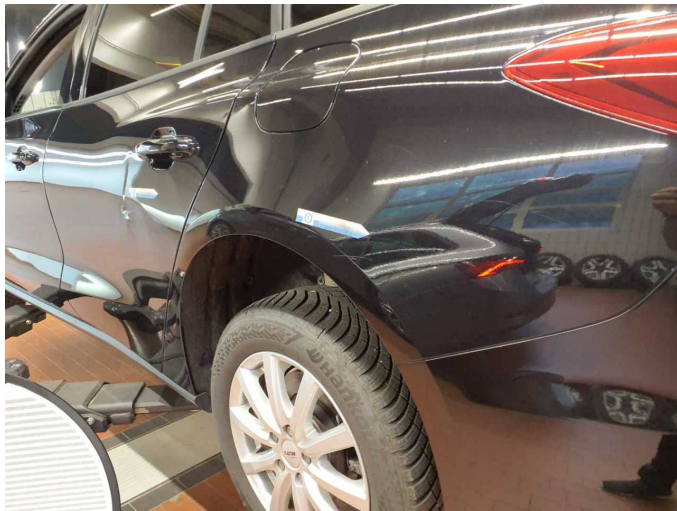
Accident 1: Side - left

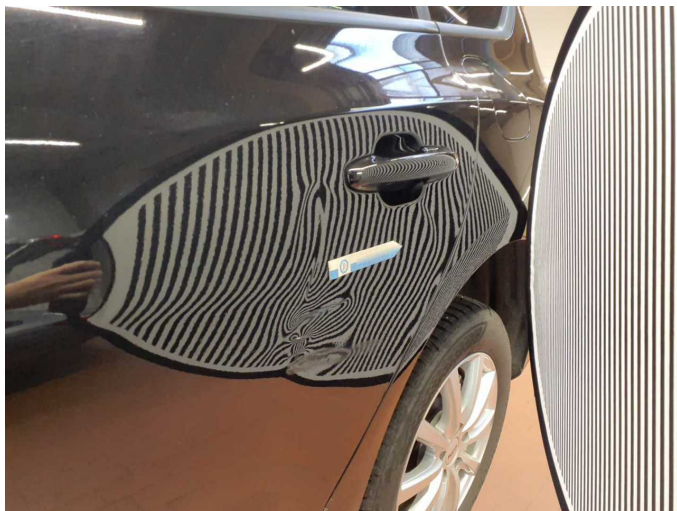
Accident 1: Side - left
