Expertise

Protocol number: 41588416
Order No. / Reference: 25196984
Inspection date: 11 Sept 2025

Manufacturer: Ford	Model: Transit Custom 340 L1H1 LKW VA Autm. Trend
VIN: WF0YXXTTGYLR14557

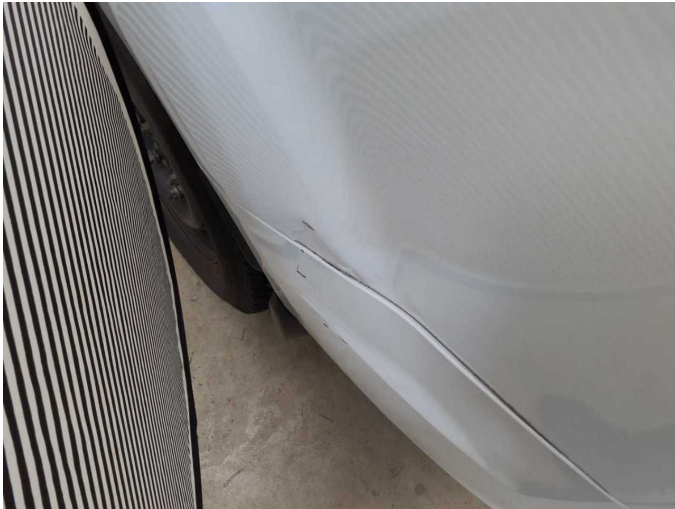
Accident 3: Rear, Side - left

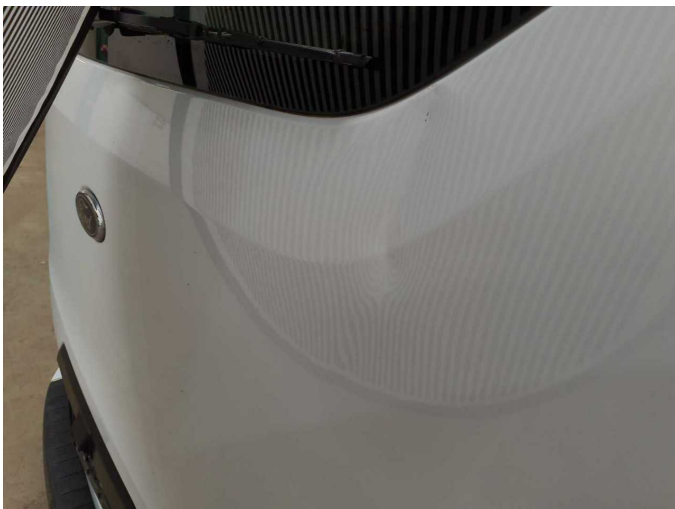
Accident 4: Rear

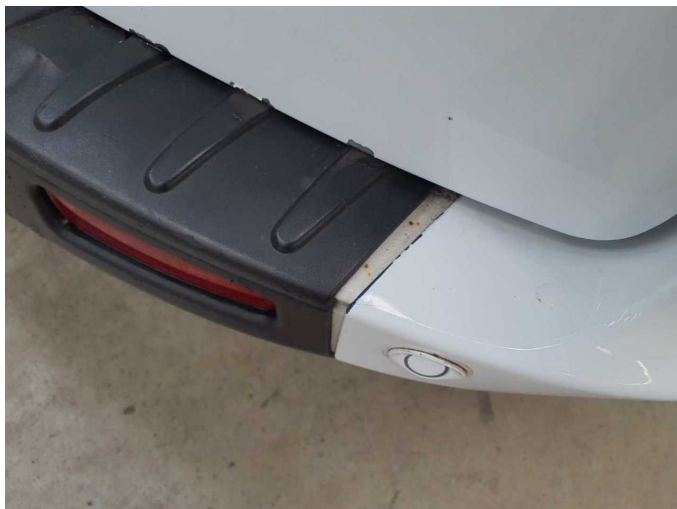
Accident 4: Rear

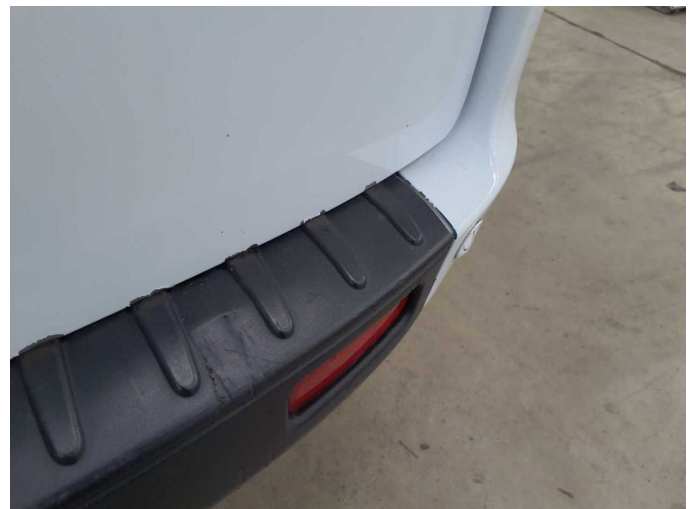
Accident 4: Rear
