Expertise

Protocol number: 41685748  
Order No. / Reference: 25226674  
Inspection date: 24 Sept 2025

Manufacturer: Volkswagen

Model: Transporter T6 Kurz BlueMotion

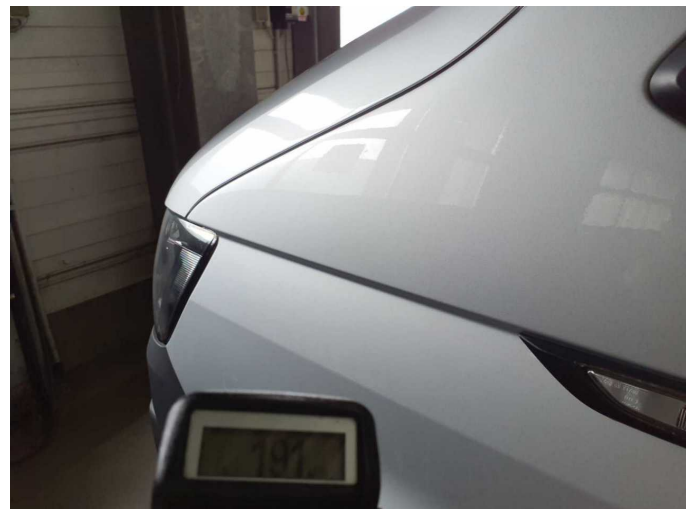
**Repainting 1:** Mudguard - left side

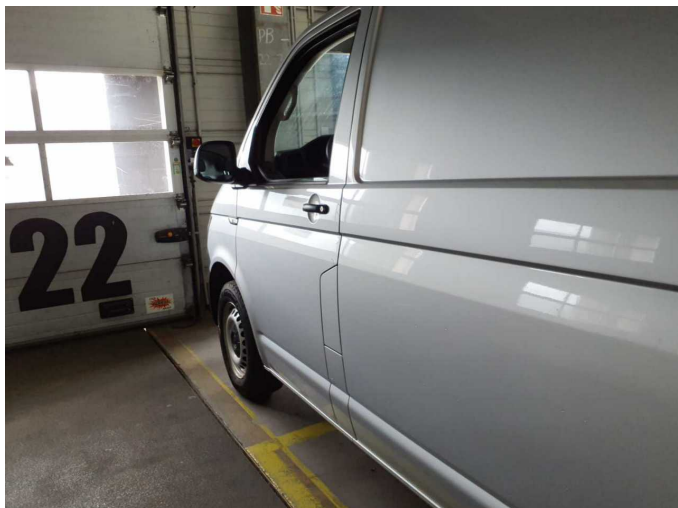
**Repainting 1:** Mudguard - left side

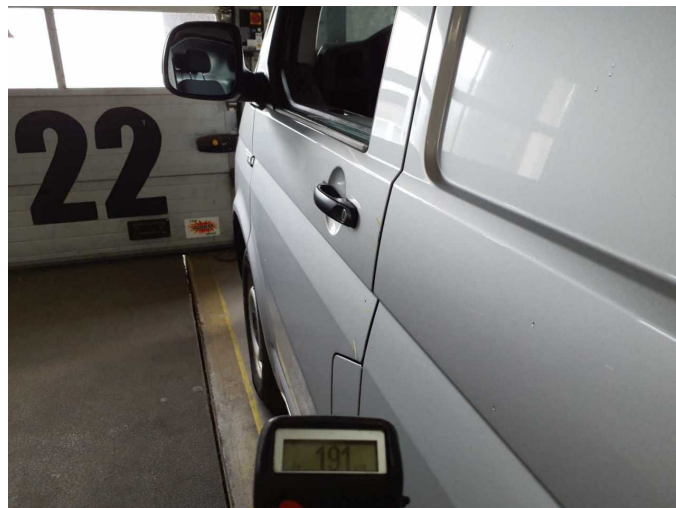
**Repainting 2:** Side panel - rear left side
