## status report

#### Volkswagen Crafter Kasten Kasten 35 lang Hochdach FWD

| Vehicle identification number | <b>WV1ZZZSYZK9054523</b> | mileage read: | <b>165978 km</b> |

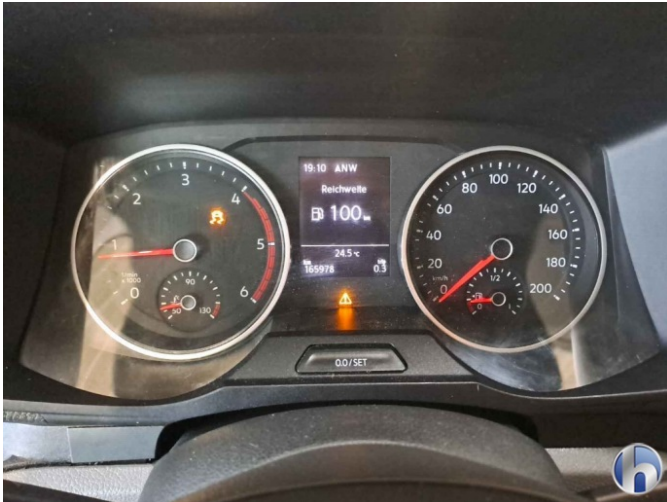
instrument cluster

| Performed testing technology | |
|---|---|
| | *Nutzfahrzeug typische Gebrauchsspuren und Beschädigungen. Kombiinstrument Fehlermeldung Fehlerdiagnose durchführen lassen Lose Fahrzeugteile im Innenraum Dach nicht prüfbar keine Leiter vorhanden Unfallschaden Stoßfänger vorne, Hecktüren, linke und rechte Fahrzeugseite Schaden und Kosten Erweiterung möglich |

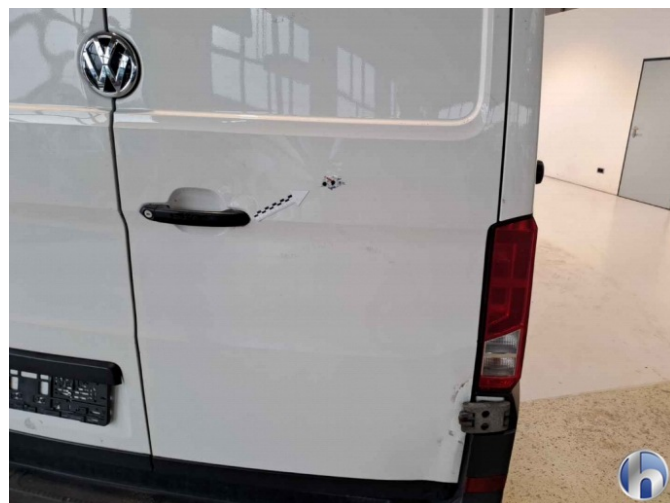
| component | Damage | Rep kind |
|---|---|---|
| 9. Türanschlag Hecktür Rechts | Missing | Replace |

9. Türanschlag Hecktür Rechts

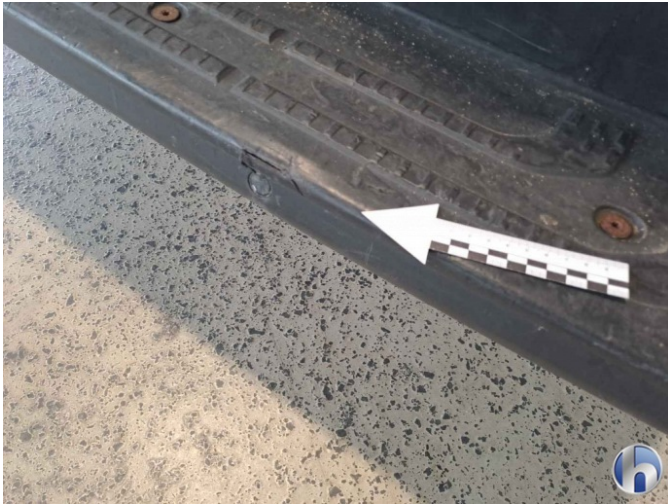
| component | Damage | Rep kind |
|---|---|---|
| 10. Rear bumper | Deformed | Replace |

10. Rear bumper

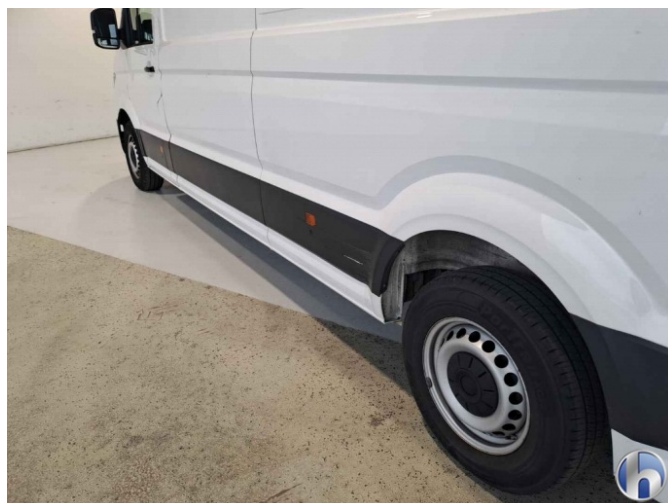
| component | Damage | Rep kind |
|---|---|---|
| 13. Beplankung links | Damaged | Replace |

13. Beplankung links

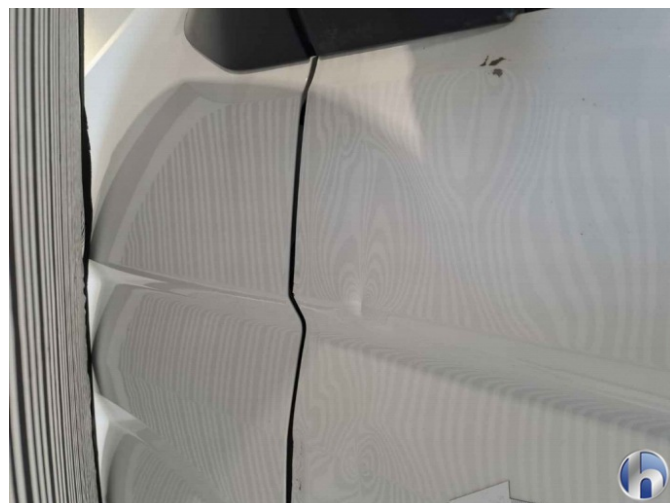
| component | Damage | Rep kind |
|---|---|---|
| 15. Front door - left | Deformed (strongly) | Replace |

15. Front door - left

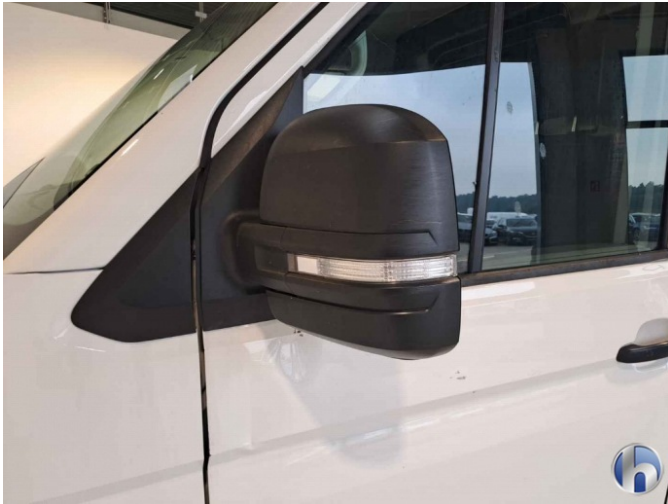
| component | Damage | Rep kind |
|---|---|---|
| 16. | Scrape | Replace |

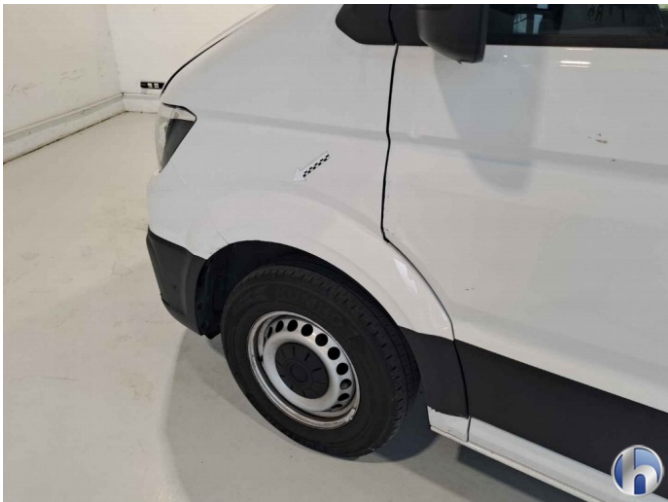
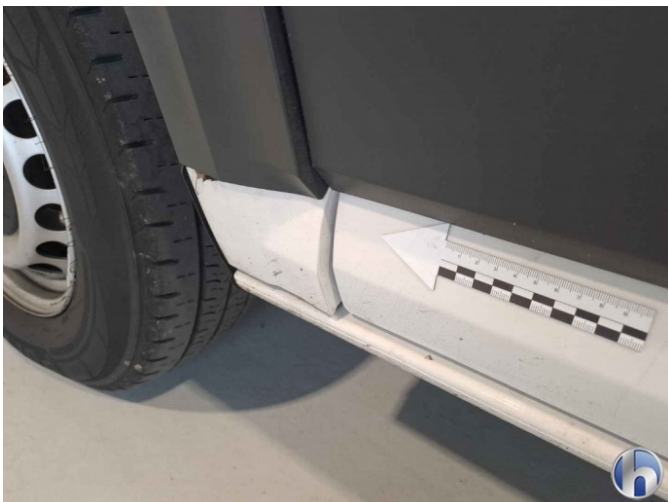
| component | Damage | Rep kind |
|---|---|---|
| 17. Front fender - left | Deformed (strongly) | Replace |

17. Front fender - left

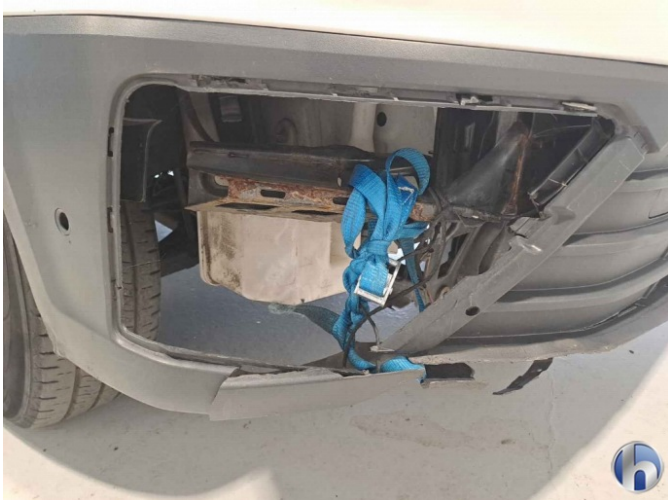
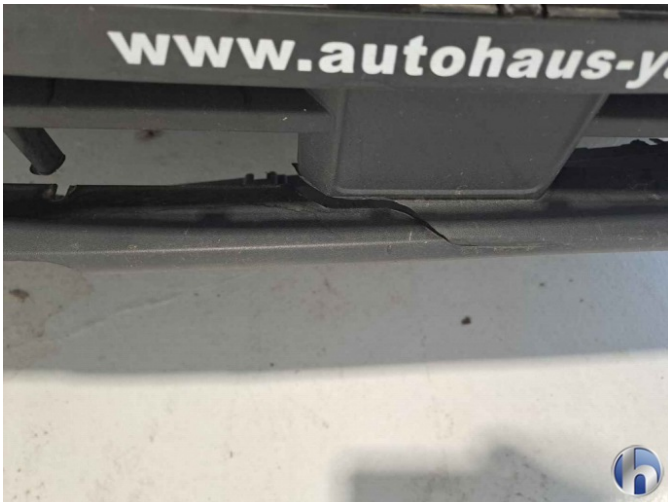
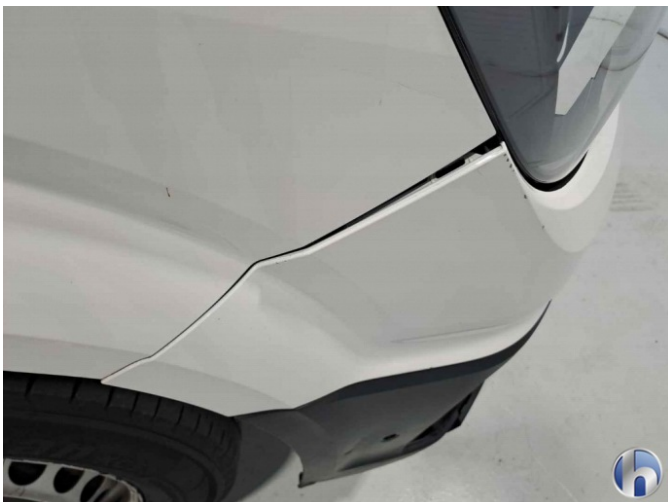
| component | Damage | Rep kind |
|---|---|---|
| 18. Front bumper | Accident damage | Replace |

18. Front bumper

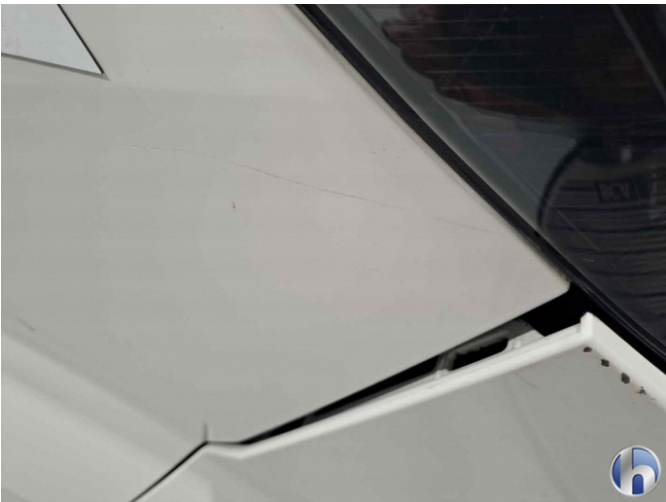
| component | Damage | Rep kind |
|---|---|---|
| 20. Front fender - right | Scratch(es) | Smart repair |

20. Front fender - right

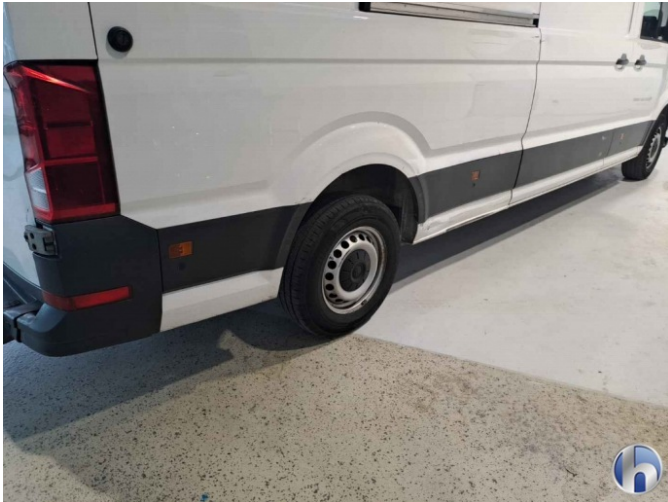
| component | Damage | Rep kind |
|---|---|---|
| 24. Beplankung rechts | Scrape | Replace |

24. Beplankung rechts

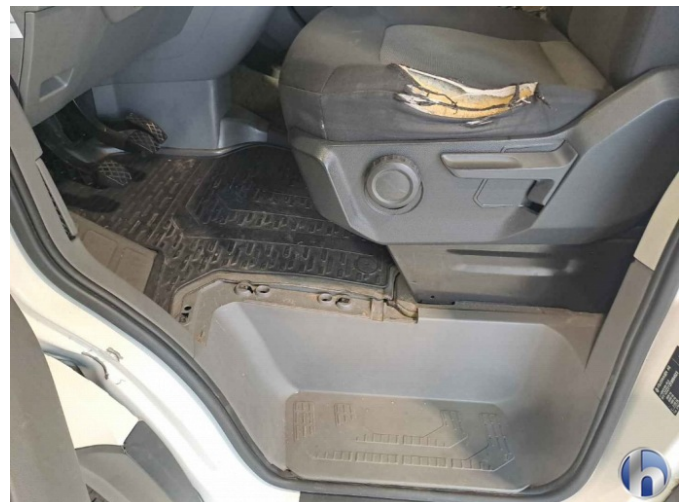
| component | Damage | Rep kind |
|---|---|---|
| 28. | Wear and tear | acceptable |

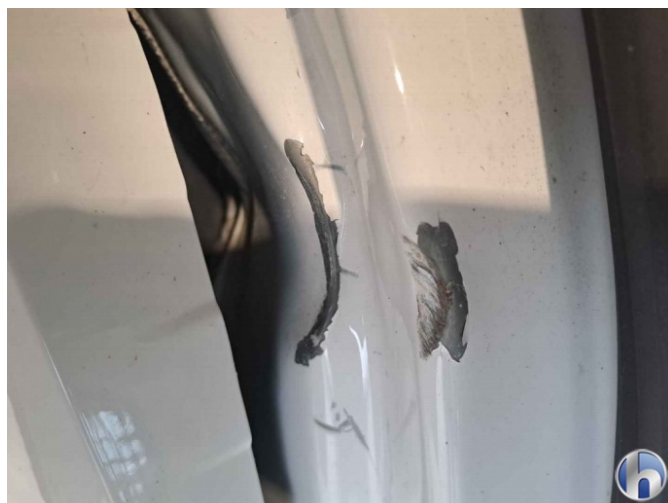
| component | Damage | Rep kind |
|---|---|---|
| 32. Türeinstieg Vorne - Links | Deformed (strongly) | Replace |

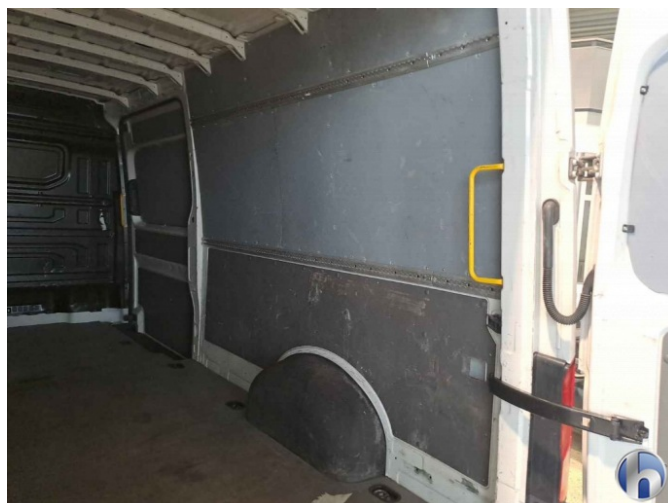
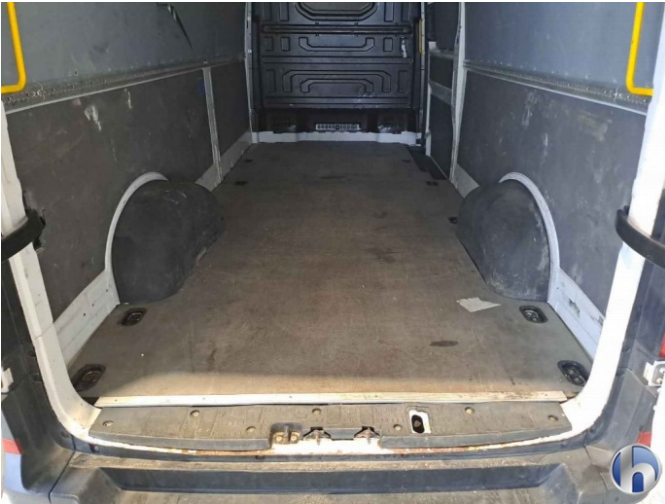
| component | Damage | Rep kind |
|---|---|---|
| 33. | Wear and tear | acceptable |

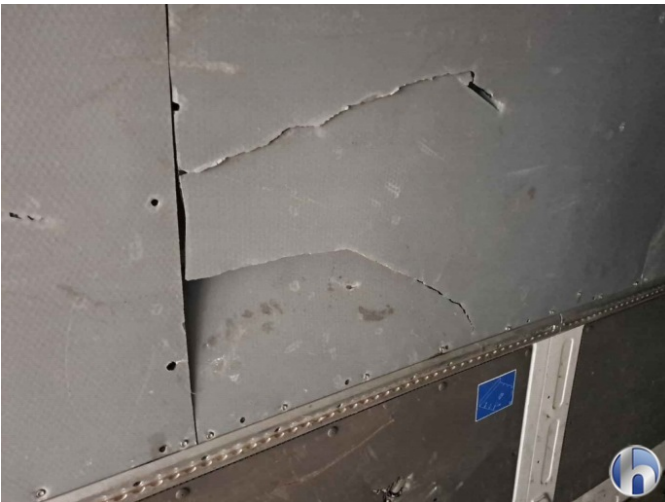
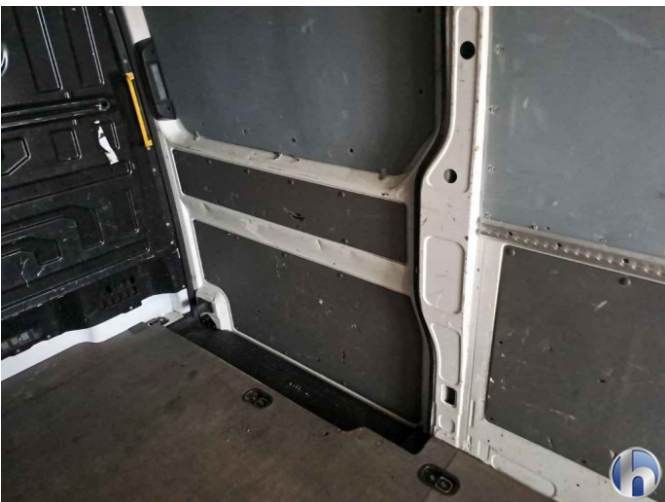
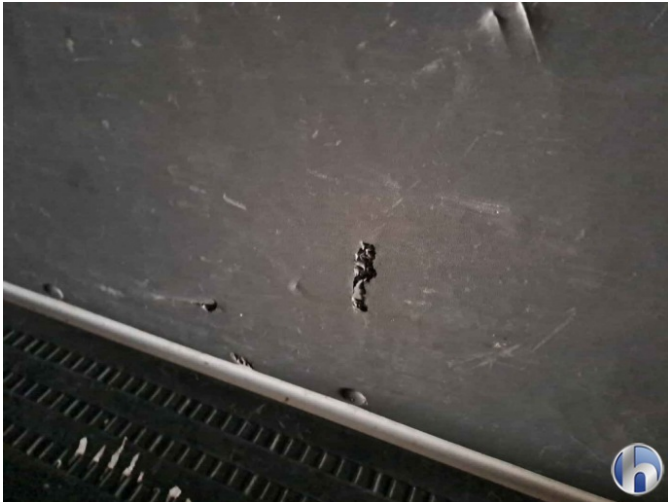
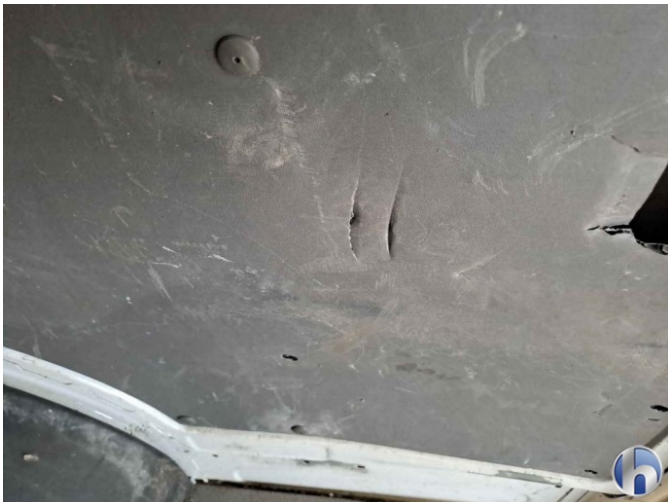
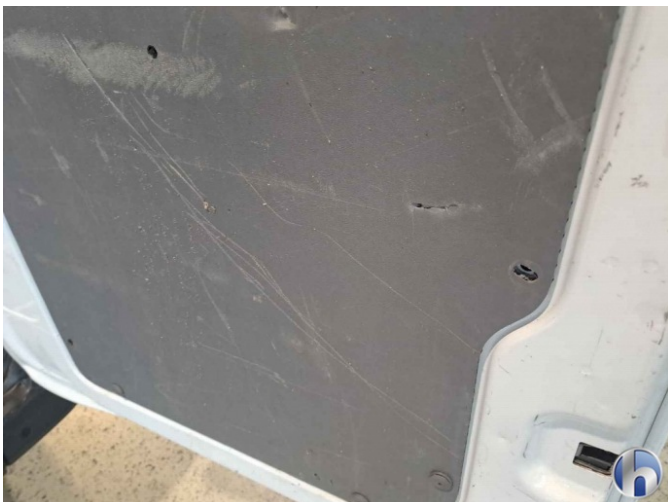
| component | Damage | Rep kind |
|---|---|---|
| 35. Verkleidung Laderaum | Damaged | Replace |

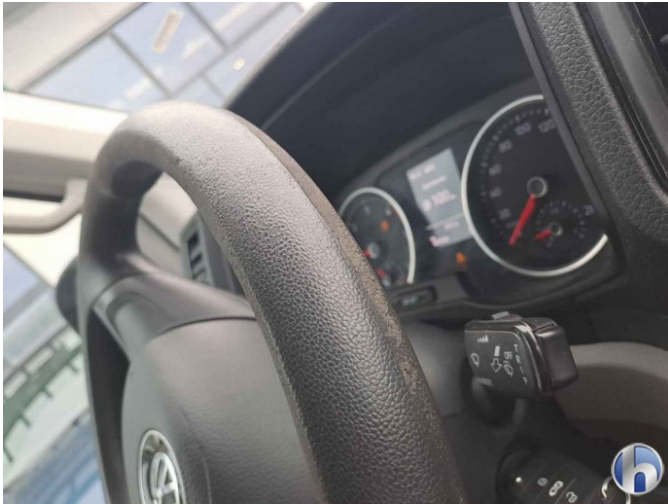
| component | Damage | Rep kind |
|---|---|---|
| 36. steering wheel | Scrape | Replace |
