Expertise

Protocol number: 41790553
Order number / reference: 25283029
Inspection date: 1 Oct 2025

Manufacturer: Volkswagen

Model: Touran 1.5 TSI ACT OPF DSG Highline

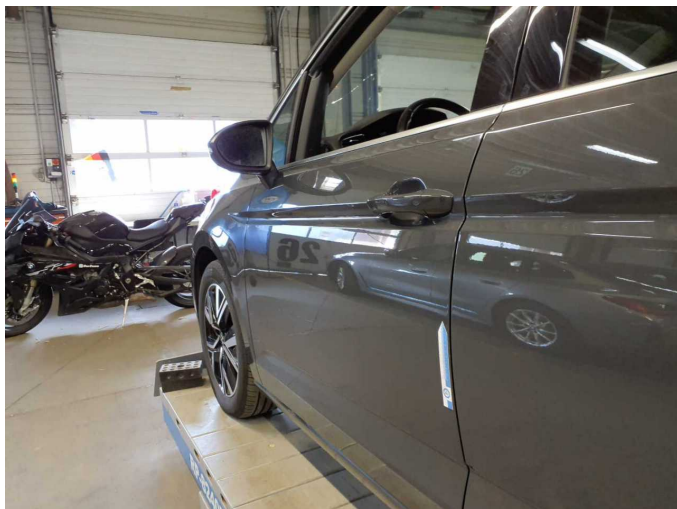
Damage 1: Door - front left side: Door edge - Scratched - Smart repair
