Expertise

Protocol number: 39741604  
Order No. / Reference: 24686615  
Inspection date: 15 May 2025

Manufacturer: Volkswagen	Model: Tiguan Allspace 2.0 TDI SCR 4Motion DSG Comfortline
VIN: WVGZZZ5NZMM146255

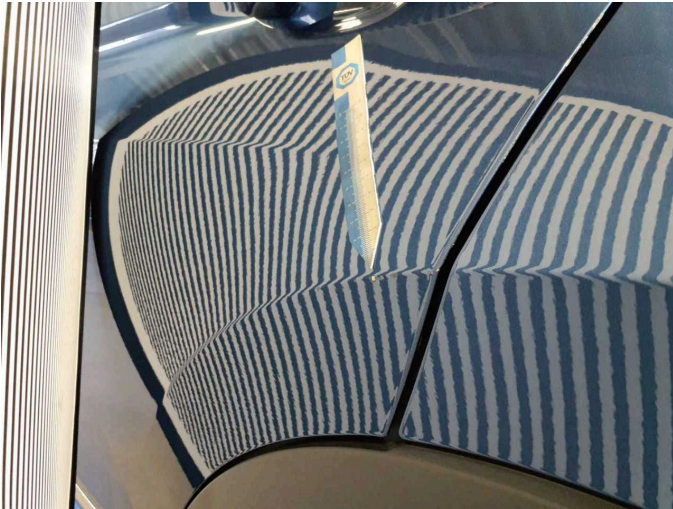
**Damage 7:** Door - rear left side: Door (Steinschlag) - Scratched - Smart repair

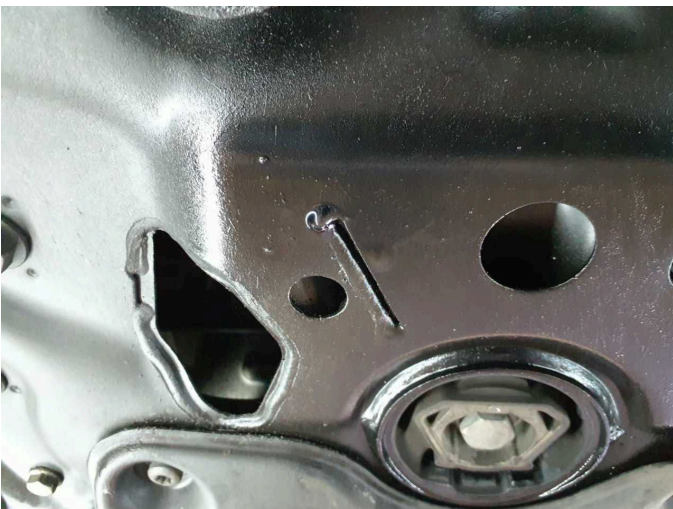
**Damage 9:** Engine: Engine (Ölundichtigkeiten Motor) - Leaking - Perform diagnosis

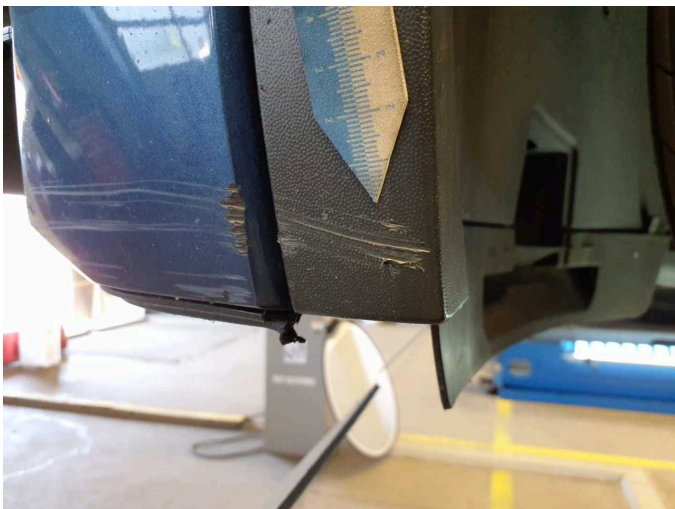
**Accident 1:** Front, Side - left, Side right

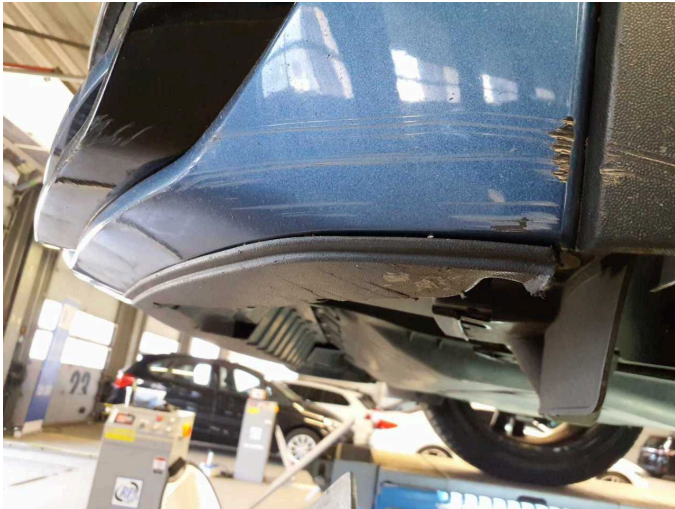
**Accident 1:** Front, Side - left, Side right

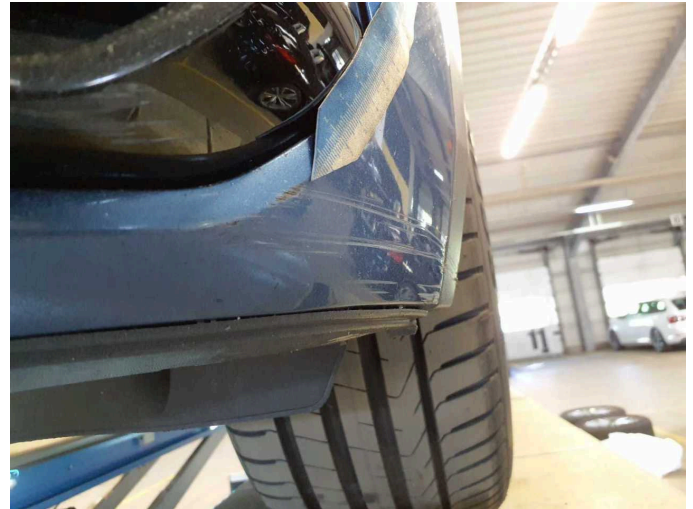
**Accident 1:** Front, Side - left, Side right

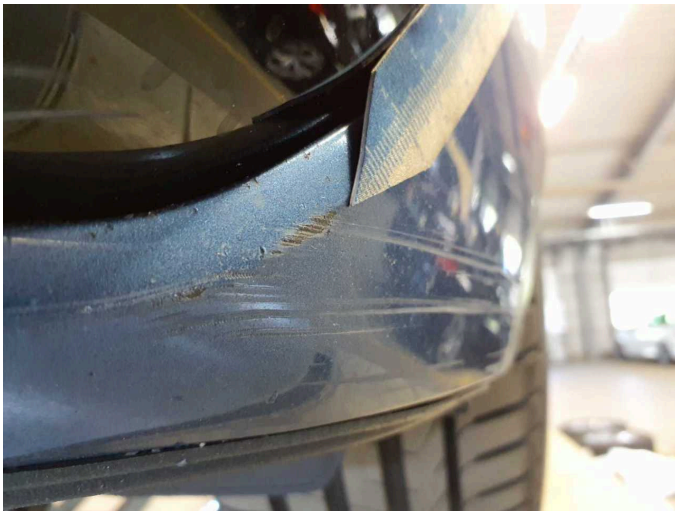
**Accident 1:** Front, Side - left, Side right

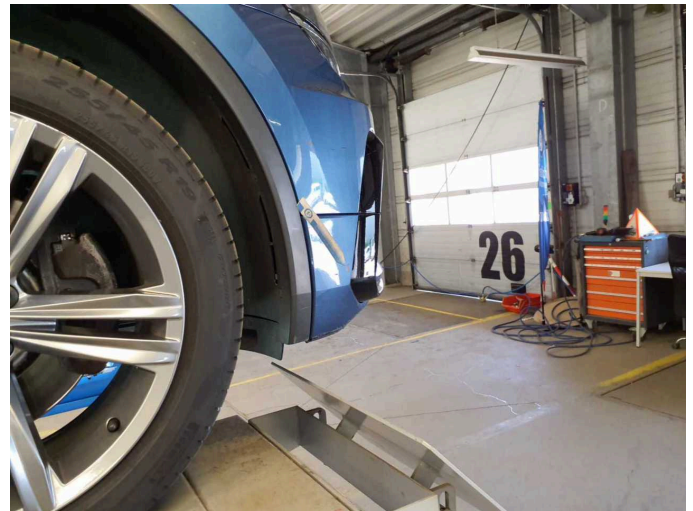
**Accident 1:** Front, Side - left, Side right

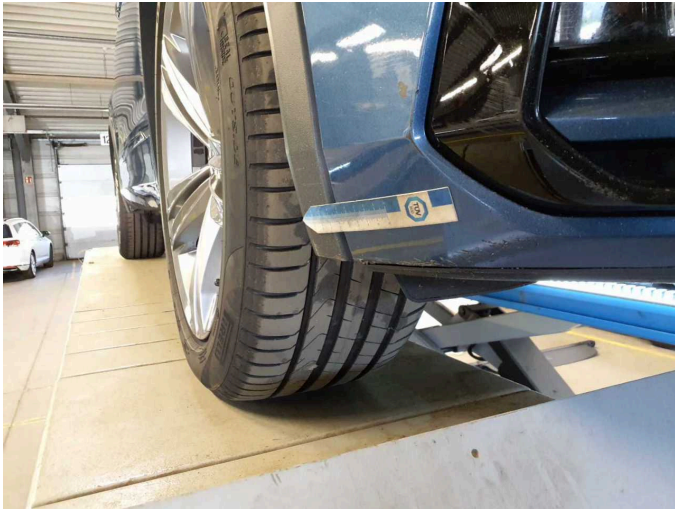
**Accident 1:** Front, Side - left, Side right

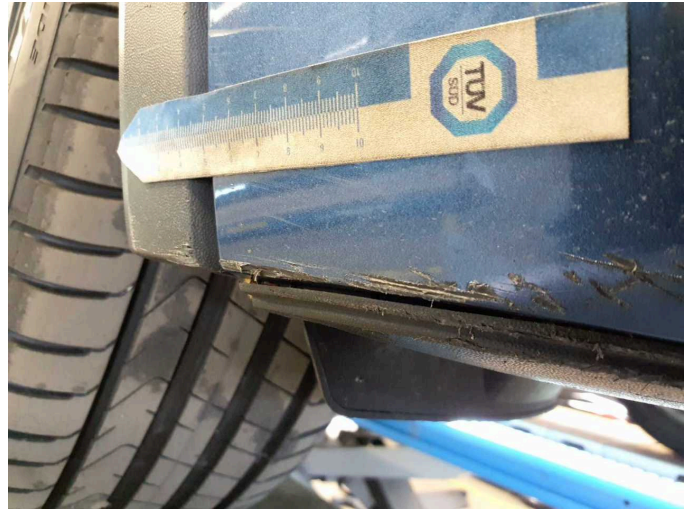
**Accident 1:** Front, Side - left, Side right

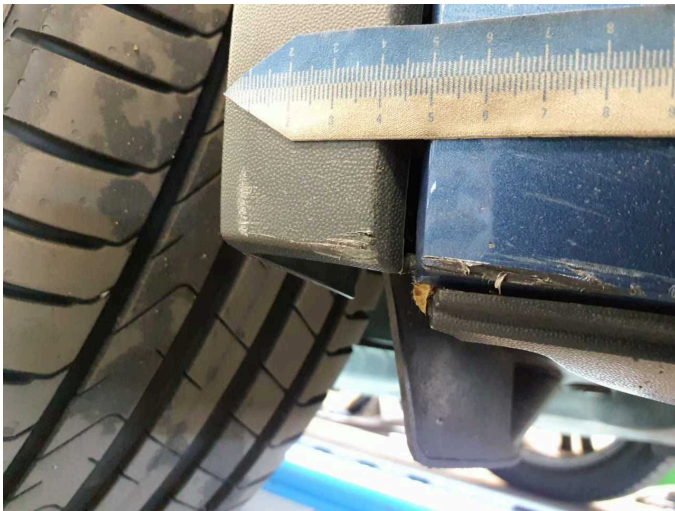
**Accident 1:** Front, Side - left, Side right

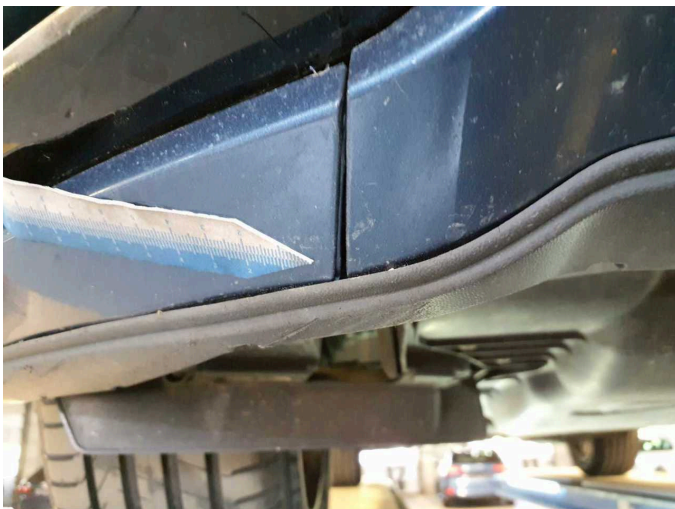
**Accident 1:** Front, Side - left, Side right

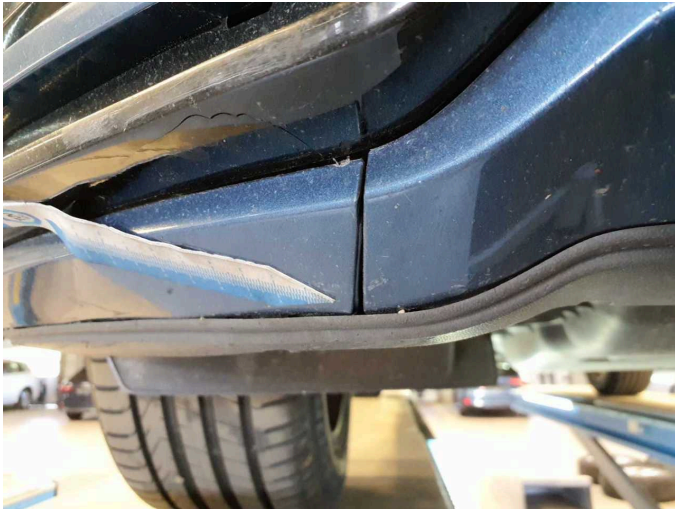
**Accident 1:** Front, Side - left, Side right

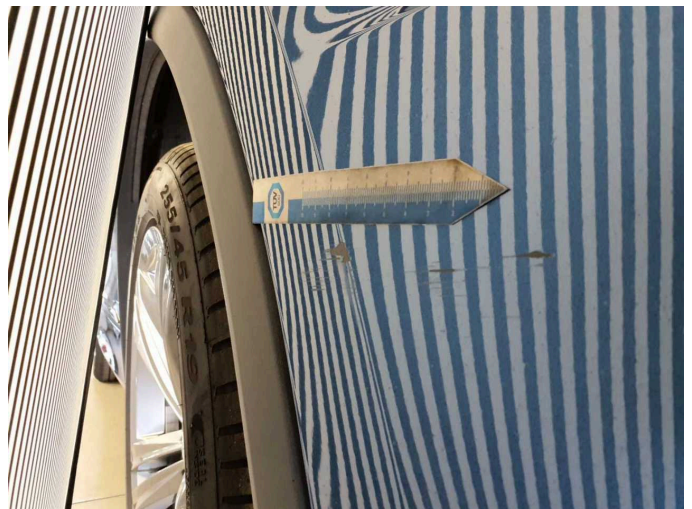
**Accident 1:** Front, Side - left, Side right

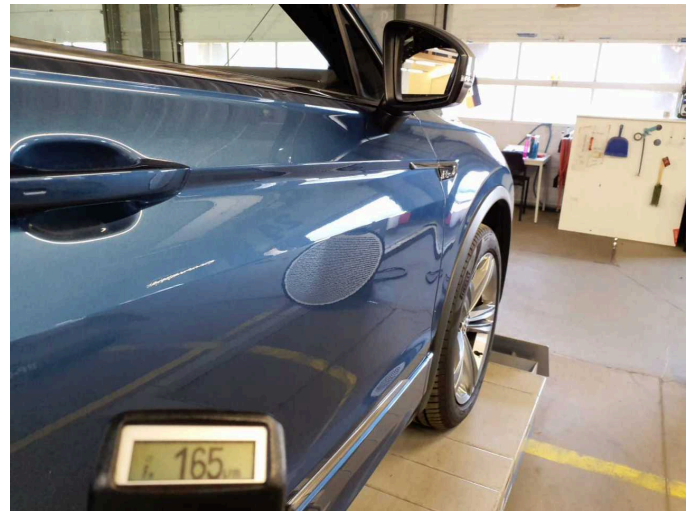
**Repainting 1:** Door - front right side
