Expertise

Protocol number: 41179667
Order No. / Reference: 25120216
Inspection date: 22 Aug 2025

Manufacturer: Volkswagen
VIN: WVGZZZ5NZMW405827

Model: Tiguan 1.4 eHybrid OPF DSG Life

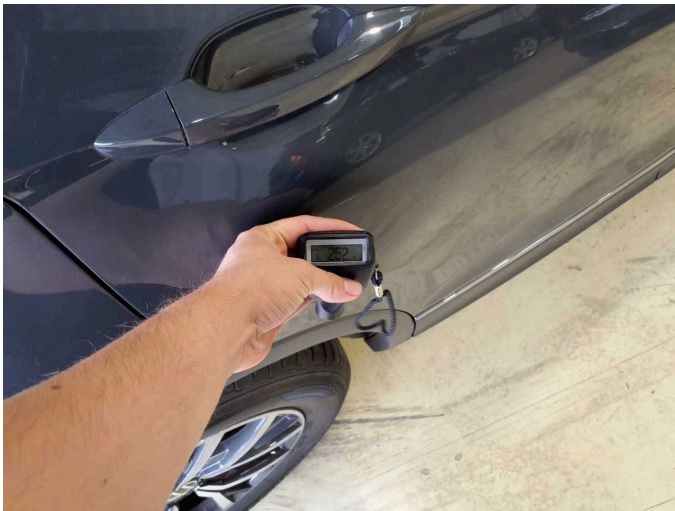
Repainting 2: Side panel - rear right side, Door - rear right side

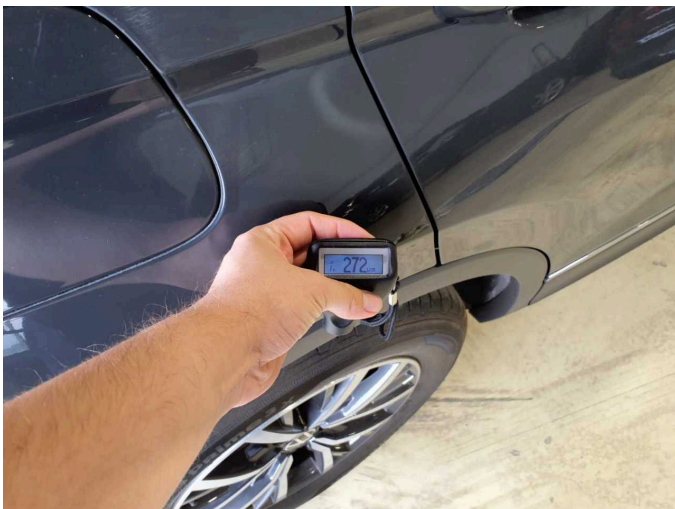
Repainting 2: Side panel - rear right side, Door - rear right side
