Expertise

Protocol number: 41459294
Order No. / Reference: 25170810
Inspection date: 8 Sept 2025

Manufacturer: Volkswagen

Model: Tiguan 2.0 TDI SCR 4MOTION DSG Elegance

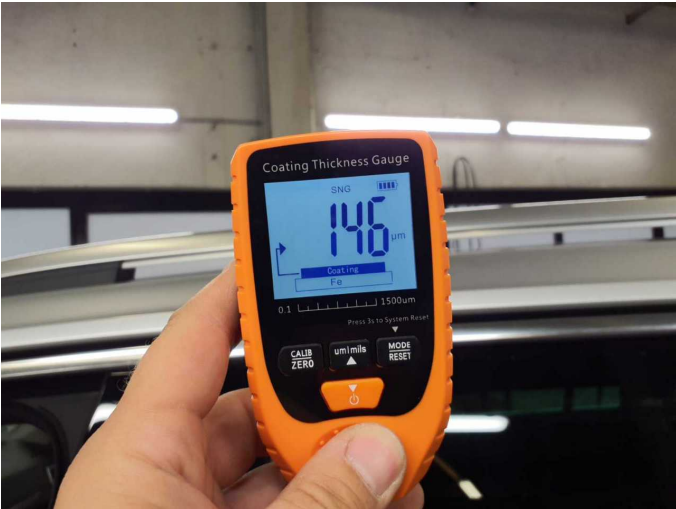
Repainting 1: Roof rail - left side, Side panel - rear left side

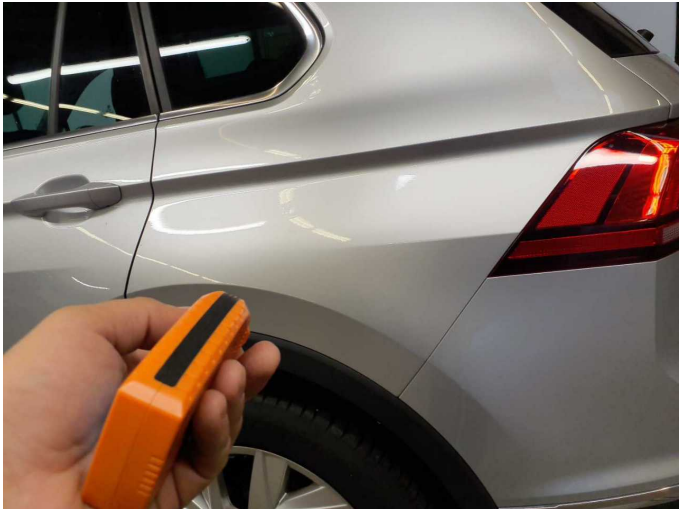
Repainting 1: Roof rail - left side, Side panel - rear left side

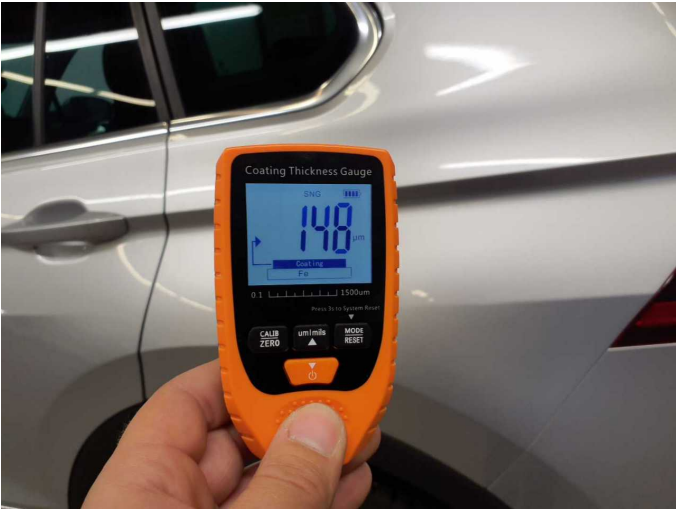
Repainting 1: Roof rail - left side, Side panel - rear left side
