Hüsges Gruppe®  
Die Gutachter

## status report

#### Volkswagen Passat Variant Highline BMT/Start-Stopp 4Motion

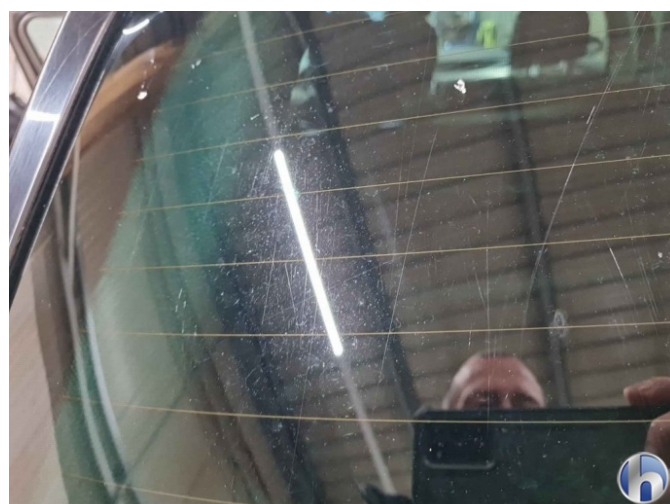
| component | Damage | Rep kind |
|---|---|---|
| 2. rear window | Scratch(es) | Replace |

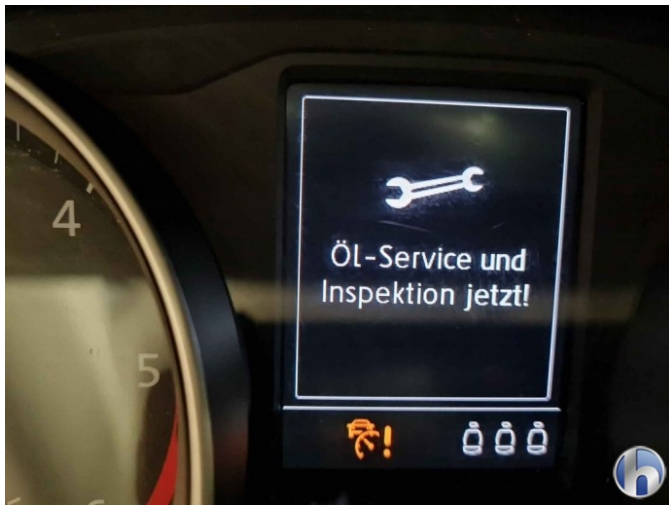
| component | Damage | Rep kind |
|---|---|---|
| 3. Wartung | Error message | Replace |

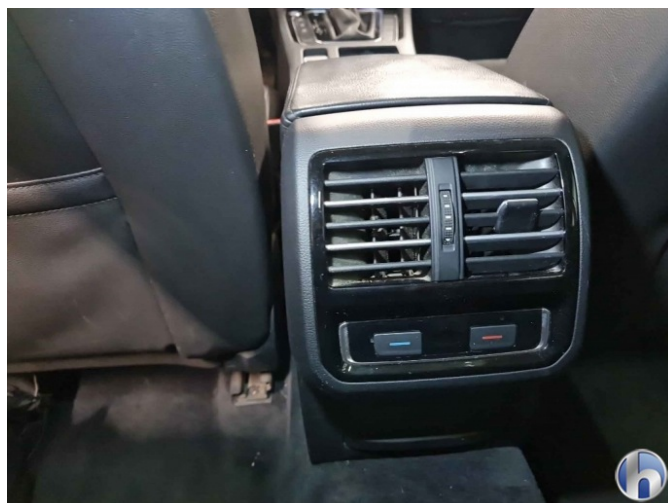
| component | Damage | Rep kind |
|---|---|---|
| 9. Luftausströmer hinten | Damaged | Replace |

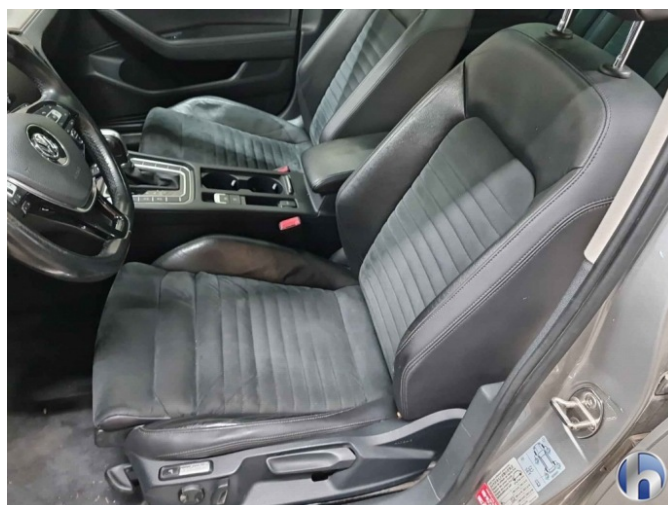
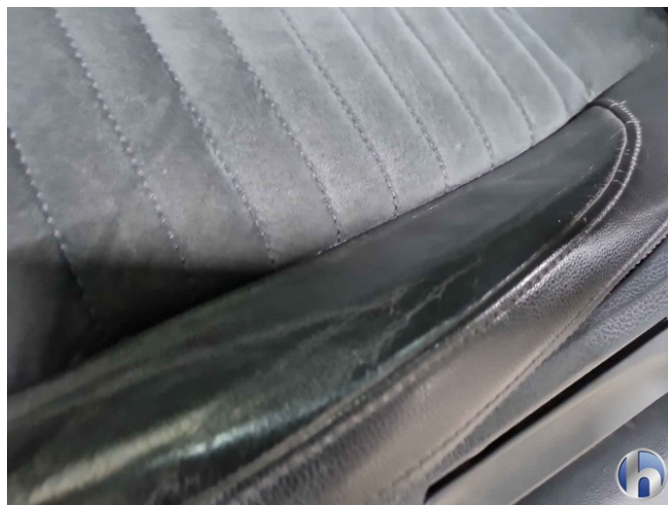
| component | Damage | Rep kind |
|---|---|---|
| 11. Sitz - Vorne - Links | Damaged | Replace |

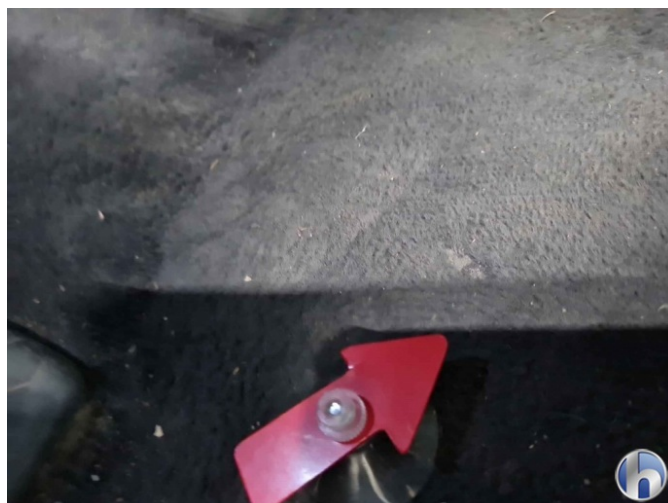
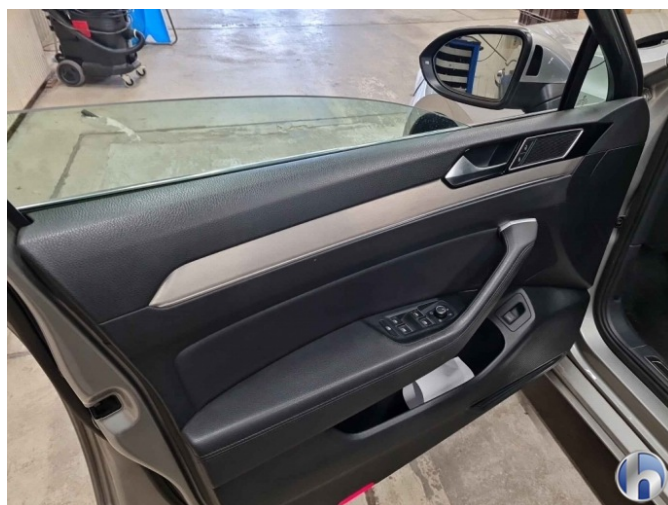
| component | Damage | Rep kind |
|---|---|---|
| 12. flooring | Burn hole | Smart repair |

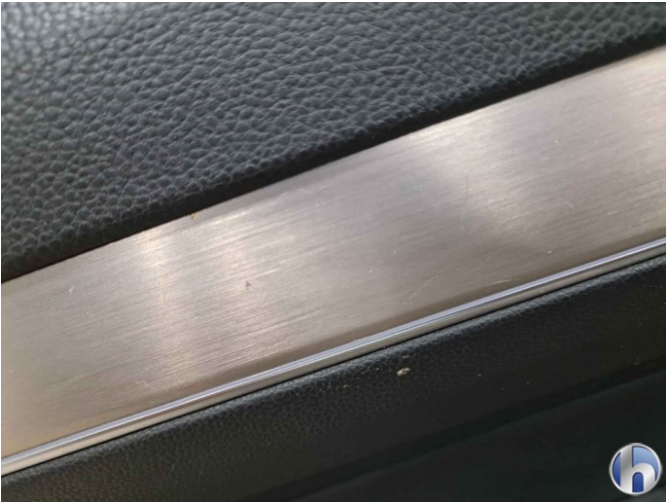
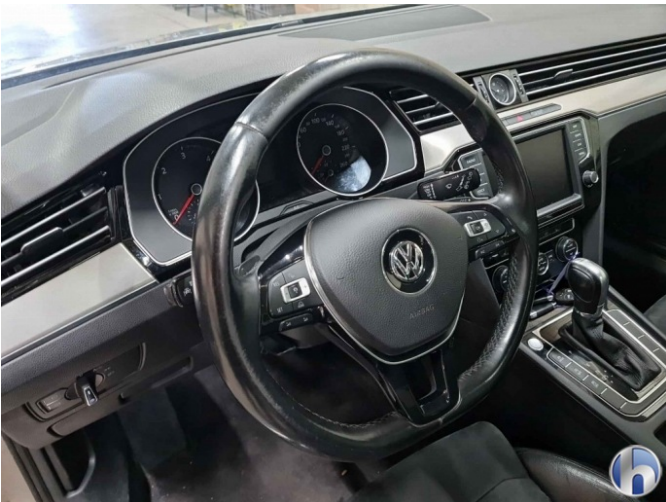
| component | Damage | Rep kind |
|---|---|---|
| 13. Türverkleidung Vorne - Links: Zierleiste | Scratch(es) | Replace |

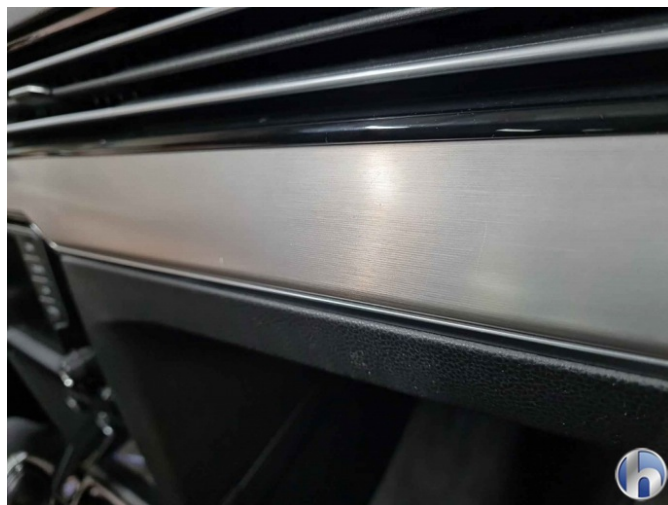
17. Armaturenbrett:Zierleiste

| component | Damage | Rep kind |
|---|---|---|
| 17. Armaturen Brett: Zierleiste | Scratch(es) | Replace |

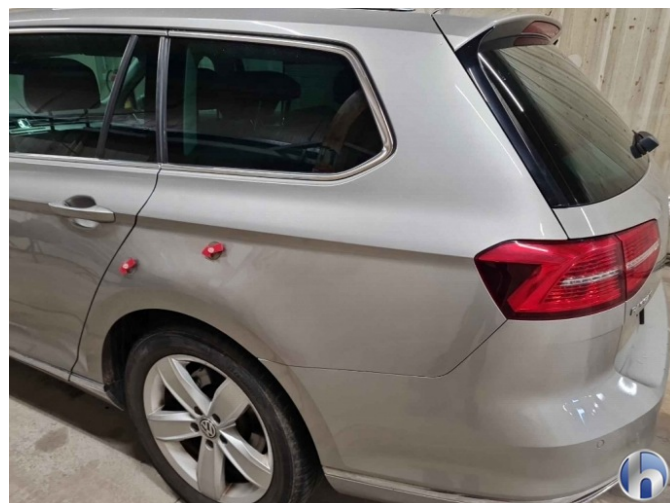
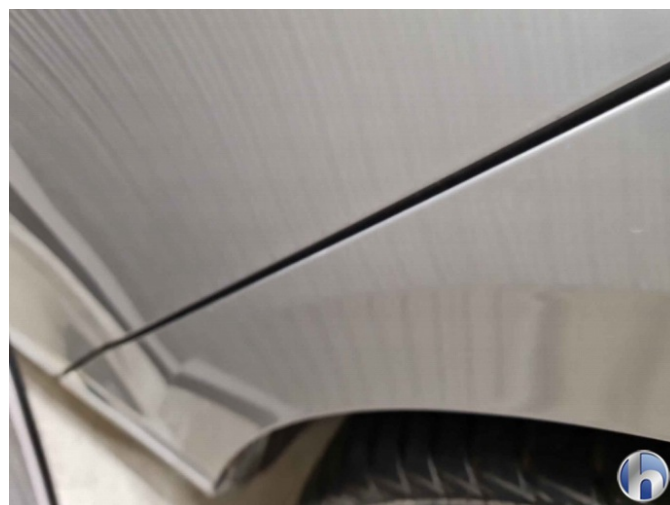
| component | Damage | Rep kind |
|---|---|---|
| 22. Sidewall - Rear - Left | Damaged | Refurbish and paint |

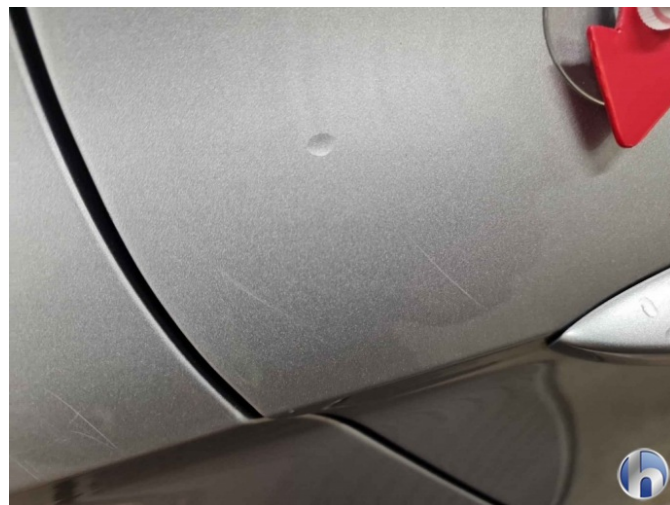
| component | Damage | Rep kind |
|---|---|---|
| 25. Door Rear - right | Damaged | Refurbish and paint |

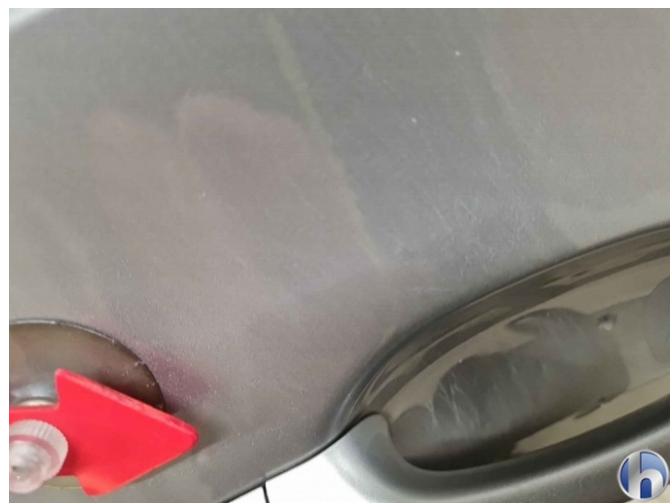
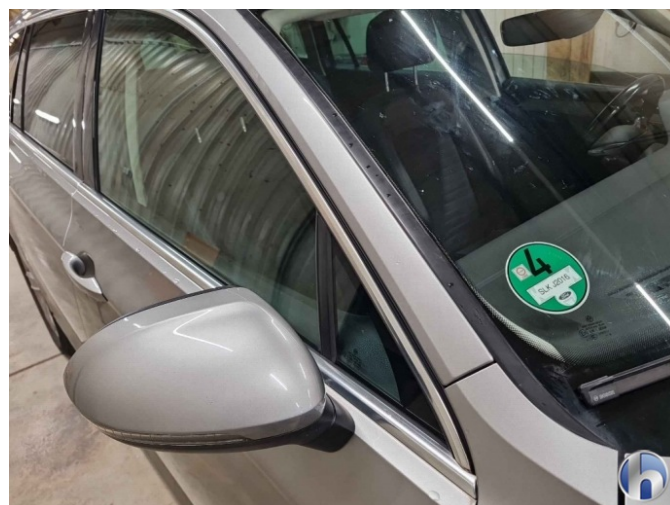
| component | Damage | Rep kind |
|---|---|---|
| 26. Front door - right | Scratch(es) | Smart repair |

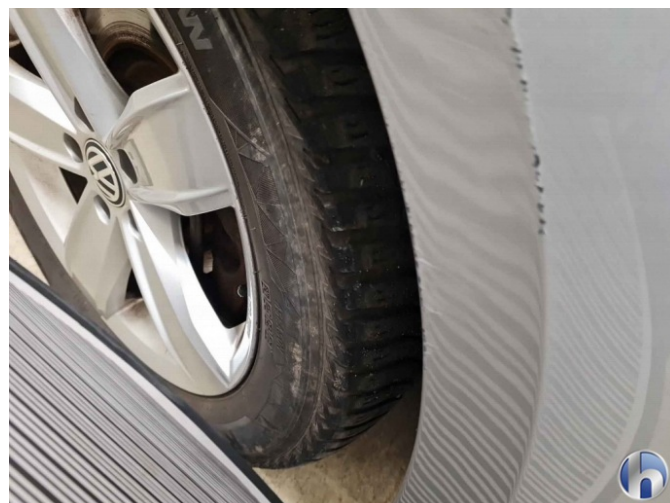
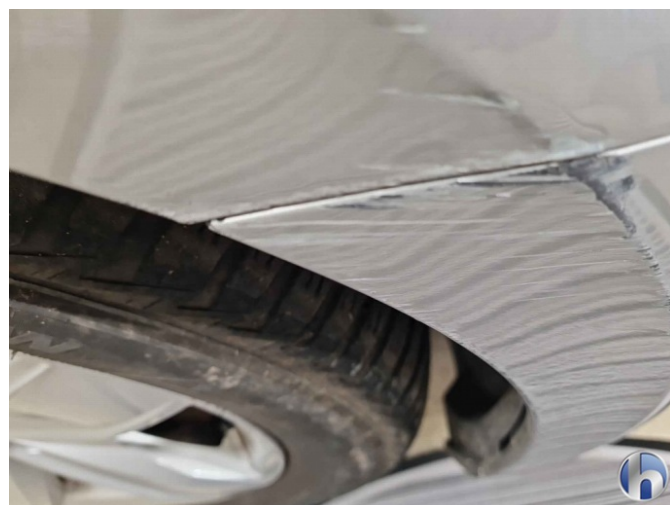
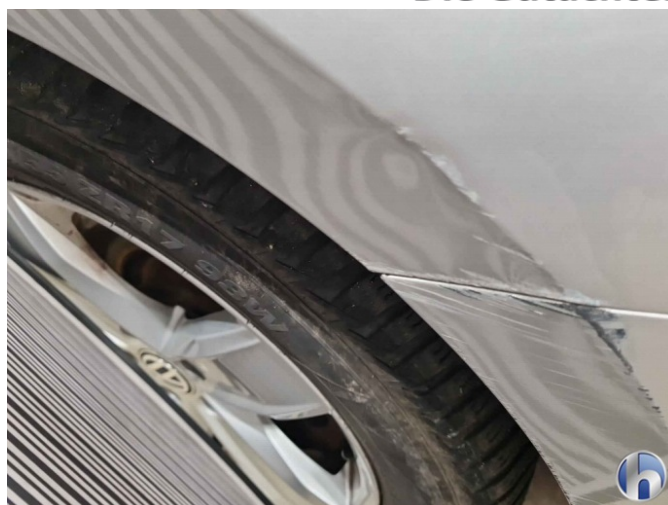
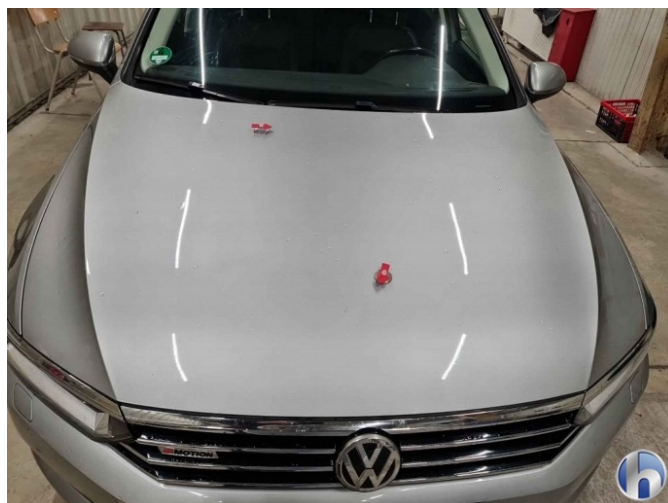
| component | Damage | Rep kind |
|---|---|---|
| 28. Fahrzeug vorn | Accident damage | Refurbish and paint |

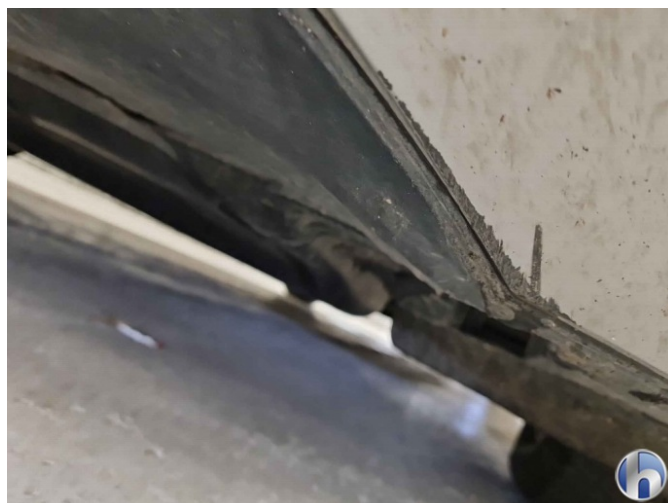
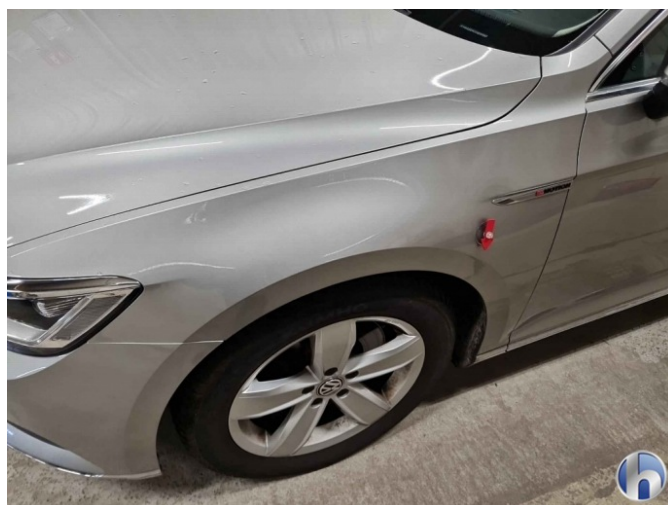
| component | Damage | Rep kind |
|---|---|---|
| 30. Frontspoiler | Scrape | Replace |

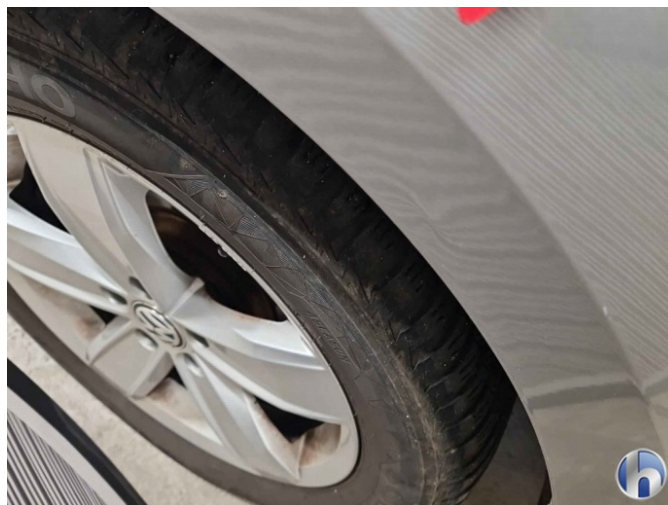
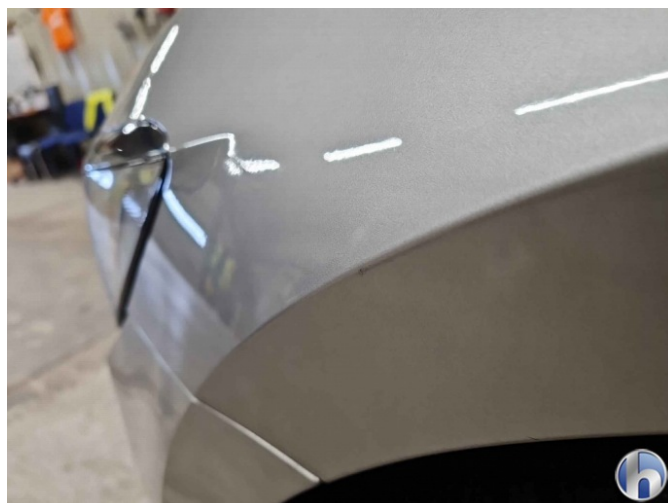
| component | Damage | Rep kind |
|---|---|---|
| 31. Front fender - left | Damaged | Refurbish and paint |

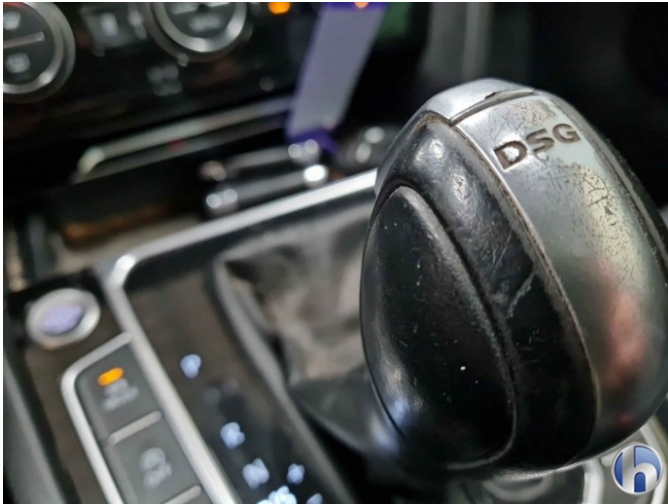
| component | Damage | Rep kind |
|---|---|---|
| 36. Wählhebel | Material wear | Replace |
