Expertise

Protocol number: 41795377  
Order number / reference: 25226219  
Inspection date: 25 Sept 2025

Manufacturer: Volkswagen

Model: Passat Variant 1.4 TSI Plug-In-Hybrid DSG GTE

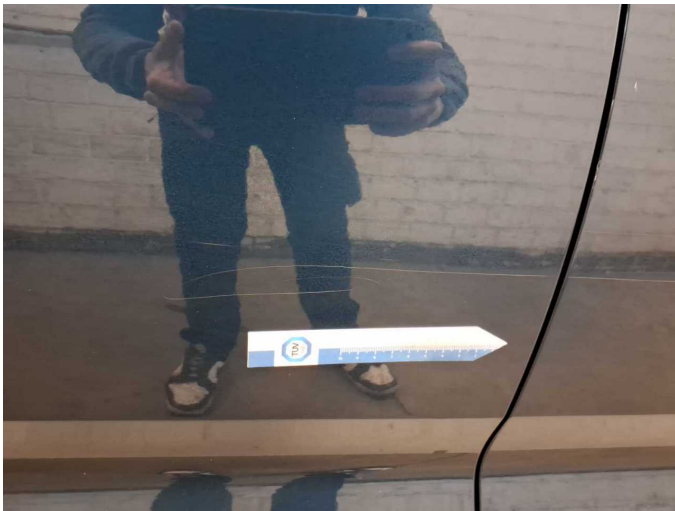
**Accident 1: Side right**

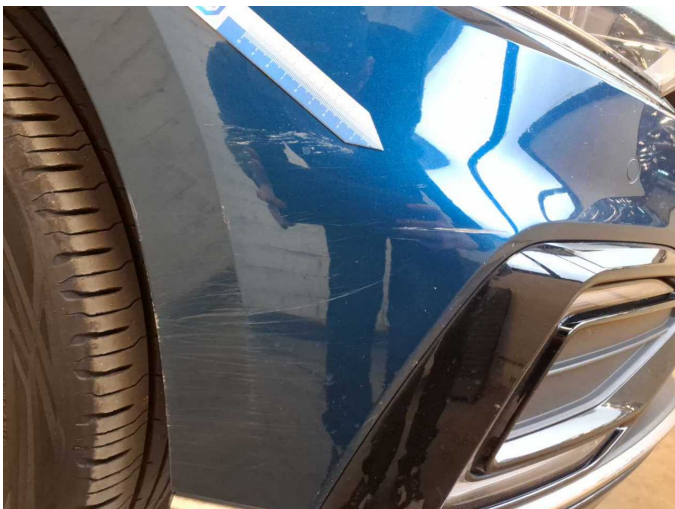
**Accident 2: Front, Side right**

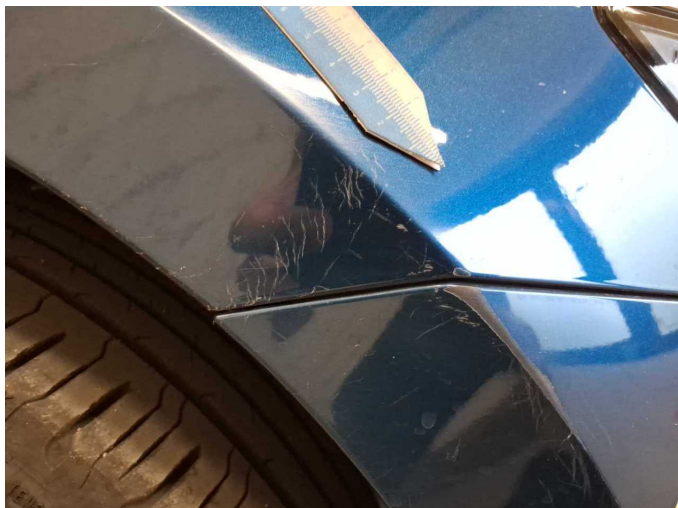
**Accident 2:** Front, Side right

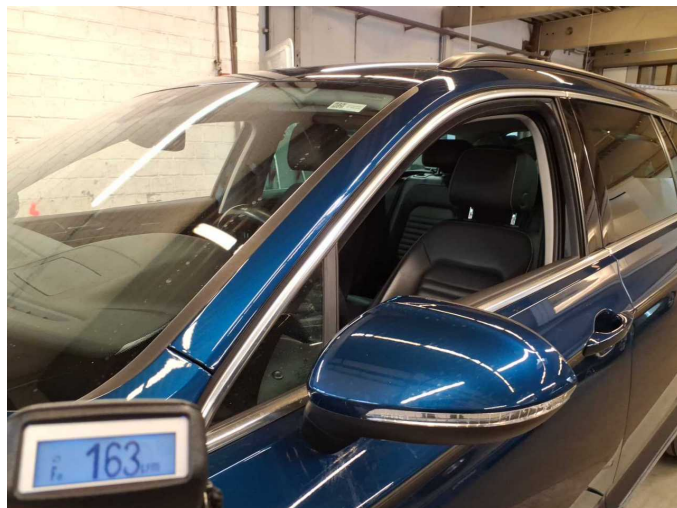
**Repainting 1:** Roof rail - left side

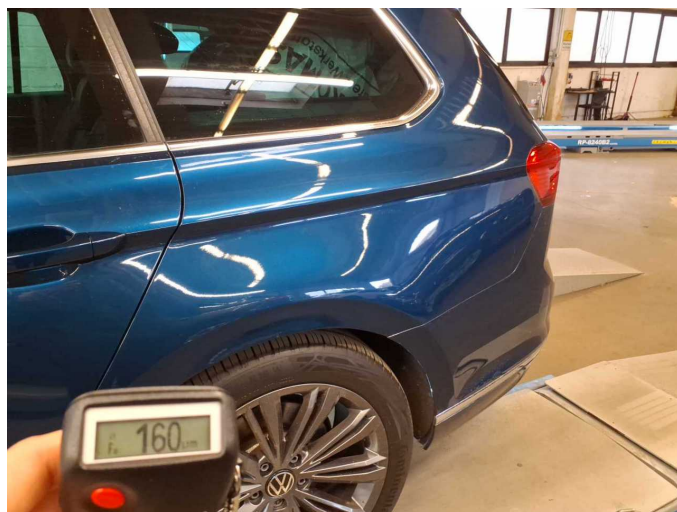
**Repainting 2:** Side panel - rear left side

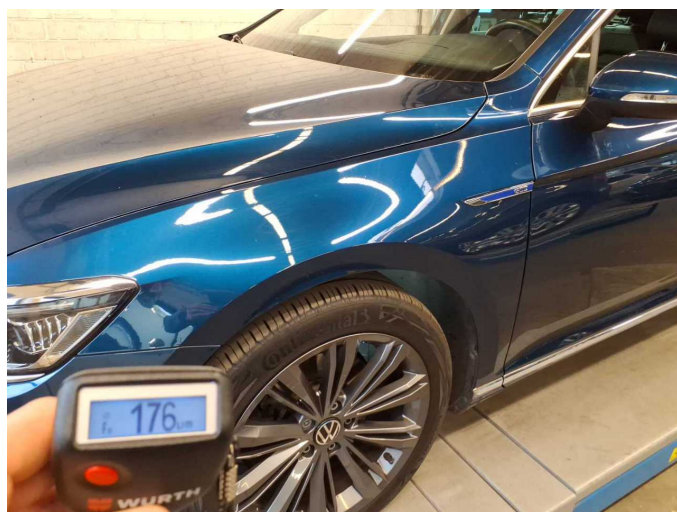
**Repainting 3:** Mudguard - left side

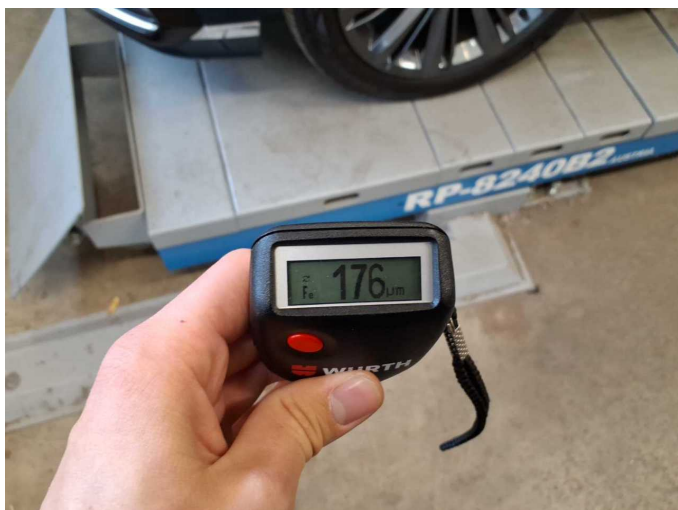
**Repainting 3:** Mudguard - left side
