Expertise

Protocol number: 41662710
Order No. / Reference: 25185031
Inspection date: 19 Sept 2025

Manufacturer: Volkswagen

Model: Passat Variant 1.4 TSI Plug-In-Hybrid DSG GTE

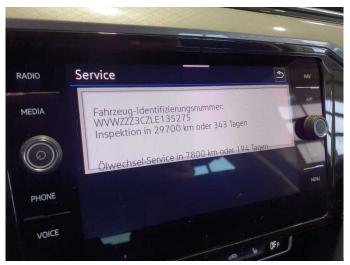
Damage 1: Multimedia system: On-board computer - Electrical fault - No deduction

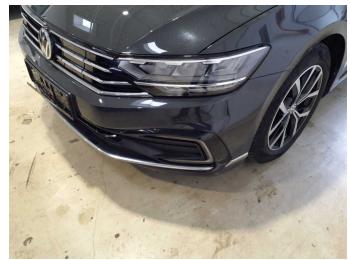
Accident 1: Front

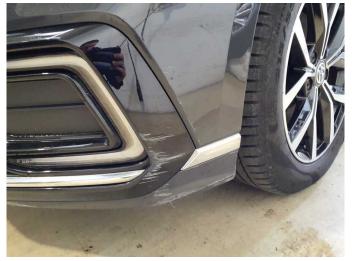
Accident 1: Front

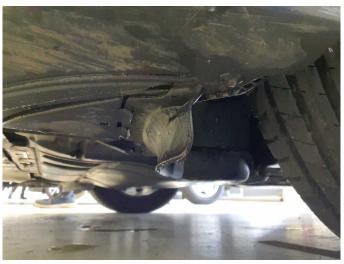
Accident 1: Front

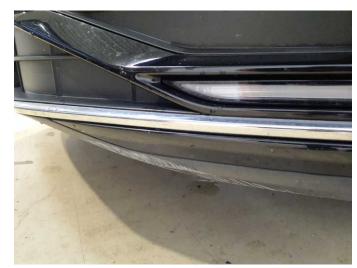
Accident 1: Front

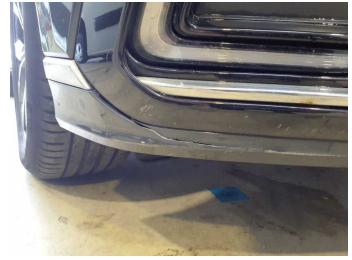
Accident 1: Front

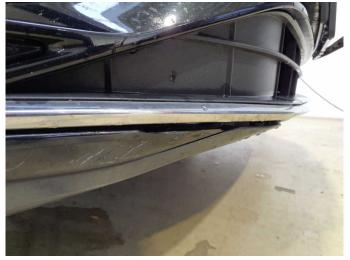
Accident 1: Front

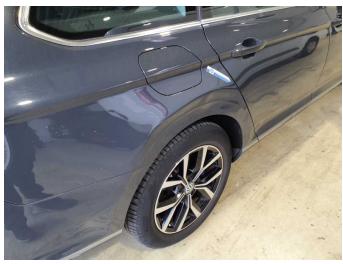
Accident 2: Side right

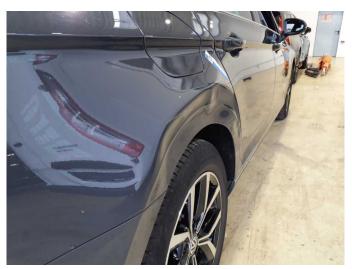
Accident 2: Side right

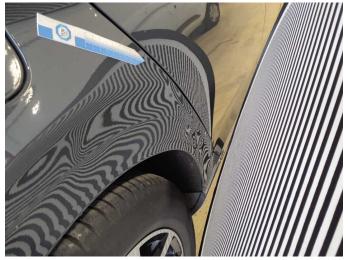
Accident 2: Side right

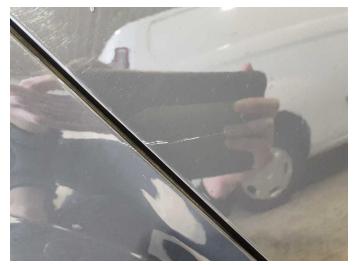
Accident 2: Side right

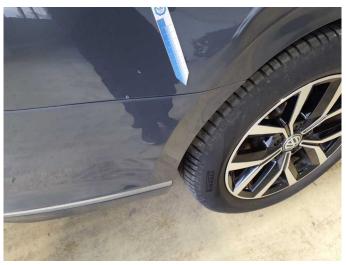
Accident 2: Side right

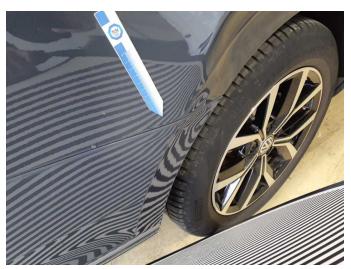
Accident 2: Side right
