Expertise

Protocol number: 41468356  
Order No. / Reference: 25144539  
Inspection date: 8 Sept 2025

Manufacturer: Volkswagen

Model: Passat Variant 1.4 TSI Plug-In-Hybrid DSG GTE

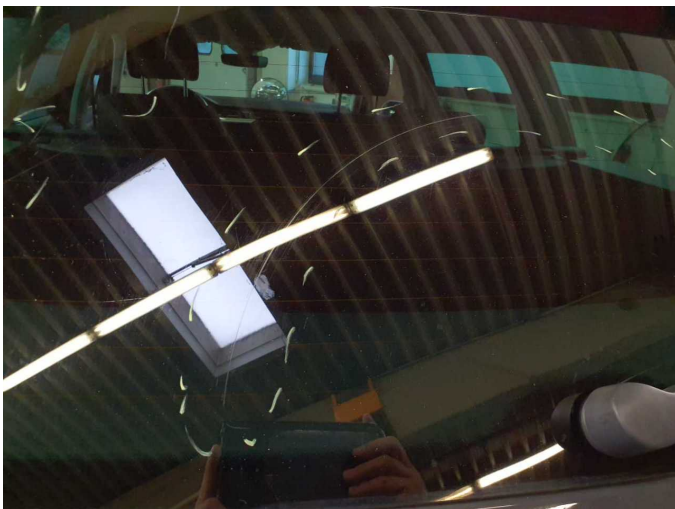
**Damage 18:** Vehicle glazing: Rear window - Scratched - Replace

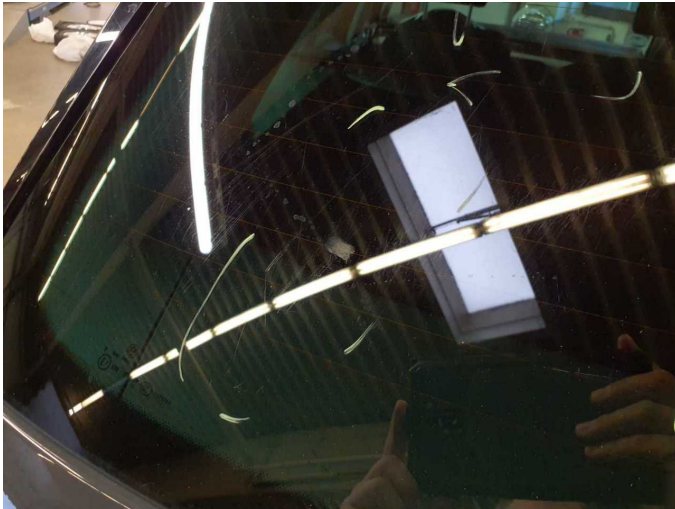
**Damage 18:** Vehicle glazing: Rear window - Scratched - Replace

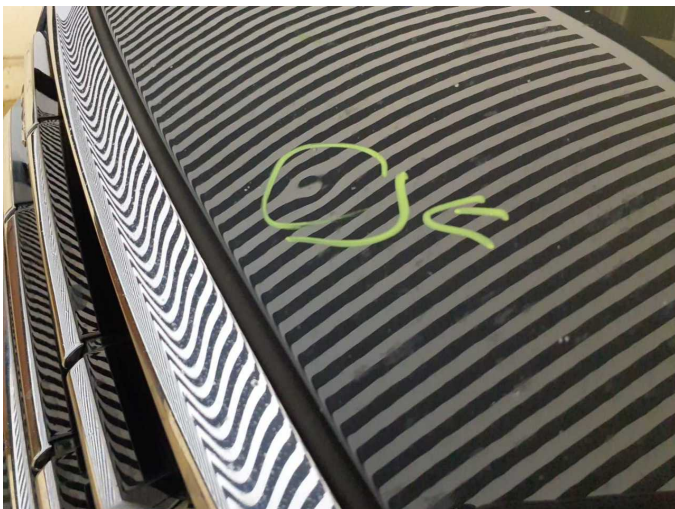
**Damage 19:** Bonnet: Bonnet - Dent / paintcoat damage - Repair and paint
