## status report

**customer:** Bank 11, Neuss  
**contract number:** 922079830  
**reference:**

#### Volkswagen up! move up!

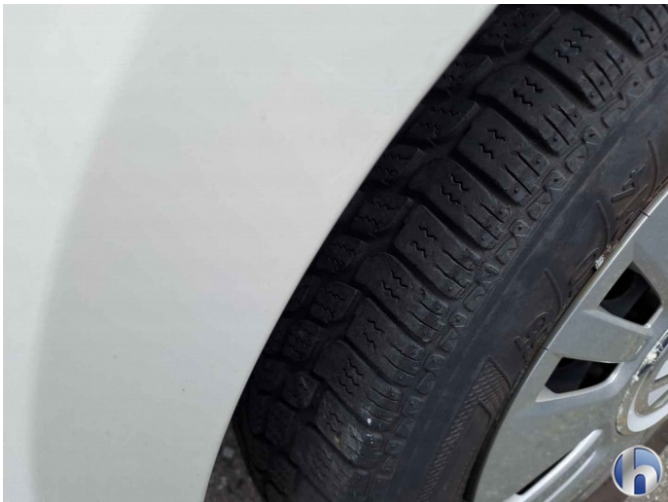
| component | Damage | Rep kind |
|---|---|---|
| 2. tire front - left | Worn | Replace |

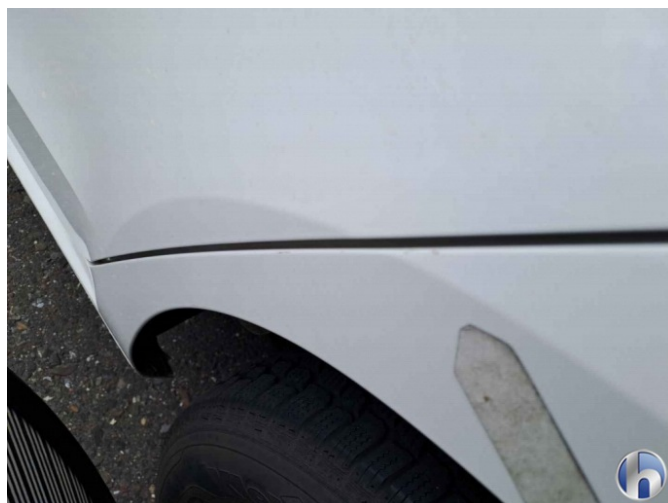
| component | Damage | Rep kind |
|---|---|---|
| 7. Sidewall - Rear - Left | Damaged | Refurbish and paint |

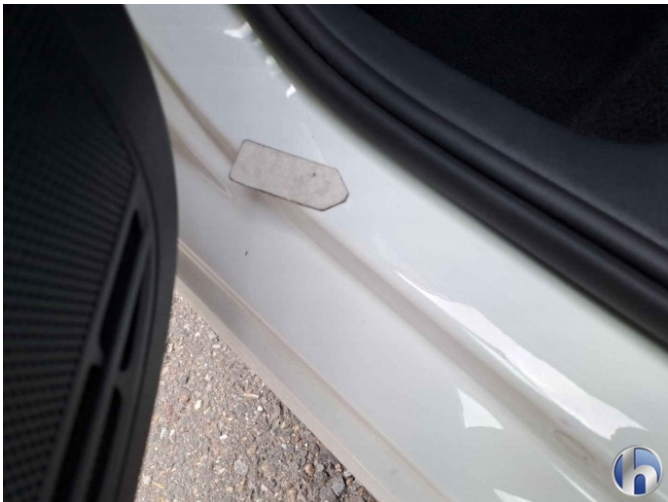
| component | Damage | Rep kind |
|---|---|---|
| 10. Türeinstieg Hinten - Links | Damaged | Refurbish and paint |

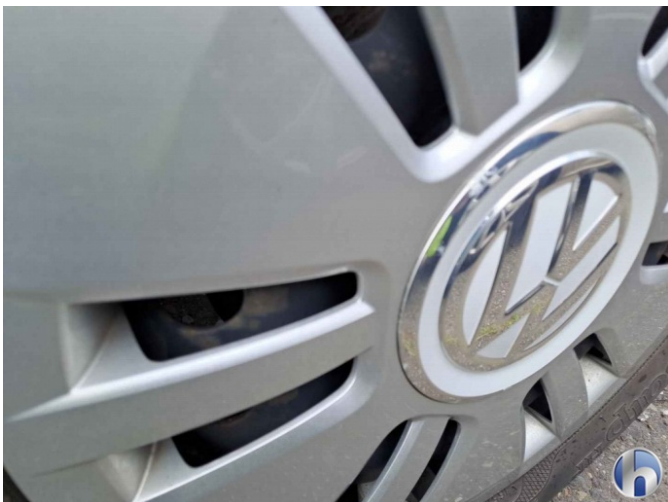
| component | Damage | Rep kind |
|---|---|---|
| 11. Hubcap - Rear - Left | Wear and tear | acceptable |

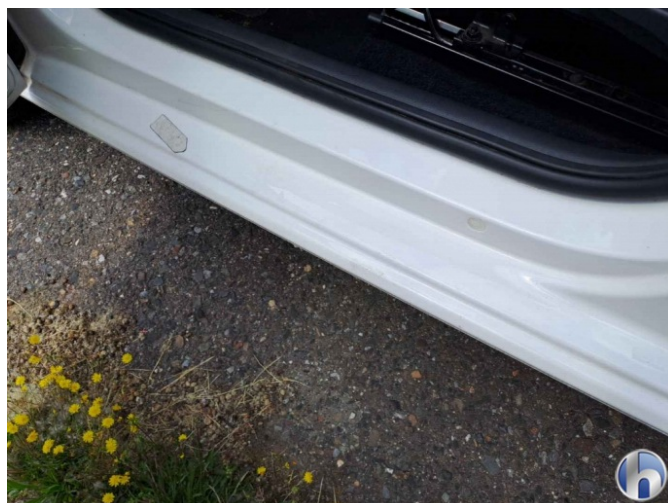
| component | Damage | Rep kind |
|---|---|---|
| 14. side skirt - left | Damaged | Refurbish and paint |

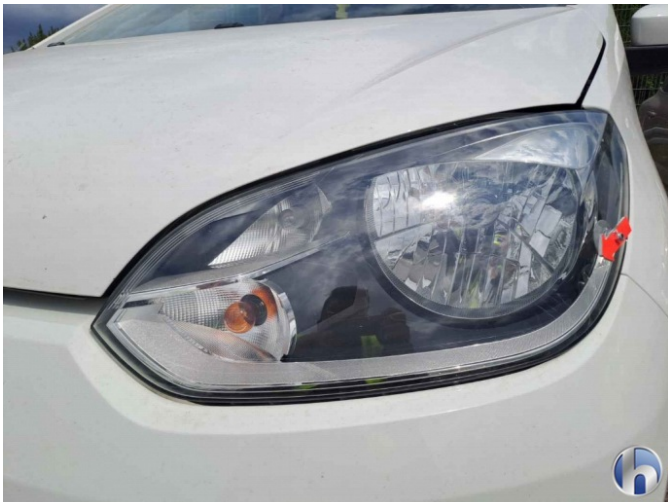
| component | Damage | Rep kind |
|---|---|---|
| 21. Halogen headlights - left | Scratch(es) | Replace |

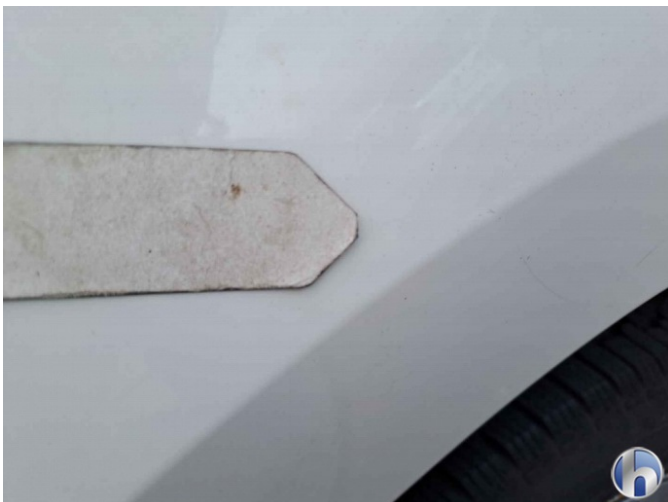
| component | Damage | Rep kind |
|---|---|---|
| 32. Sidewall - Rear - right | Damaged | Refurbish and paint |

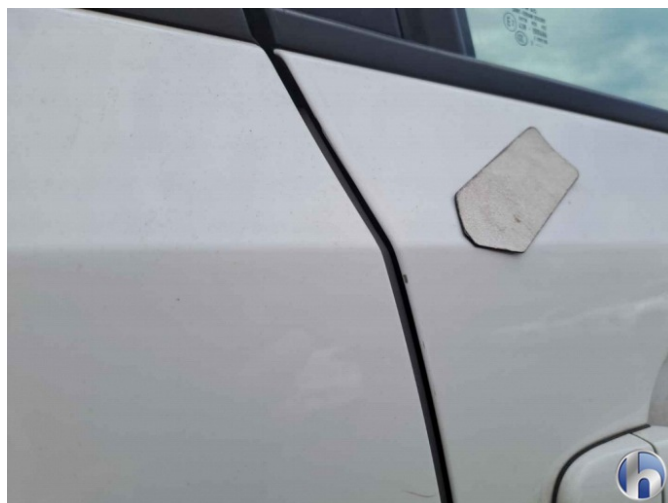
| component | Damage | Rep kind |
|---|---|---|
| 37. Front door - right | Damaged | Refurbish and paint |
