## status report

#### Volkswagen Golf VII Lim. GTI TCR Start-Stopp

| Vehicle identification number | <b>VWZZZAUZKW213637</b> | mileage read: | <b>152915 km</b> |

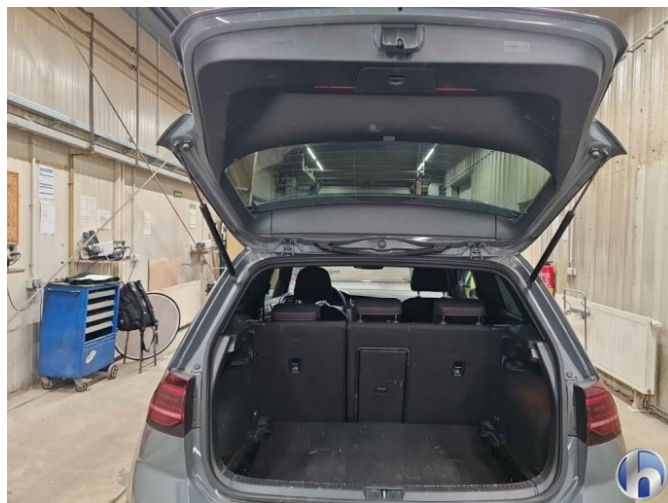
| component | Damage | Rep kind |
|---|---|---|
| 10. Kofferraum und Innenraum | Wear and tear | acceptable |

10. Kofferraum und Innenraum

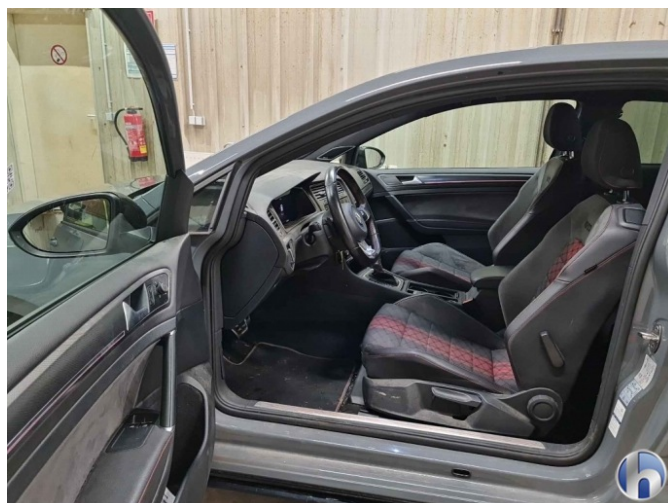
10. Kofferraum und Innenraum

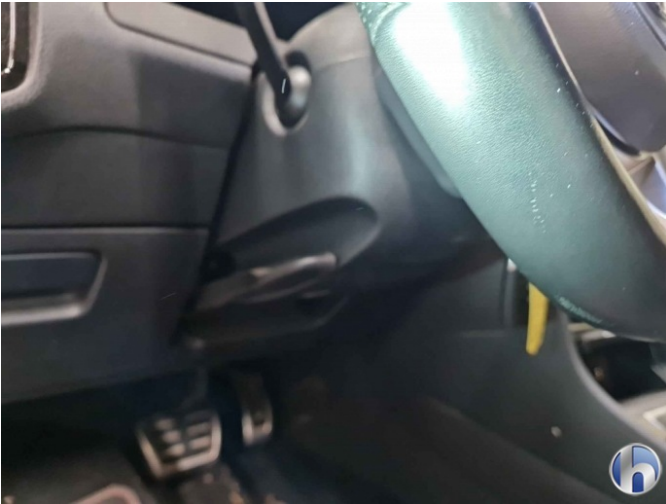
| component | Damage | Rep kind |
|---|---|---|
| 13. steering wheel | Scrape | Replace |

13. steering wheel

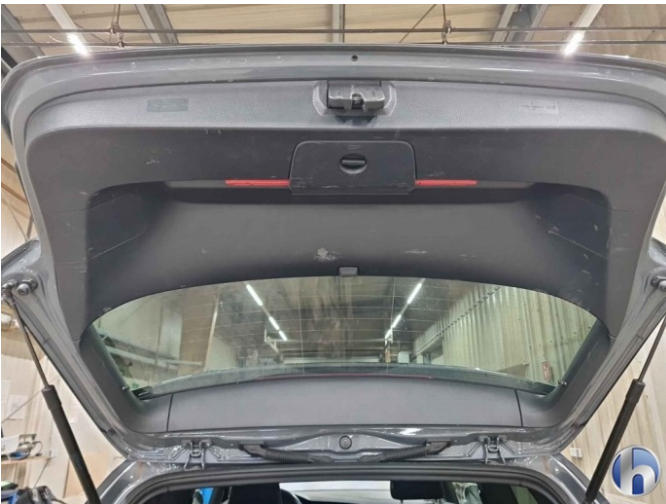
| component | Damage | Rep kind |
|---|---|---|
| 14. tailgate trim | Damaged | Replace |

14. tailgate trim

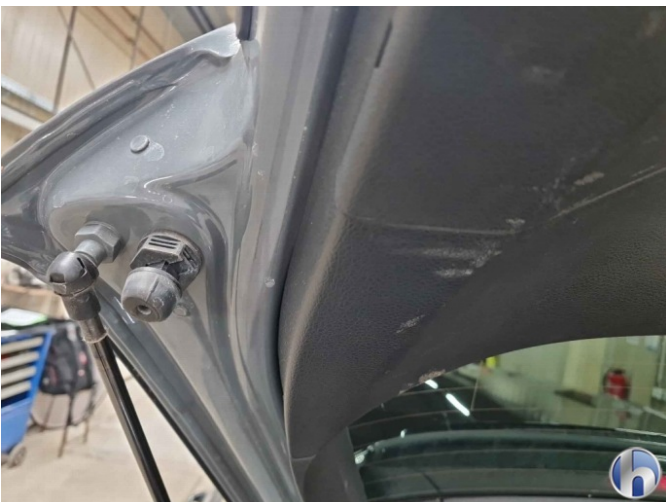
14. tailgate trim

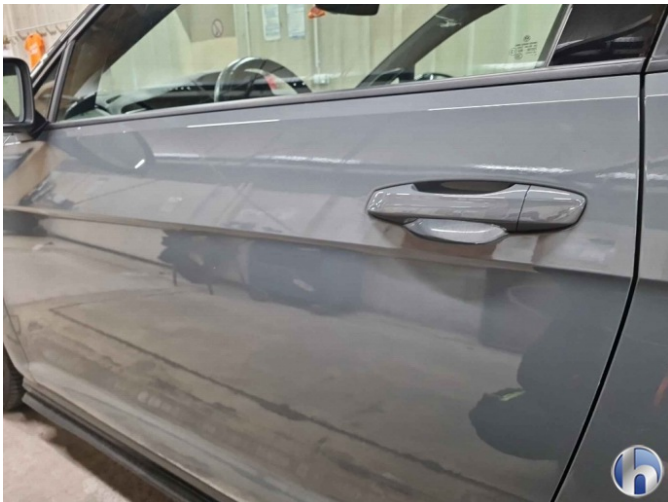
| component | Damage | Rep kind |
|---|---|---|
| 19. Front door - left | Wear and tear | acceptable |

19. Front door - left

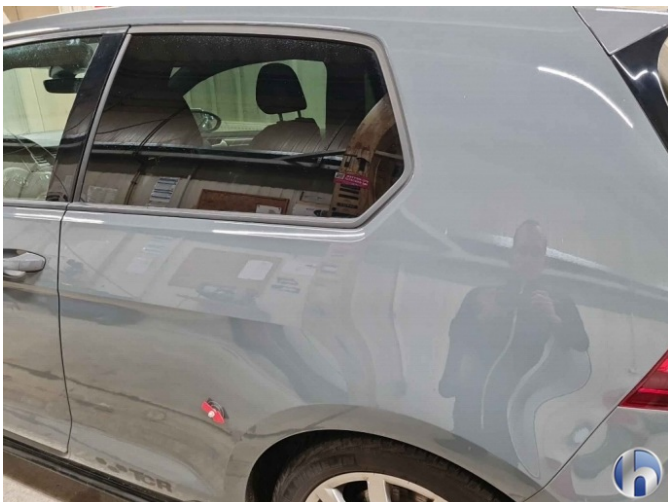
| component | Damage | Rep kind |
|---|---|---|
| 20. Sidewall - Rear - Left | Damaged | Refurbish and paint |

20. Sidewall - Rear - Left

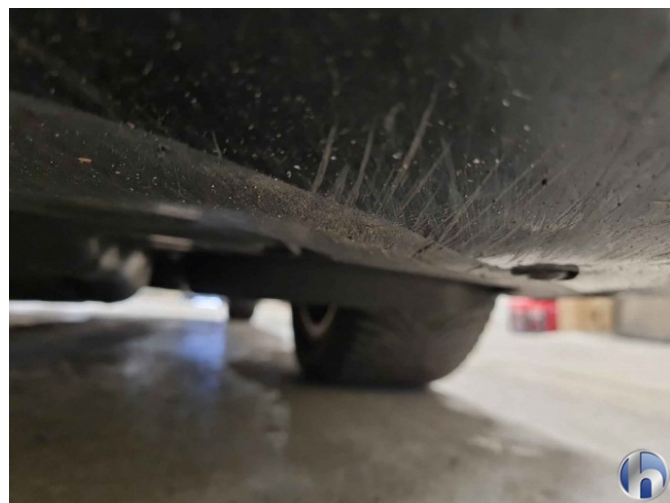
| component | Damage | Rep kind |
|---|---|---|
| 25. spoiler | Scrape | Replace |

25. spoiler
