Expertise

Protocol number: 41228948
Order No. / Reference: 25124708
Inspection date: 25 Aug 2025

Manufacturer: Volvo

Model: XC90 B5 D AWD Geartronic Momentum Pro

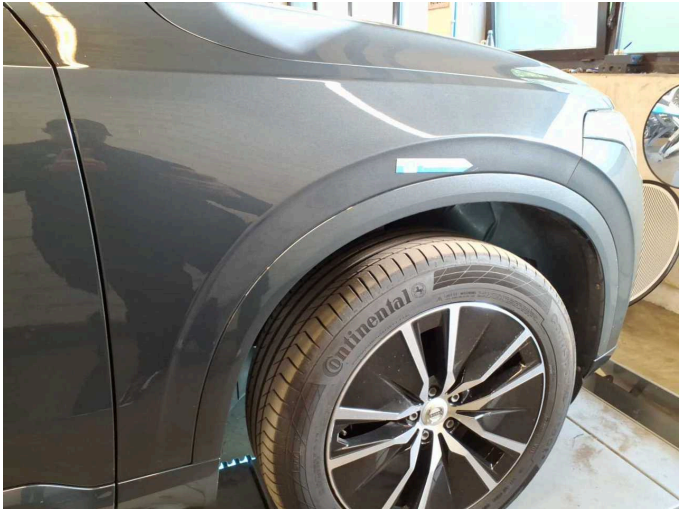
Damage 1: Mudguard - right side: Mudguard - right side - Scratch(es) - Smart repair

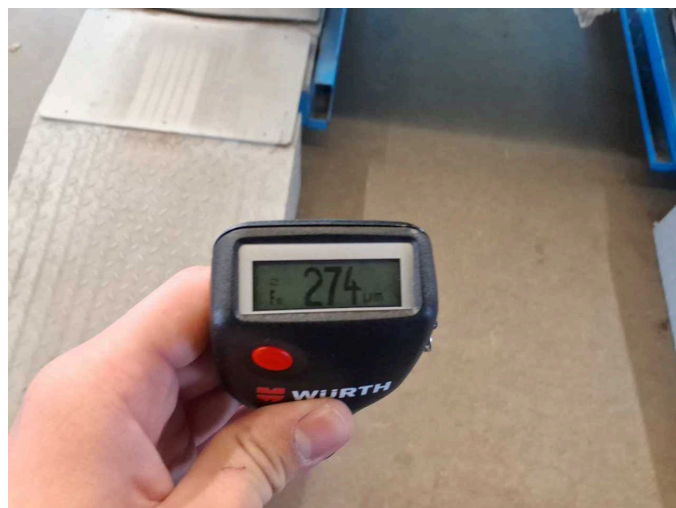
Repainting 1: Boot lid / rear door
