Expertise

Protocol number: 41153596
Order No. / Reference: 25096669
Inspection date: 18 Aug 2025

Manufacturer: Volvo	Model: XC60 B4 D AWD Geartronic Inscription
VIN: YV1UZZK5VCM1855235

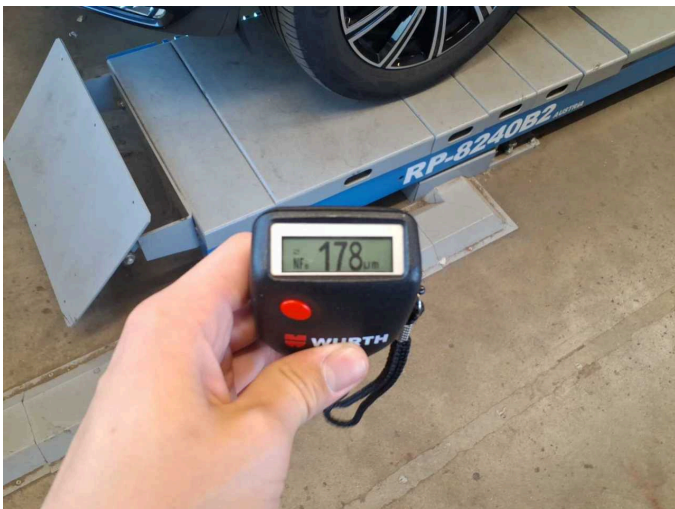
Repainting 1: Mudguard - left side

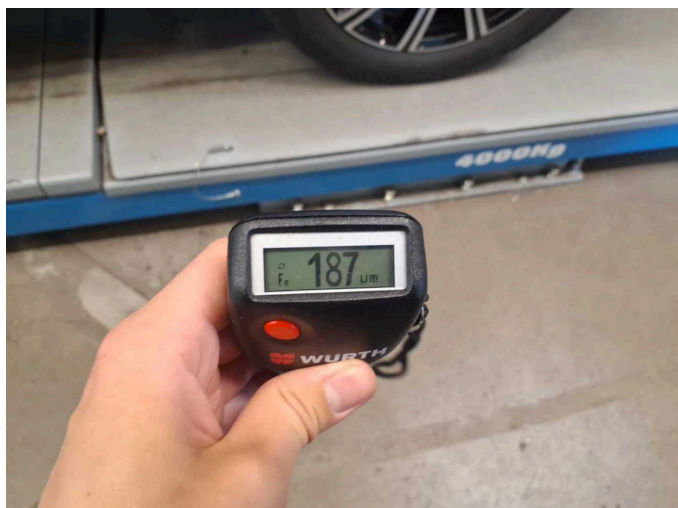
Repainting 2: Side panel - rear left side
